Lessons Learned Through 54 Years of Mistakes

Chuck Easton, P.E.
Freese and Nichols, Inc.
Fort Worth, Texas

Lessons Learned Through 54 Years of Mistakes: SOME EXPERIENCES WITH AUGERED PILES

Some Lessons Learned Through 54 Years of Mistakes:

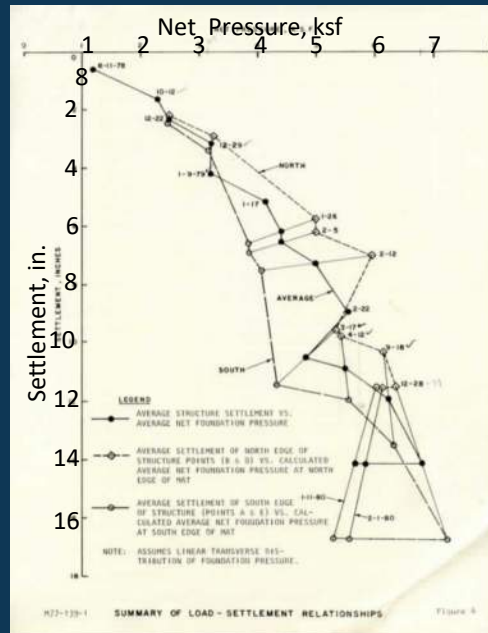
Settlement of Structure vs Net Bearing Pressure, ksf

Settlement, tilting, and pore pressure changes were closely monitored. Initial filling of the structure with grain took two harvest seasons. The elevator had a persistent tendency to tilt southward. More grain was placed in the north tanks to counteract the tilt, but when all the cells were full, the average settlement was 14 inches, and the tilt was 17 inches at the top of the cells.

The facility was still usable.

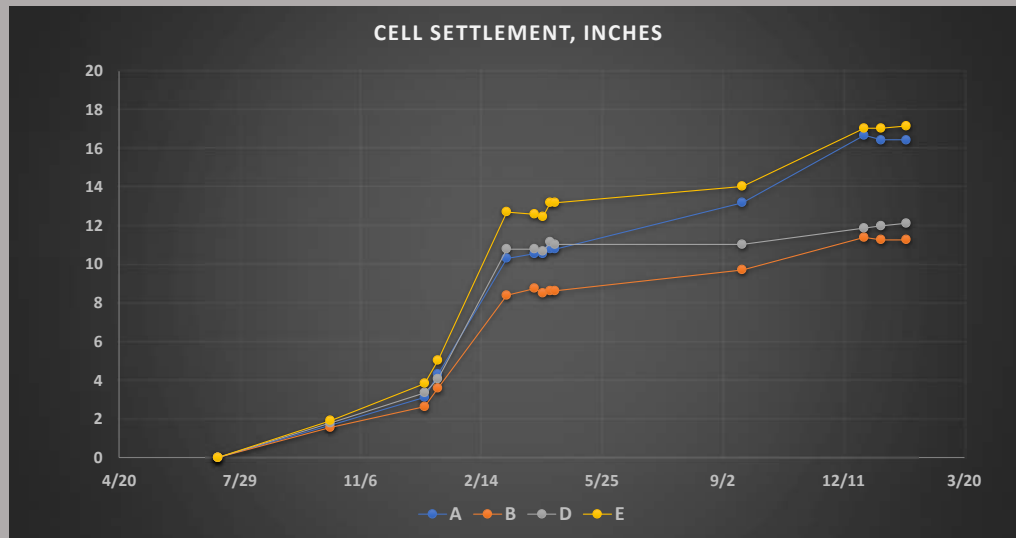
Structure Settlement vs Time

This chart shows the settlement of the four corners versus time. The south side settled about 4 inches more than the north side.

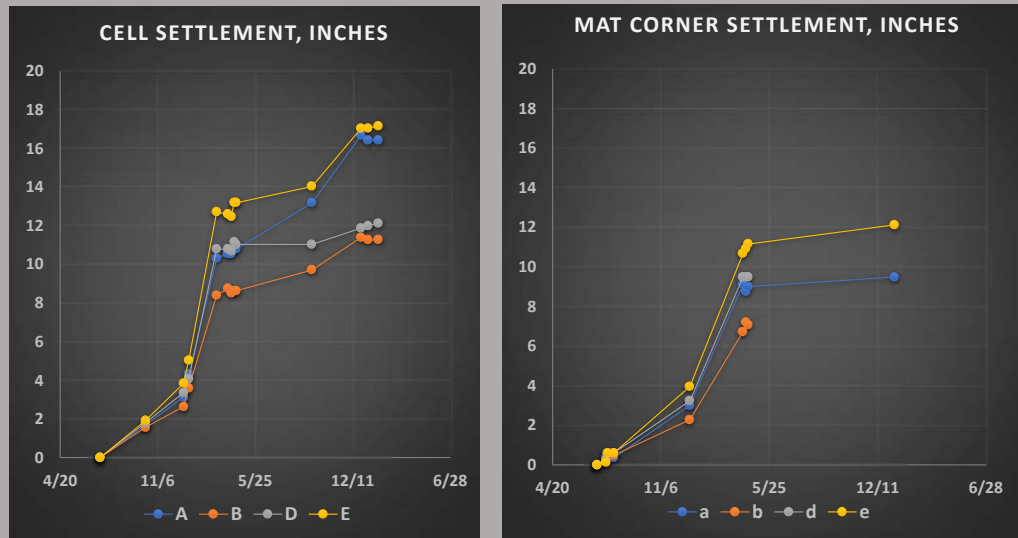
Settlement of Mat vs Cells

Comparison of the settlement of the mat corners to the settlement of the walls showed differences of several inches.

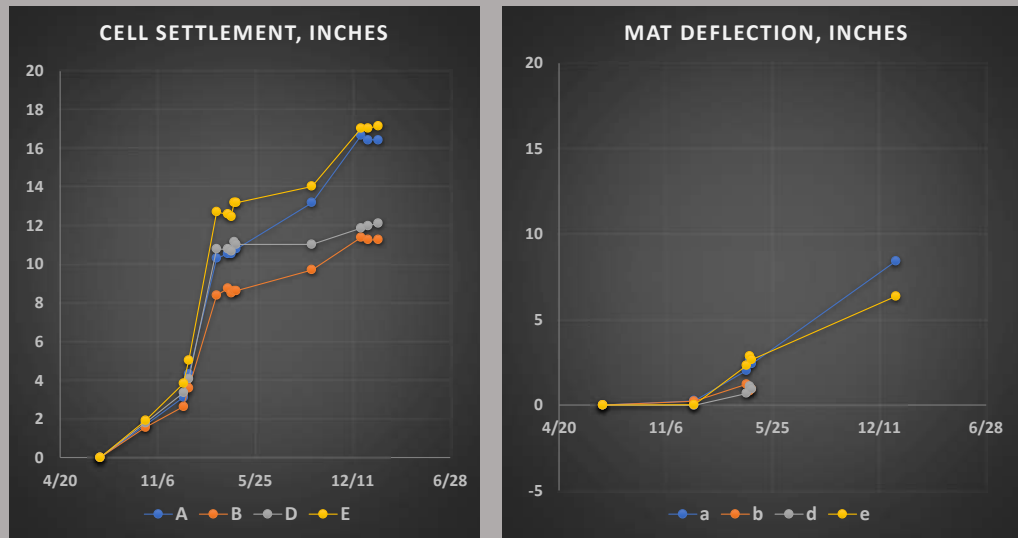
Settlement of Mat vs Cells

The two south corners of the mat had deflected upwards about 5.2 and 6.8 inches. This deflection must have involved a structural failure of the foundation.

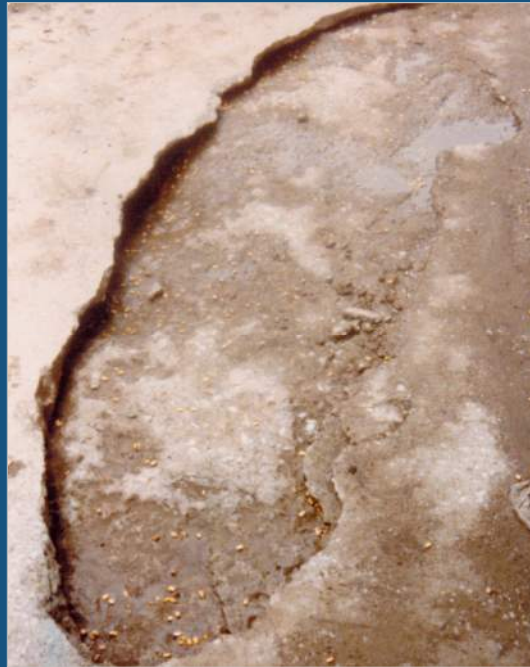
Broken Mat

In the spring, when most of the grain had been removed through normal seasonal operations, the builder uncovered the foundation. The cantilever had sheared off.

- The mat foundation was designed assuming a uniform soil bearing pressure across the mat, including the cantilevered parts outside the walls. The high pressures that developed there created bending and shear stresses that greatly exceeded the strength of the reinforced concrete.

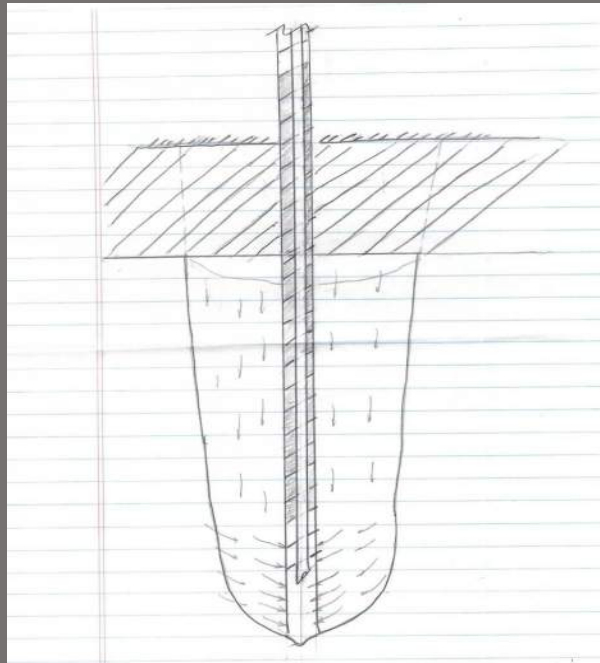
Apparent effect of Pulling Auger without Grouting

It appears that the auger removal completely loosened the sand in a column at least 10 feet in diameter.

We concluded that withdrawing the auger without grouting loosened the sand to a distance of more than 5 feet away.

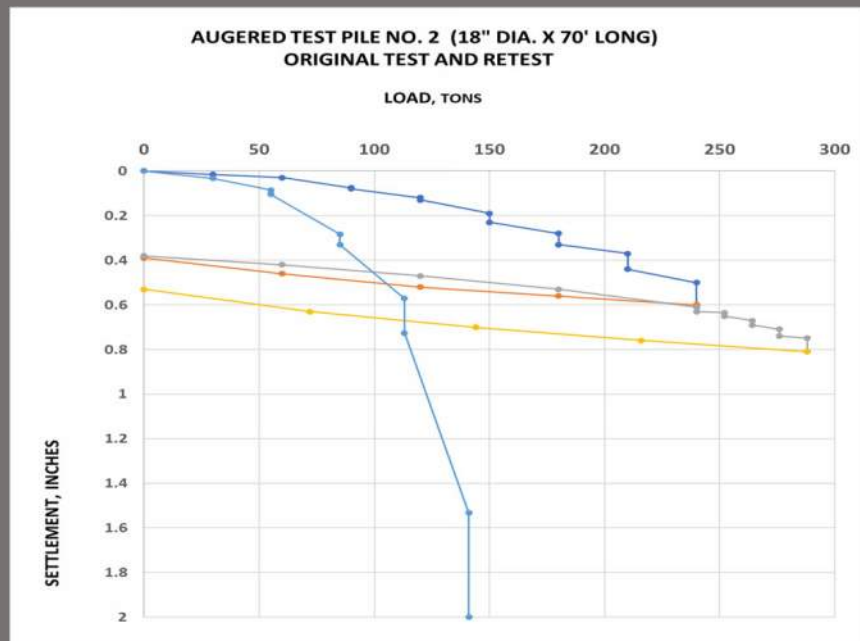
LOAD TEST RESULTS

Guess which trace is the retest.

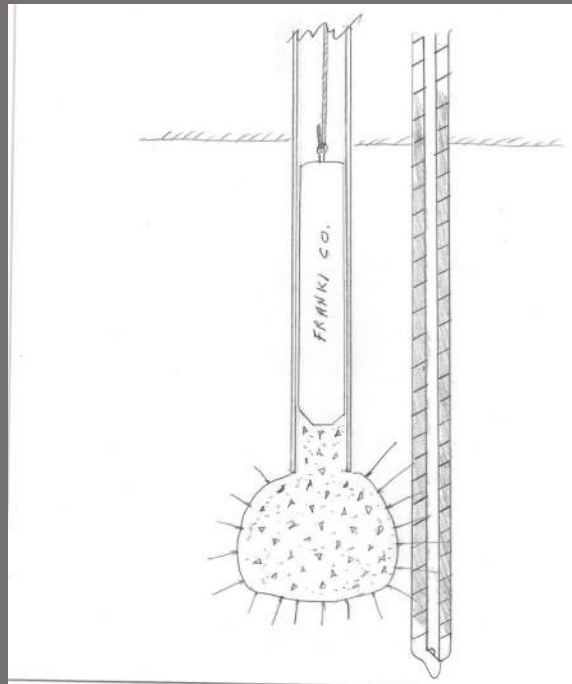
Augered Pile Installed Adjacent to Franki Pile

THE FOLLOWING MORNING, THE SOUTHEAST COLUMN OF THE EXISTING GARAGE WAS FOUND TO HAVE SETTLED ABOUT 7 INCHES OVERNIGHT.

The settlement was clearly due to the installation of the new augered piles close to the existing Franki PIFs.

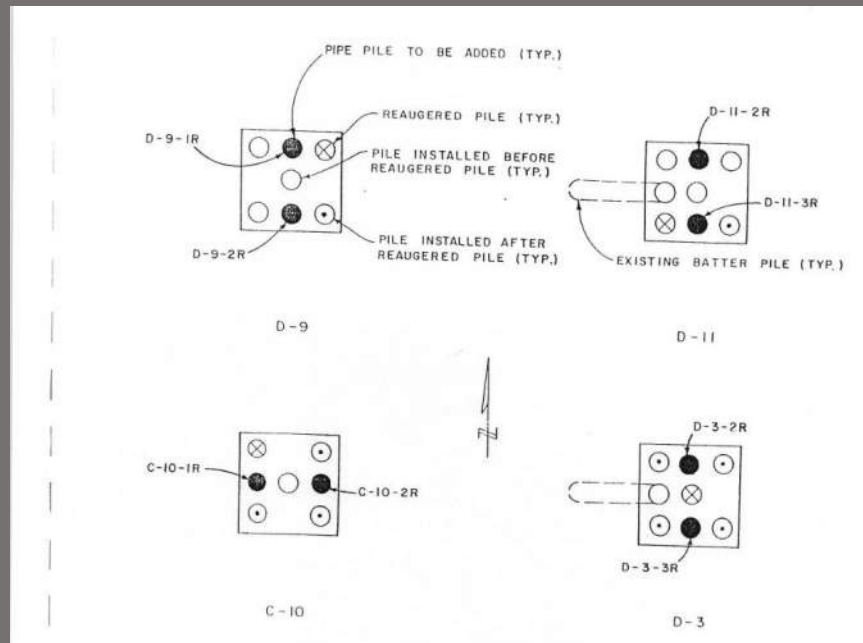
ASSUMED EFFECT OF PULLING AUGER

Previously placed piles adjacent to a re-augered pile were assumed to have negligible capacity. Piles added after the re-augered pile were assumed to have full design capacity. Steel piles were added to make up the lost capacity and provide balanced support. It was assumed that the heavy steel piles bearing on rock could provide more than 120 tons support if needed.

STEEL PIPE PILES WERE LOCATED IN PLACE OF OR BETWEEN THE AUGERED PILES AND DRIVEN TO BEDROCK AT DEPTHS RANGING FROM ABOUT 116 TO 147 FEET.

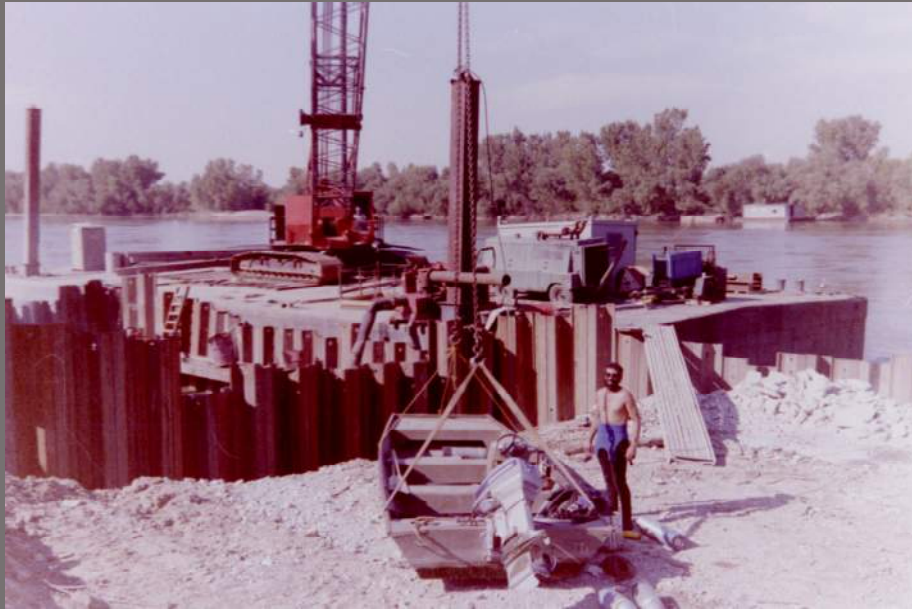
COFFERDAM AS CONSTRUCTED

Note that the sheet pile tops are higher near the left end of the downstream side.

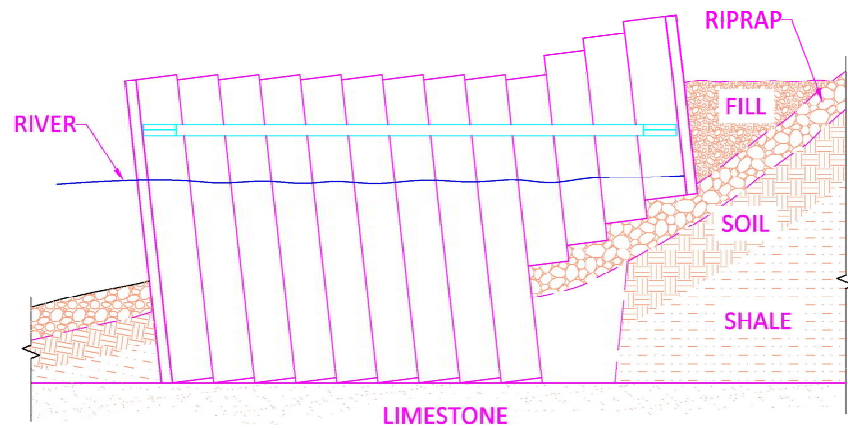
COFFERDAM AS CONSTRUCTED

The cofferdam had wracked and tilted towards the river. The excavation was short of its design width on the landward side. Some sheet piles had refused on the riprap.

Sheet piles had refused on the riprap. They never reached the shale.

The contact with the riprap was quite leaky.

More excavation needed to be done along the shoreward side, the riprap needed to be removed, and the sheet piles needed to be driven down.

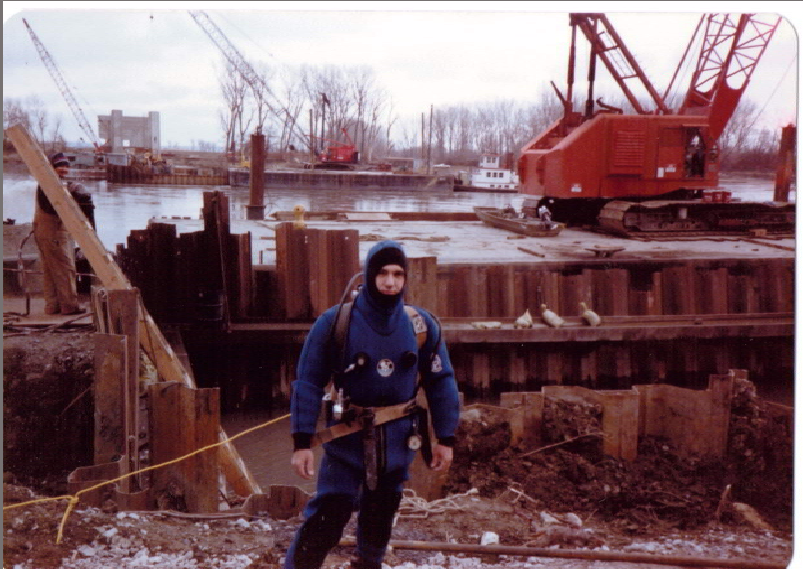
FINAL INSPECTION

I swept the bottom with my hand while following a pipe across the excavation. The pipe was moved, and the procedure was repeated until the entire surface had been examined. Footing corners were marked using a plumb pipe, and I confirmed that the entire bearing surface was ready
