Foundation Performance of Millennium Tower in San Francisco, CA

Jonathan P. Stewart, PhD, PE

UCLA Samueli Engineering

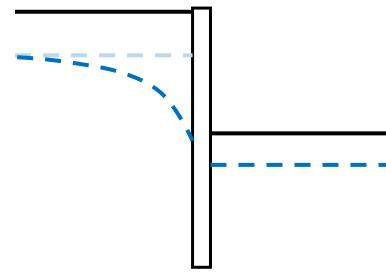
Cutoff walls; gw lowering possible if:

Leaks through walls
Gaps in walls
Underseepage

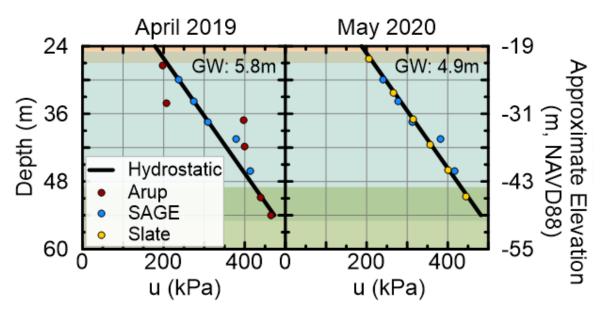
Piezometers in OBC

- Used to evaluate potential under-consolidation
- Interpretation: Consolidation effectively complete in mid-2020 (maybe earlier)

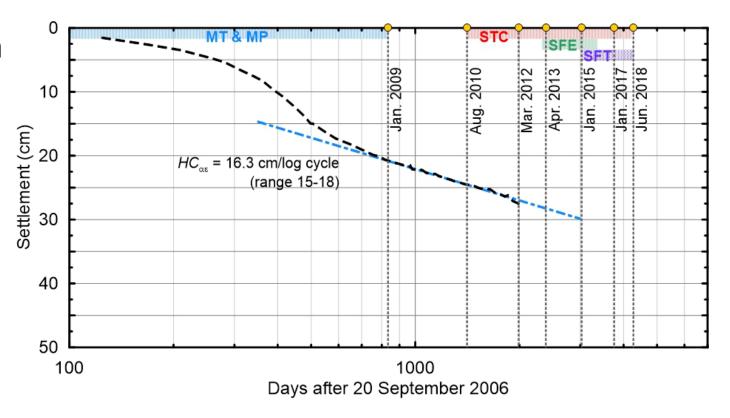
- Stress comparison to σ_p'
- Secondary compression was strong contributor
- Some consolidation may have still been occurring > 2009

H=7-12 m \rightarrow implied $C_{\alpha\varepsilon} = 0.013 - 0.022$

Laboratory data: 0.006-0.016 (avg 0.01)

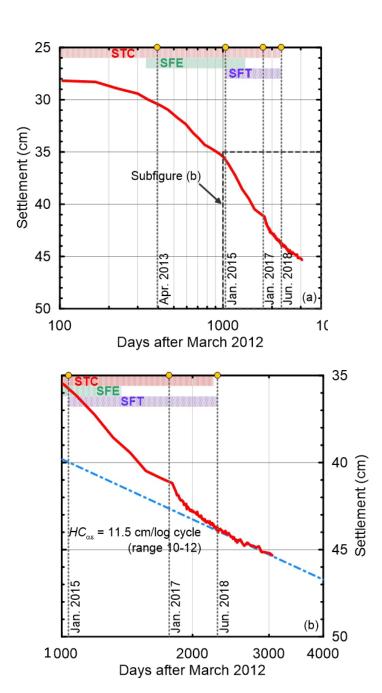
Since 2012

- Concept of time "reset"
- Reset in 2012
- Pattern complicated by multiple loading cycles
- Recent slope suggests consolidation is complete

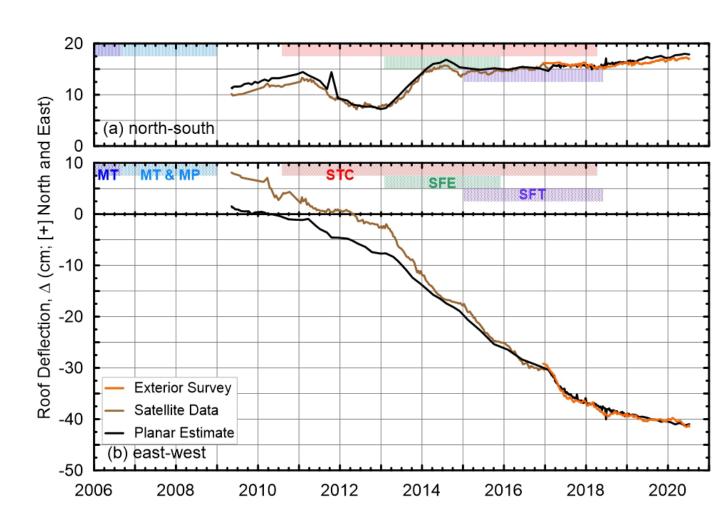
Initial (May '09) tilts estimated 2009-11: movement to north and west

2012-13: STC dewatering & excavation. 2013 SFE

2015-18: SFT / plaza dewatering & construction

After 2018: deceleration of W tilt

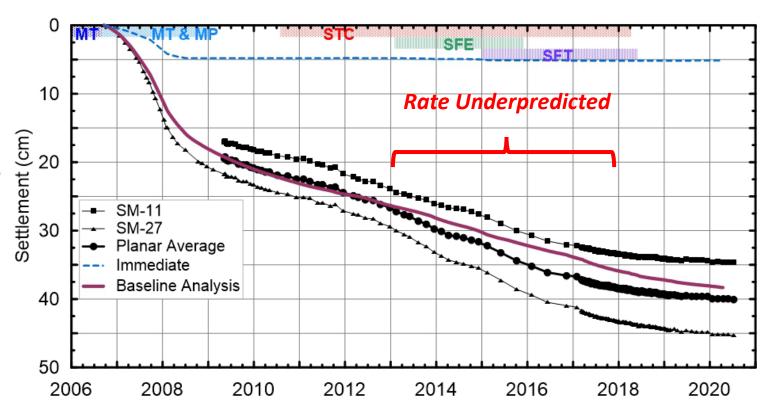
1D Settlement Results

Baseline properties

- U_{1D} =81% (late 2011)
- U_{1D}=96% (late 4/2019)
- OCR = 1.02 in 5/2020 due to gw rebound (2.1 m)

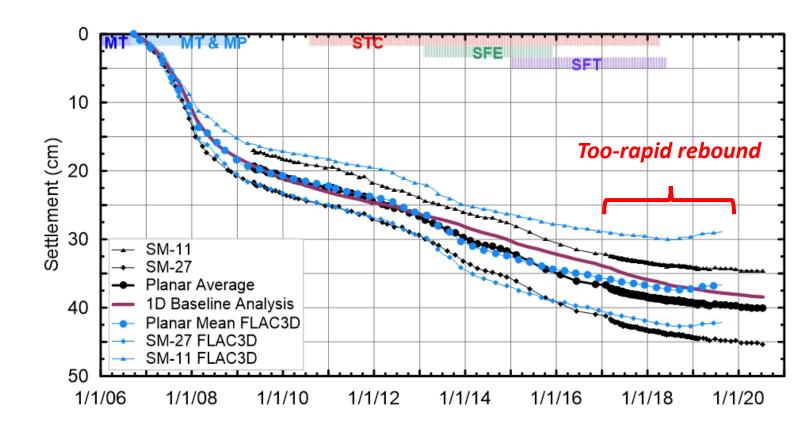
- U_{3D} =90% (late 2011)
- U_{3D}=100% (late 4/2019)
