Some Lessons Learned Through 54 Years of Mistakes: HYDROCOMPRESSION SETTLEMENT OF DEEP EARTH FILLS

CHUCK EASTON, P.E.
cne@freese.com

Some Lessons Learned Through 54 Years of Mistakes

Collapse of Tempering Cooler

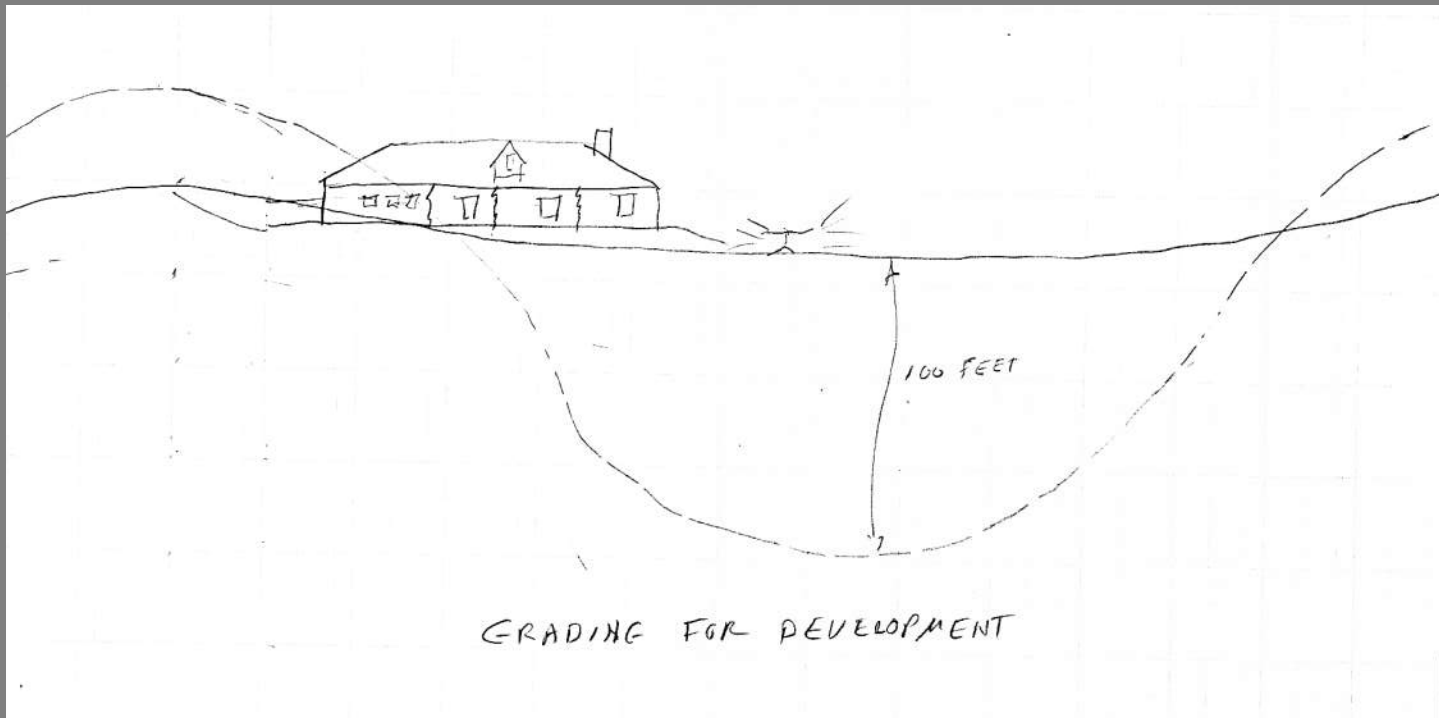
- SETTLEMENTS WERE NOTICED IN MID-1970s IN HOUSING OVER 5 YEARS OLD.
- SETTLEMENTS UP TO 18 INCHES ULTIMATELY OCCURRED
- SOME HOUSES WERE DAMAGED

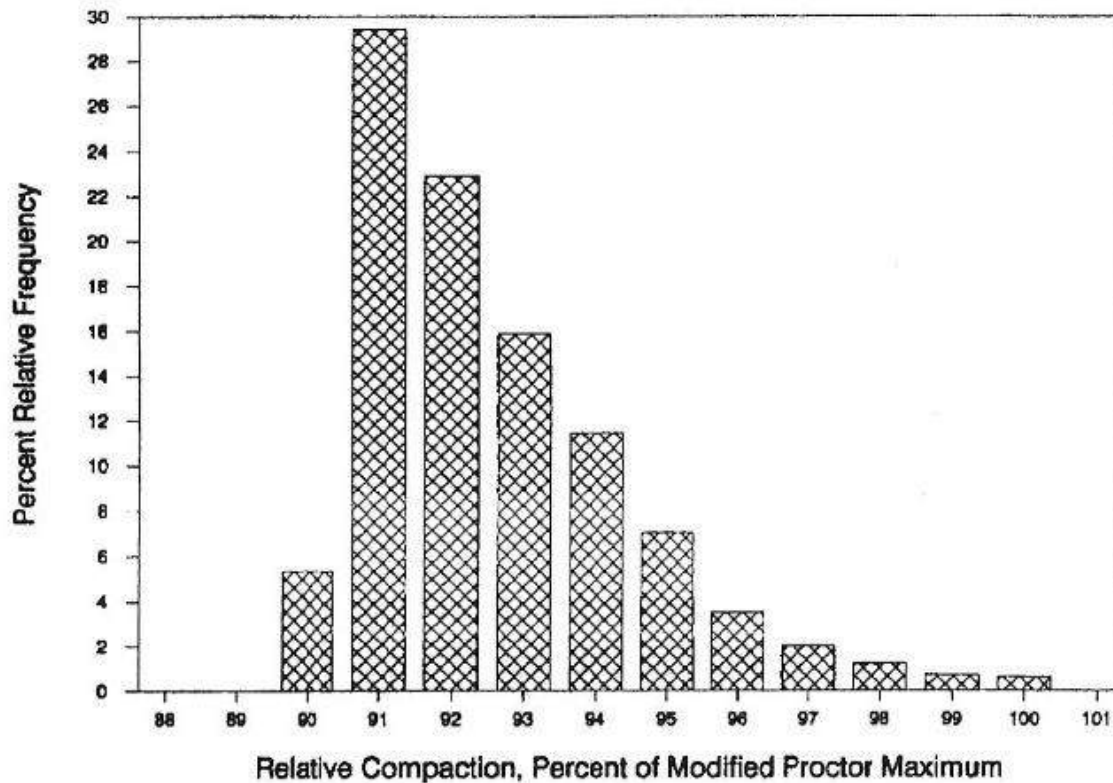
FIG. 1. Relative Compaction (ASTM D-1557) Measured for Villa Martinique Development

- PLACEMENT COMPACTION AND DENSITY COMPLIED WITH SPECS AND WERE PRETTY UNIFORM

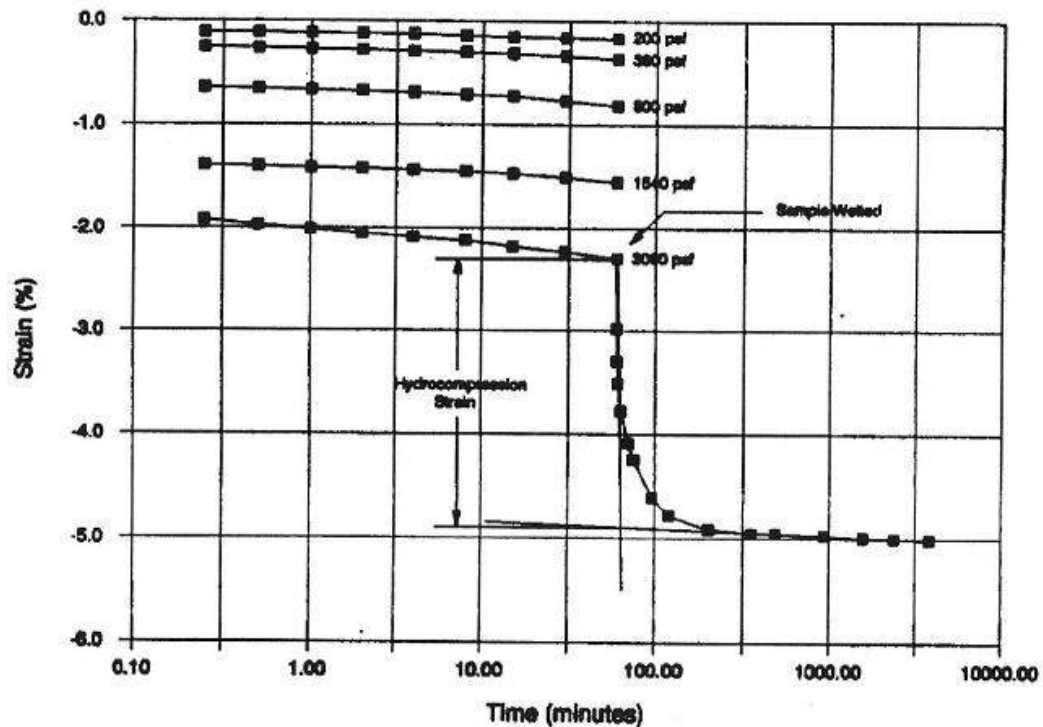
FIG. 4. Results of Test to Measure Compression due to Wetting in Sandy Clay from Villa Trinidad

- CONSOLIDATION SAMPLES COMPACTED AS SPECIFIED, LOADED TO MORE THAN 1000 PSF, AND WETTED COMPRESSED 0.3 TO 7 PERCENT

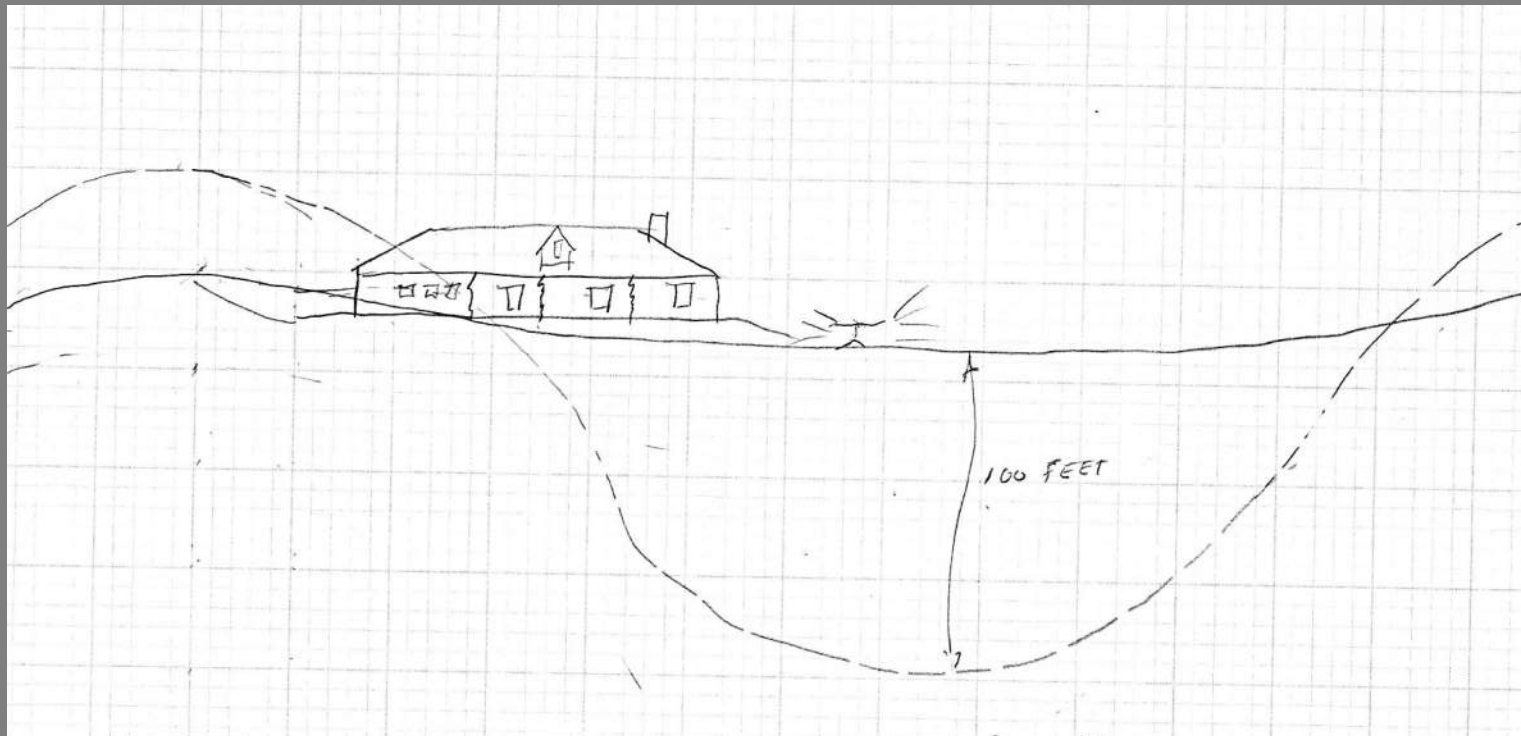
- BUILDING DAMAGE WAS GREATEST WHERE THE DEPTH OF FILL VARIED RAPIDLY ACROSS THE SITE

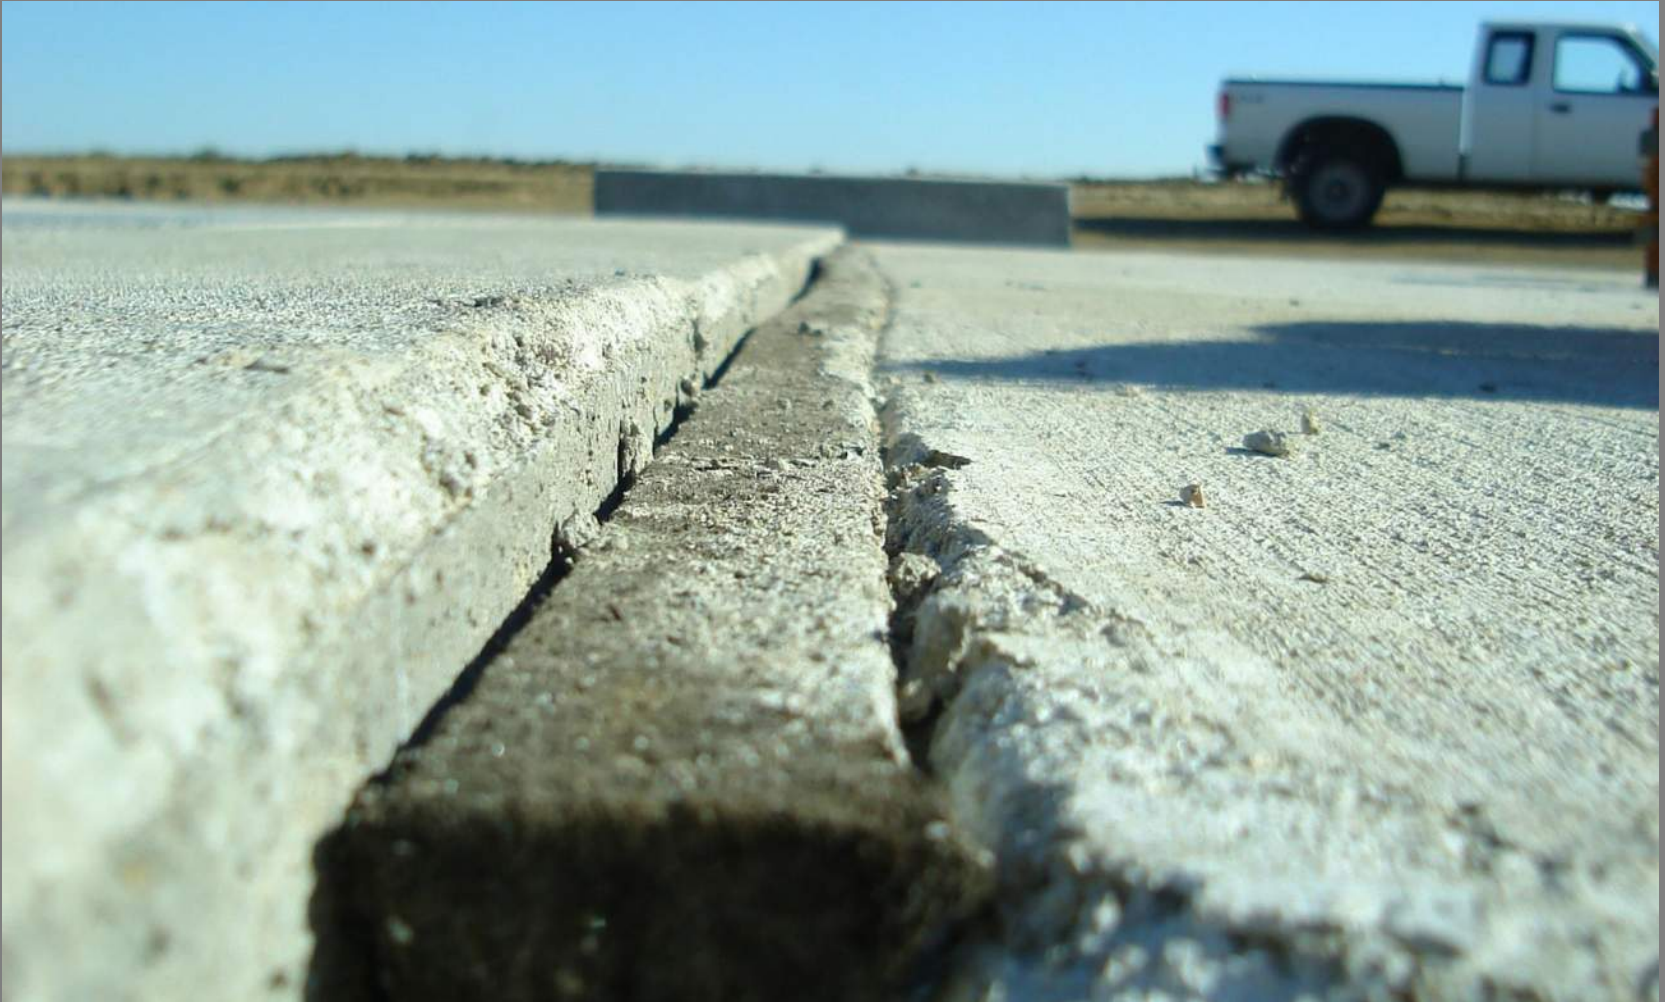
- BY SEPTEMBER 25, THE FOOTING HAD SETTLED ONE-HALF INCH

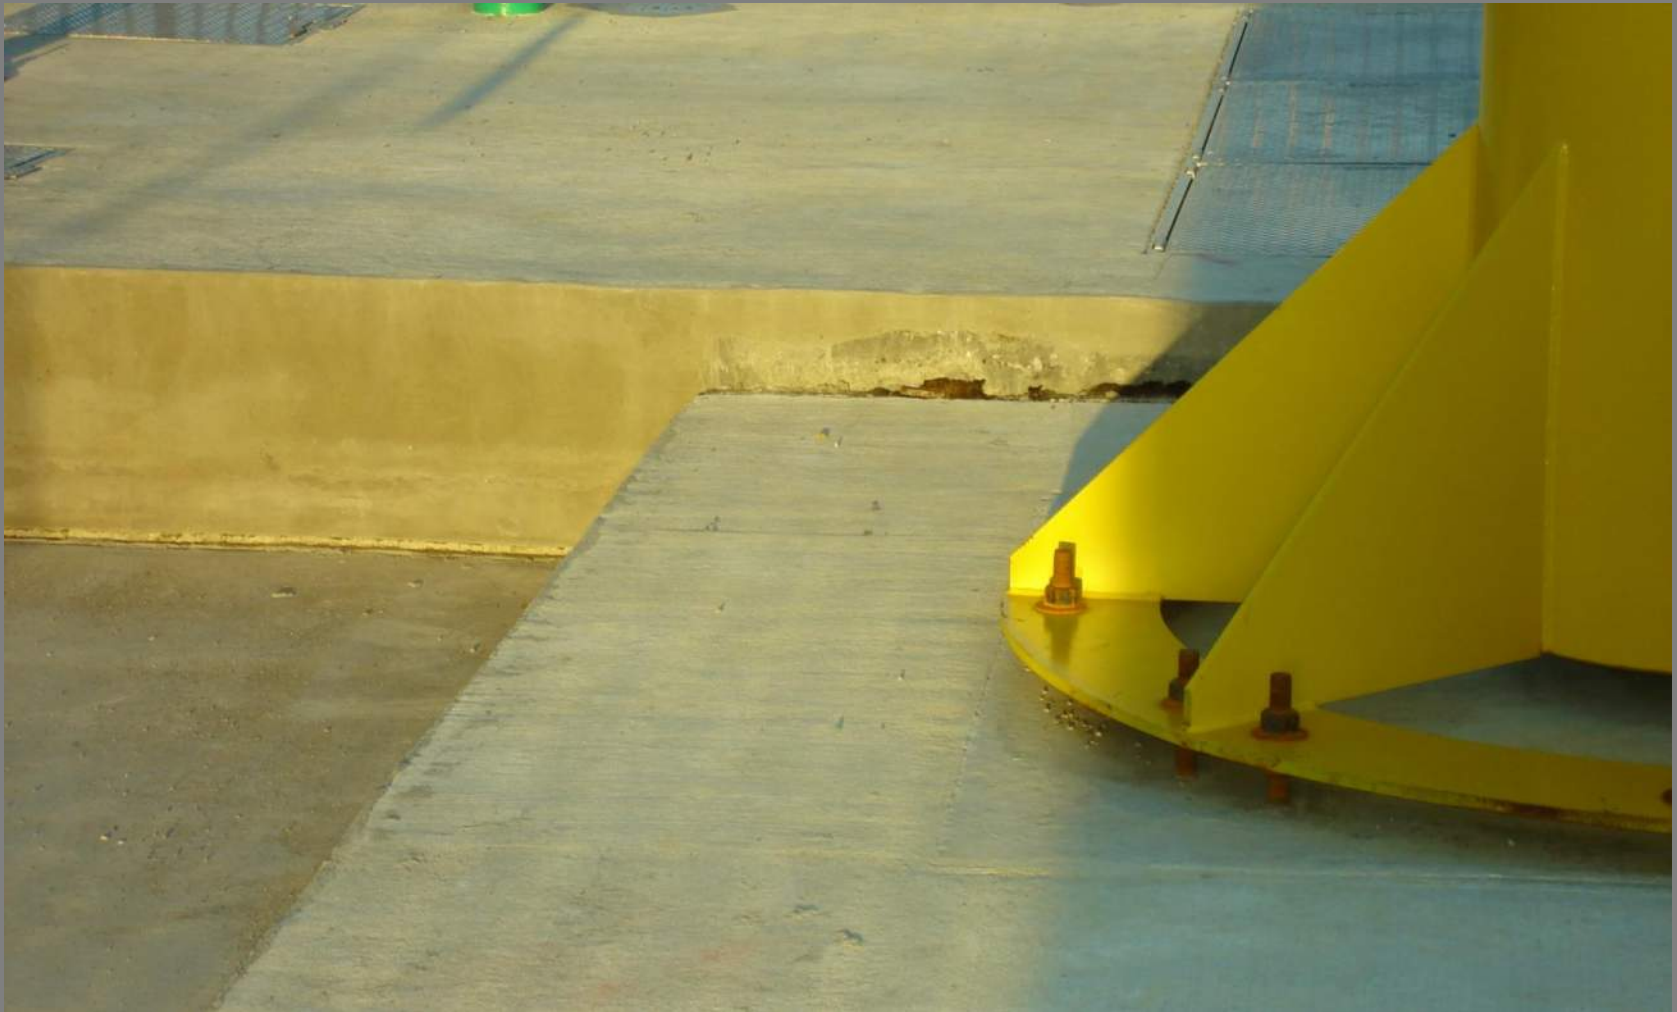
BY JANUARY 10, IT HAD SETTLED 5-1/2 TO 9 INCHES, AND THE RATE OF SETTLEMENT APPEARED TO BE INCREASING

- 9 INCHES OF SETTLEMENT IN A 43-FOOT FILL IS AN AVERAGE COMPRESSION OF 1.7 PERCENT
- THE OWNER ELECTED TO RETURN THE JIB CRANE FOR CREDIT

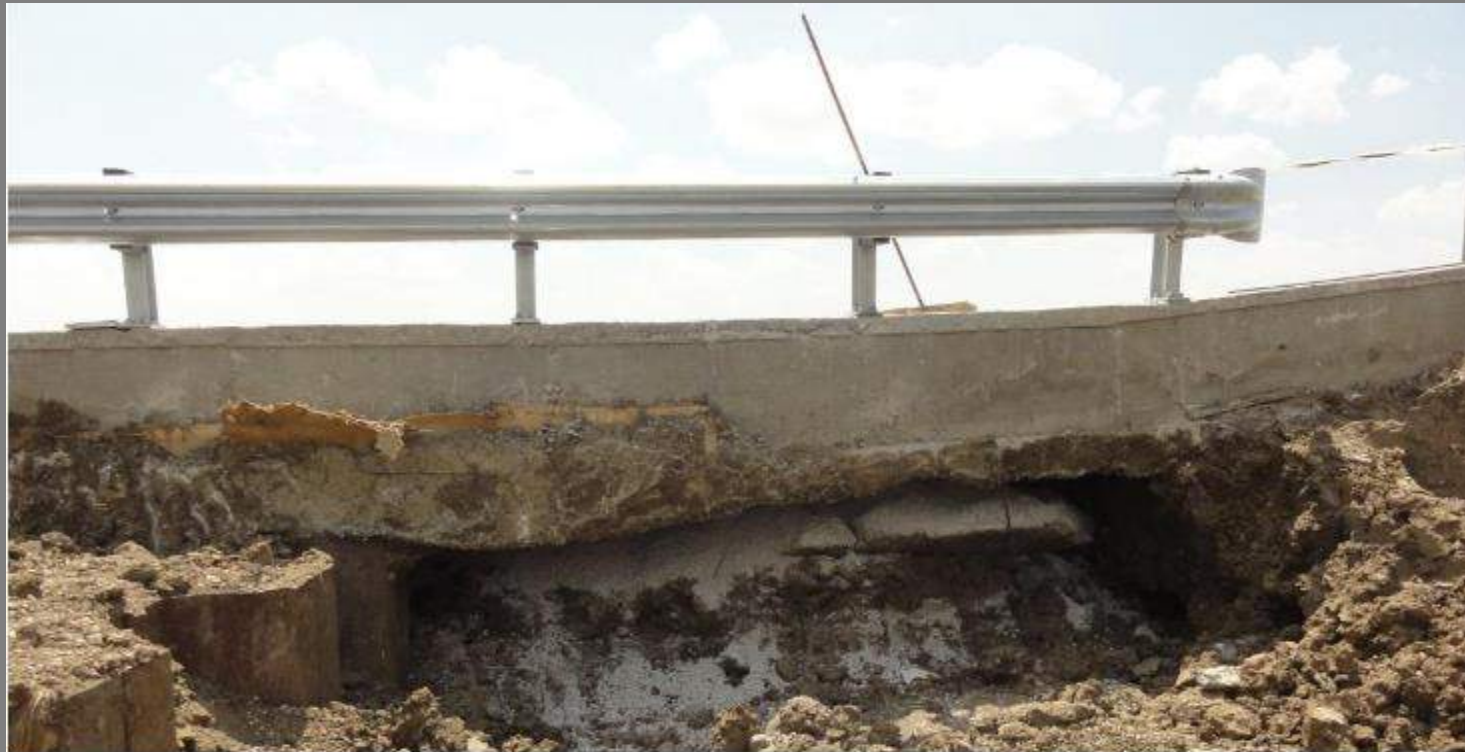
- LEAKAGE OF A CONSTRUCTION DEWATERING PIPE SATURATED THE BACKFILL
- THE FULL WIDTH OF THE BACKFILL BETWEEN THE SHEET PILES SETTLED

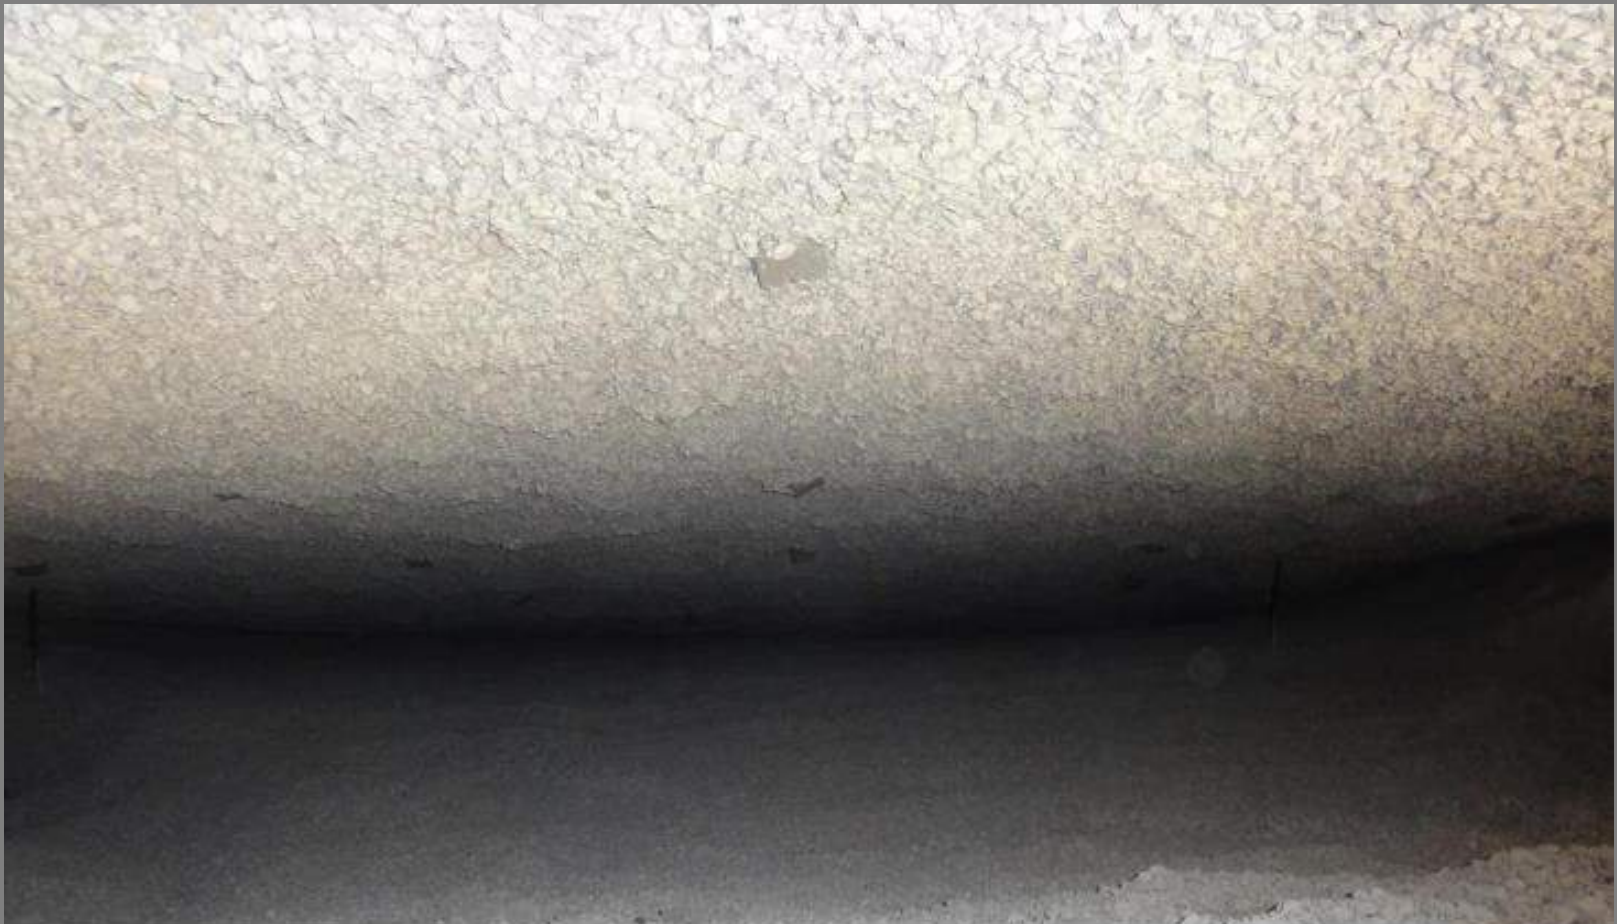
- THE GAP BETWEEN THE DRAINAGE LAYER AND THE SLAB WAS GENERALLY ABOUT 12 INCHES HIGH, BUT IN SOME LOCATIONS ABOUT 18 INCHES

- THE SETTLEMENT WAS ABOUT 2 TO 4 PERCENT OF THE FILL THICKNESS.

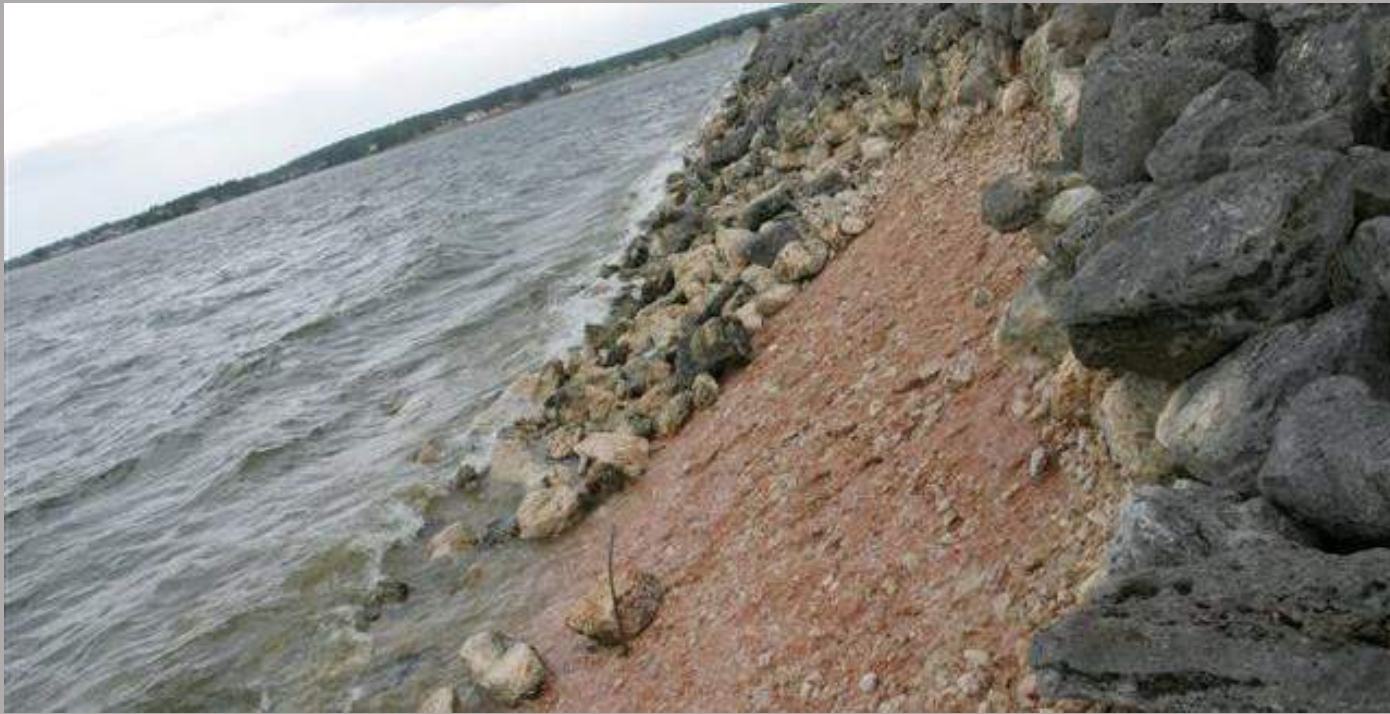
RIPRAP AND BEDDING WERE REMOVED IN PATCHES.

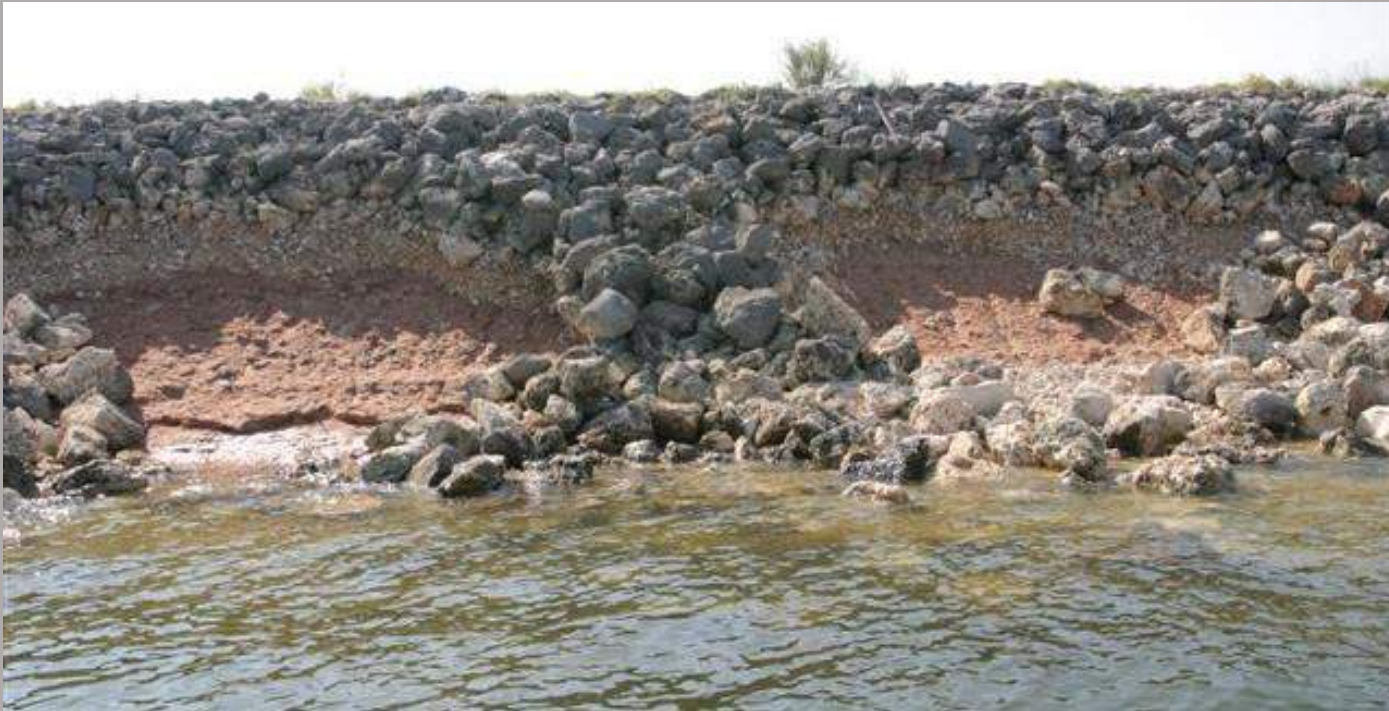
THE WAVES TOOK AWAY THE RIPRAP AT THE WATERLINE,
THEN ERODED THE BEDDING, AND THE ROCKS ROLLED DOWN.

- DO RESEARCH BEFORE DEPARTING FROM STANDARD PRACTICE
- IF YOU STEEPEN THE SLOPE, INCREASE THE ROCK SIZE
- CHECK THE HISTORICAL PERFORMANCE OF A ROCK SOURCE
- CONSIDER A PETROGRAPHIC ANALYSIS
- IF POSSIBLE, USE CLAY EMBANKMENT IN AREAS THAT MAY BECOME EXPOSED

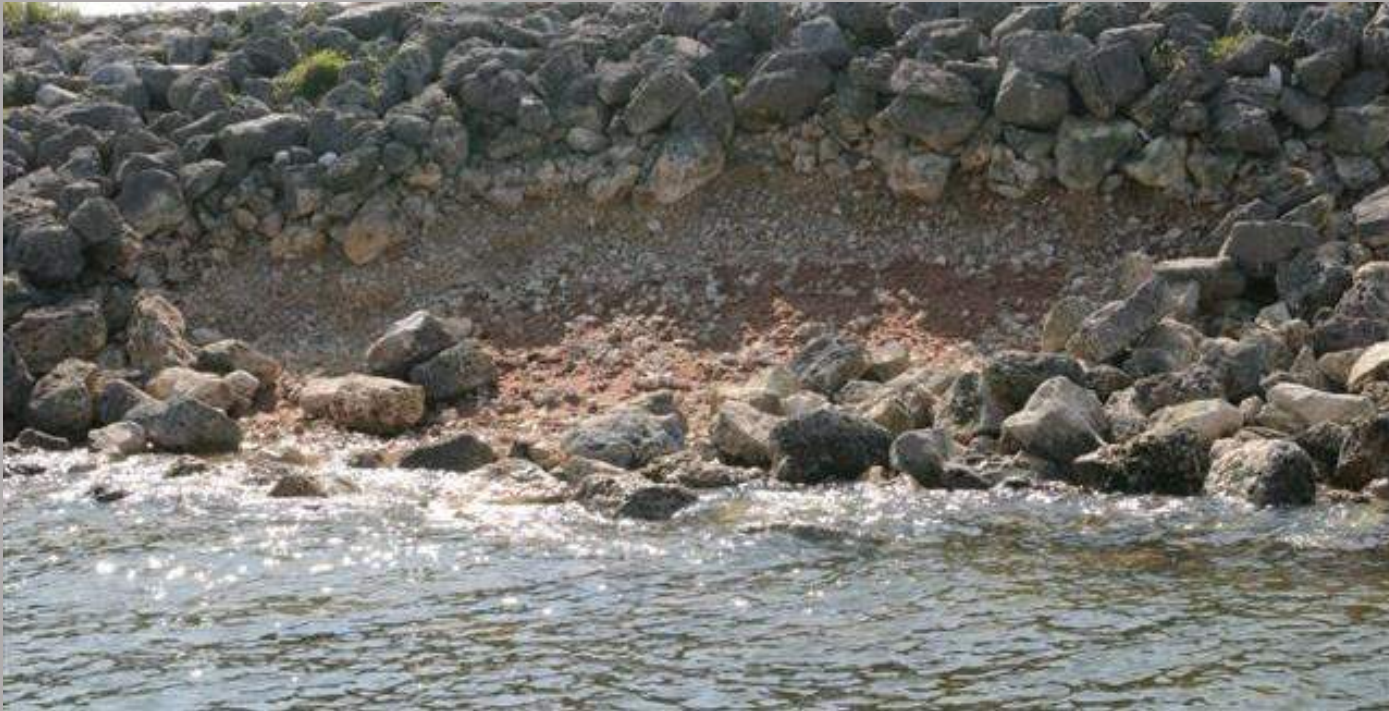
THE CLAY EMBANKMENT WAS ONLY SLIGHTLY
DISTURBED

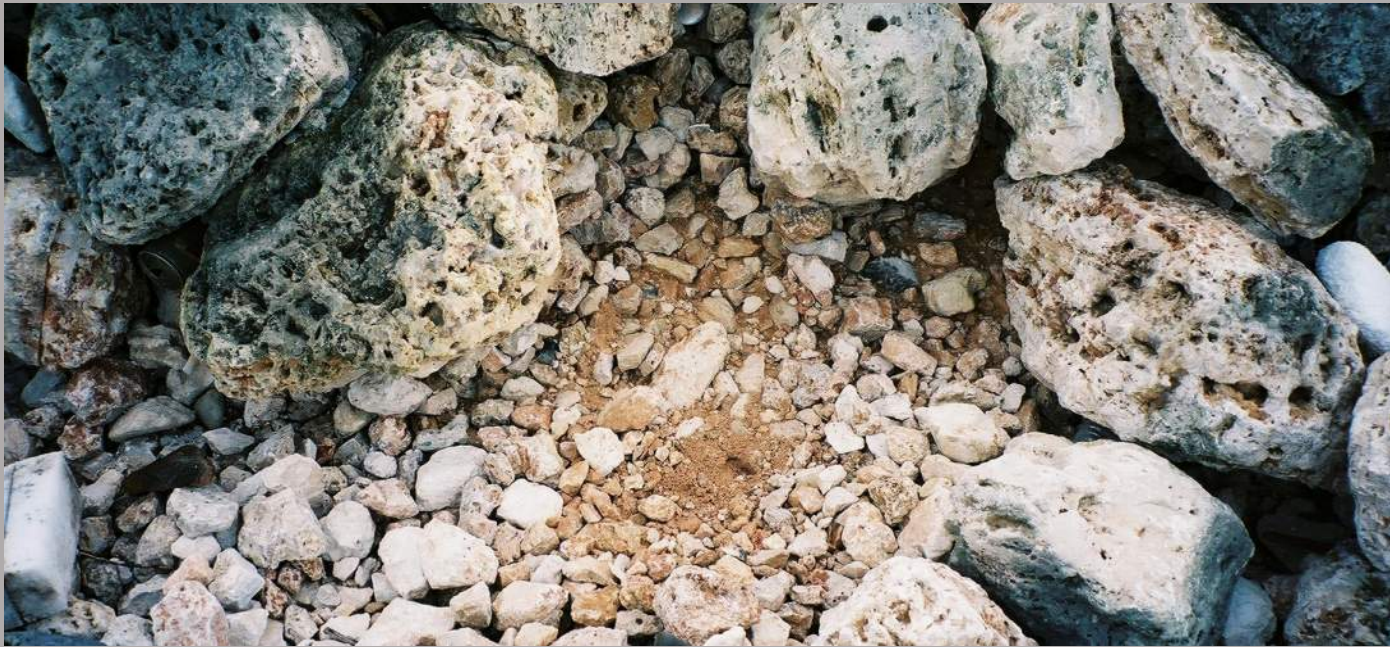
THE LIMESTONE RIPRAP HAD BECOME POKED WITH HOLES BY SELECTIVE DISSOLUTION. THIS SIGNIFICANTLY REDUCED THE WEIGHT OF THE ROCKS.

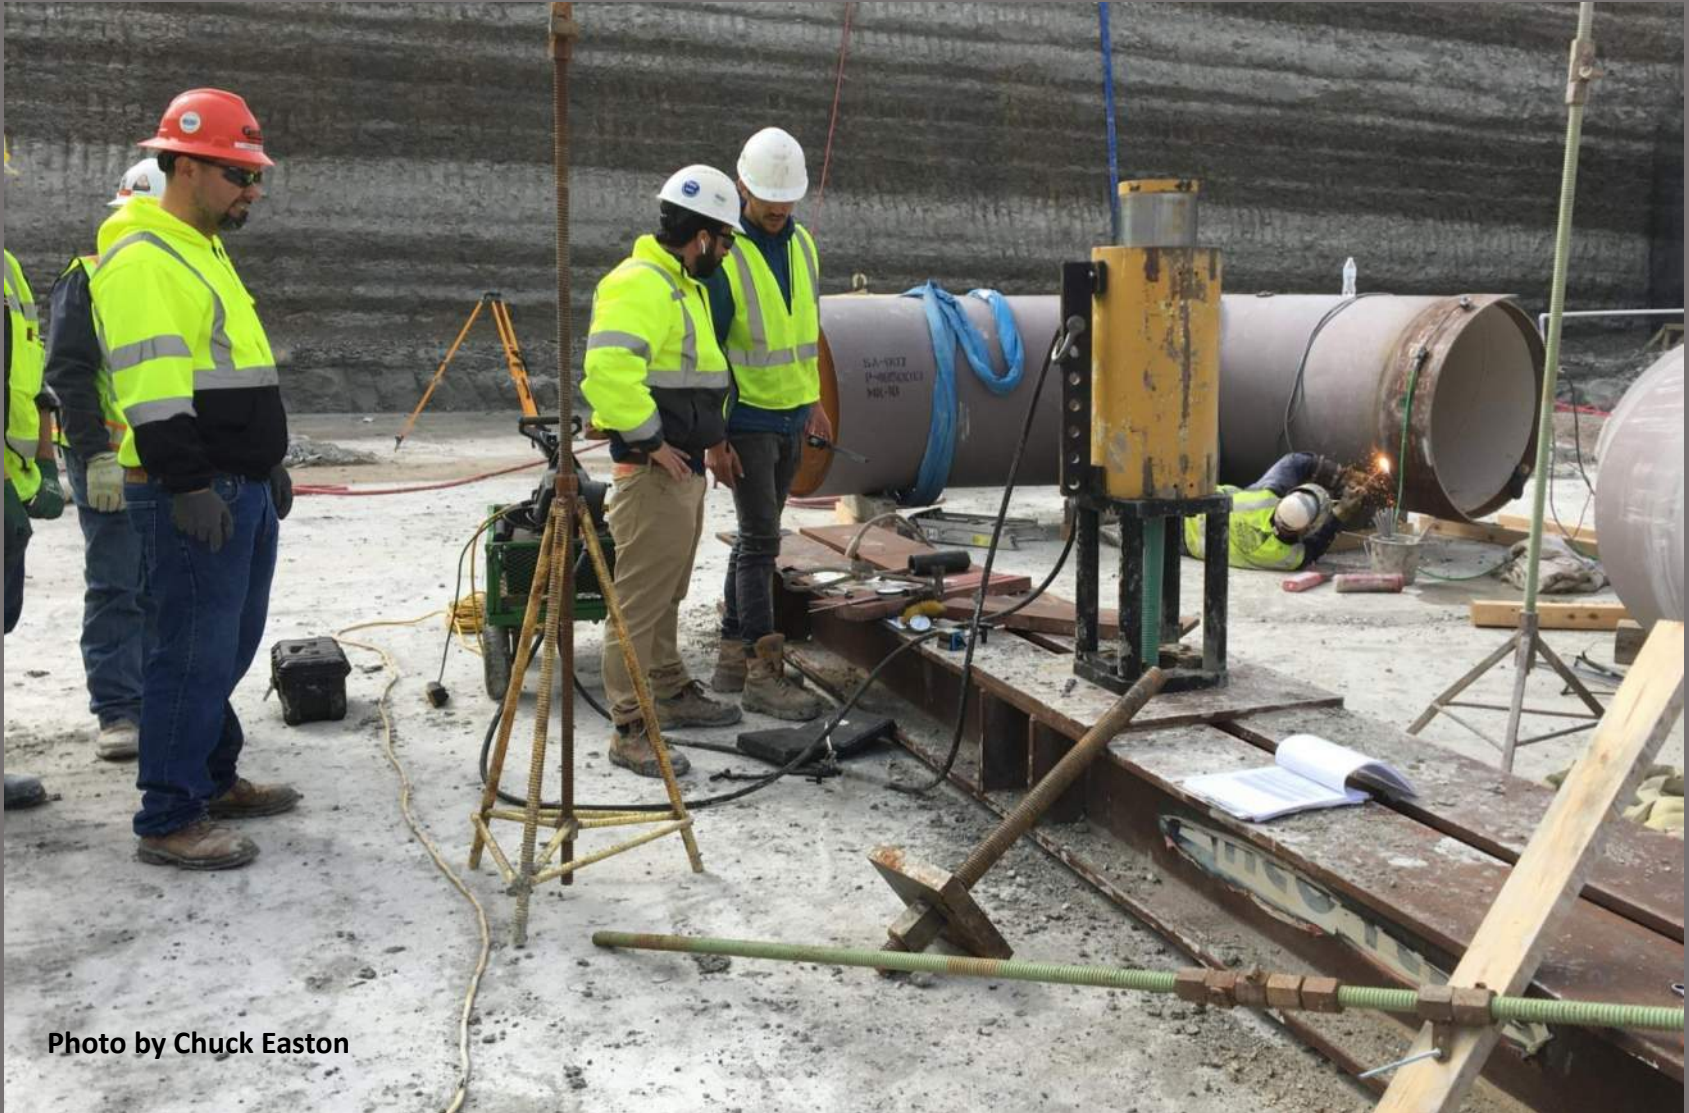
The Coupling Failed

Watch the work.

Don't stand too close.

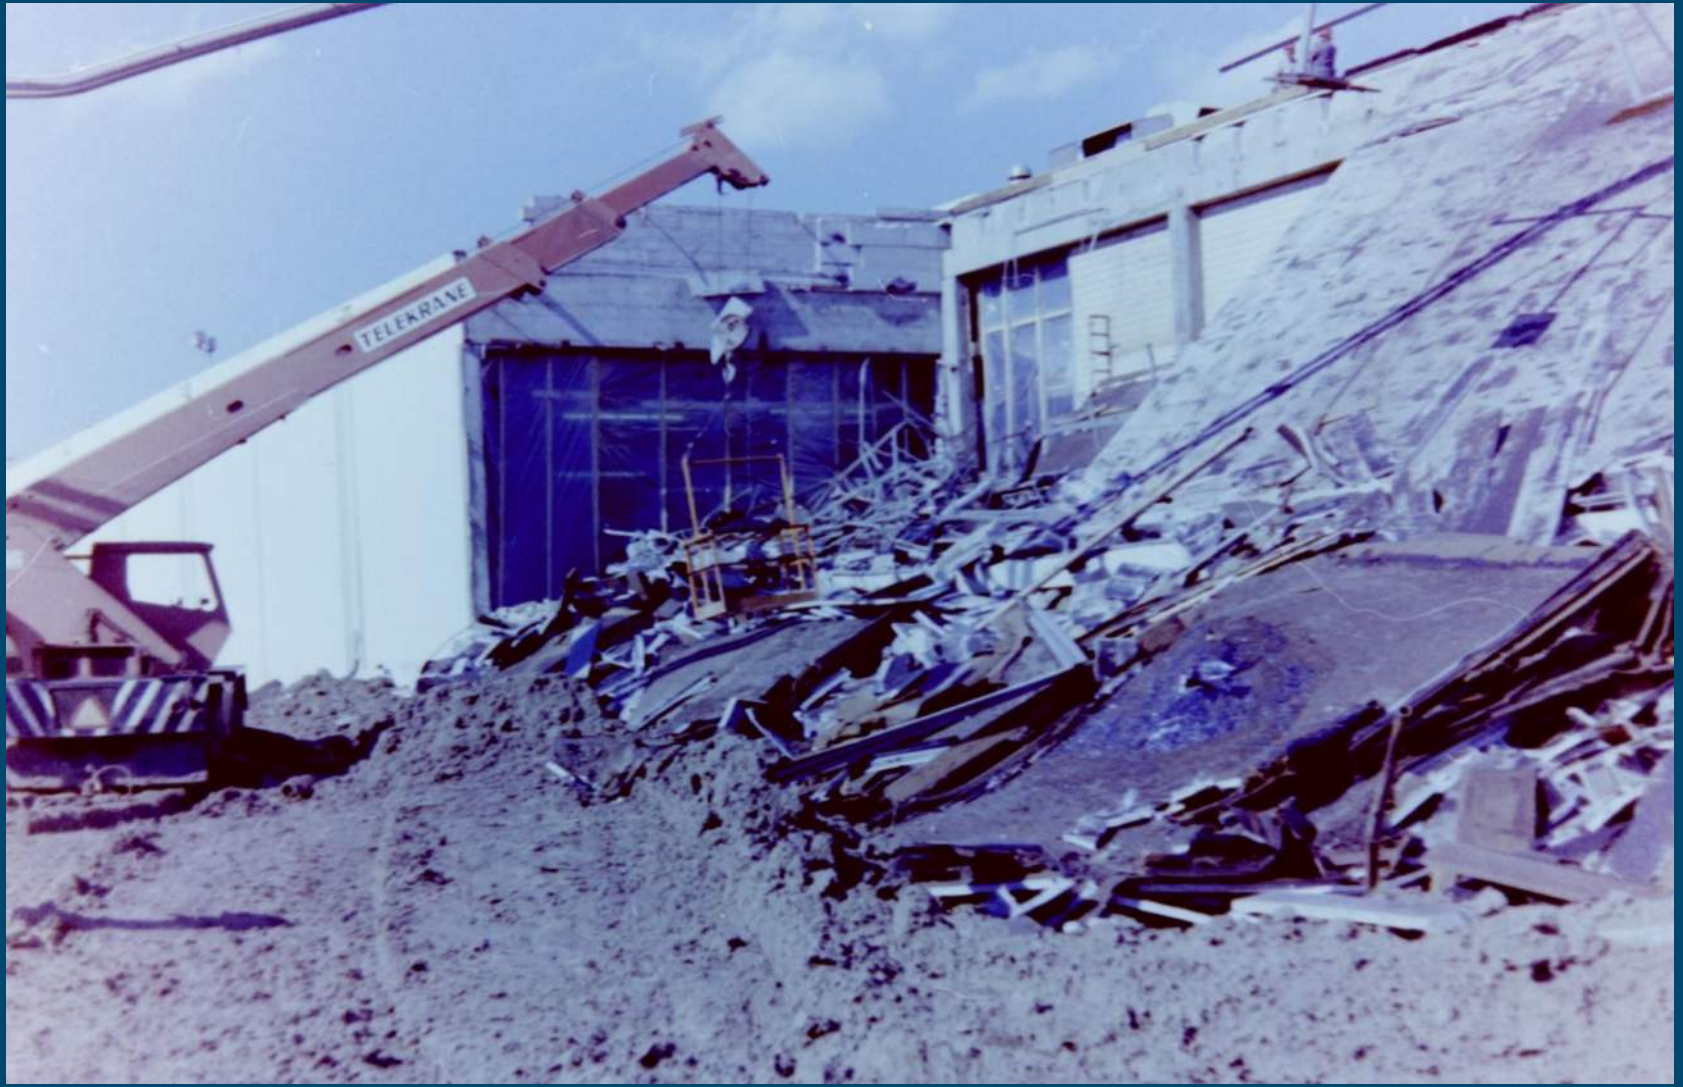
Rubble of Tempering Cooler

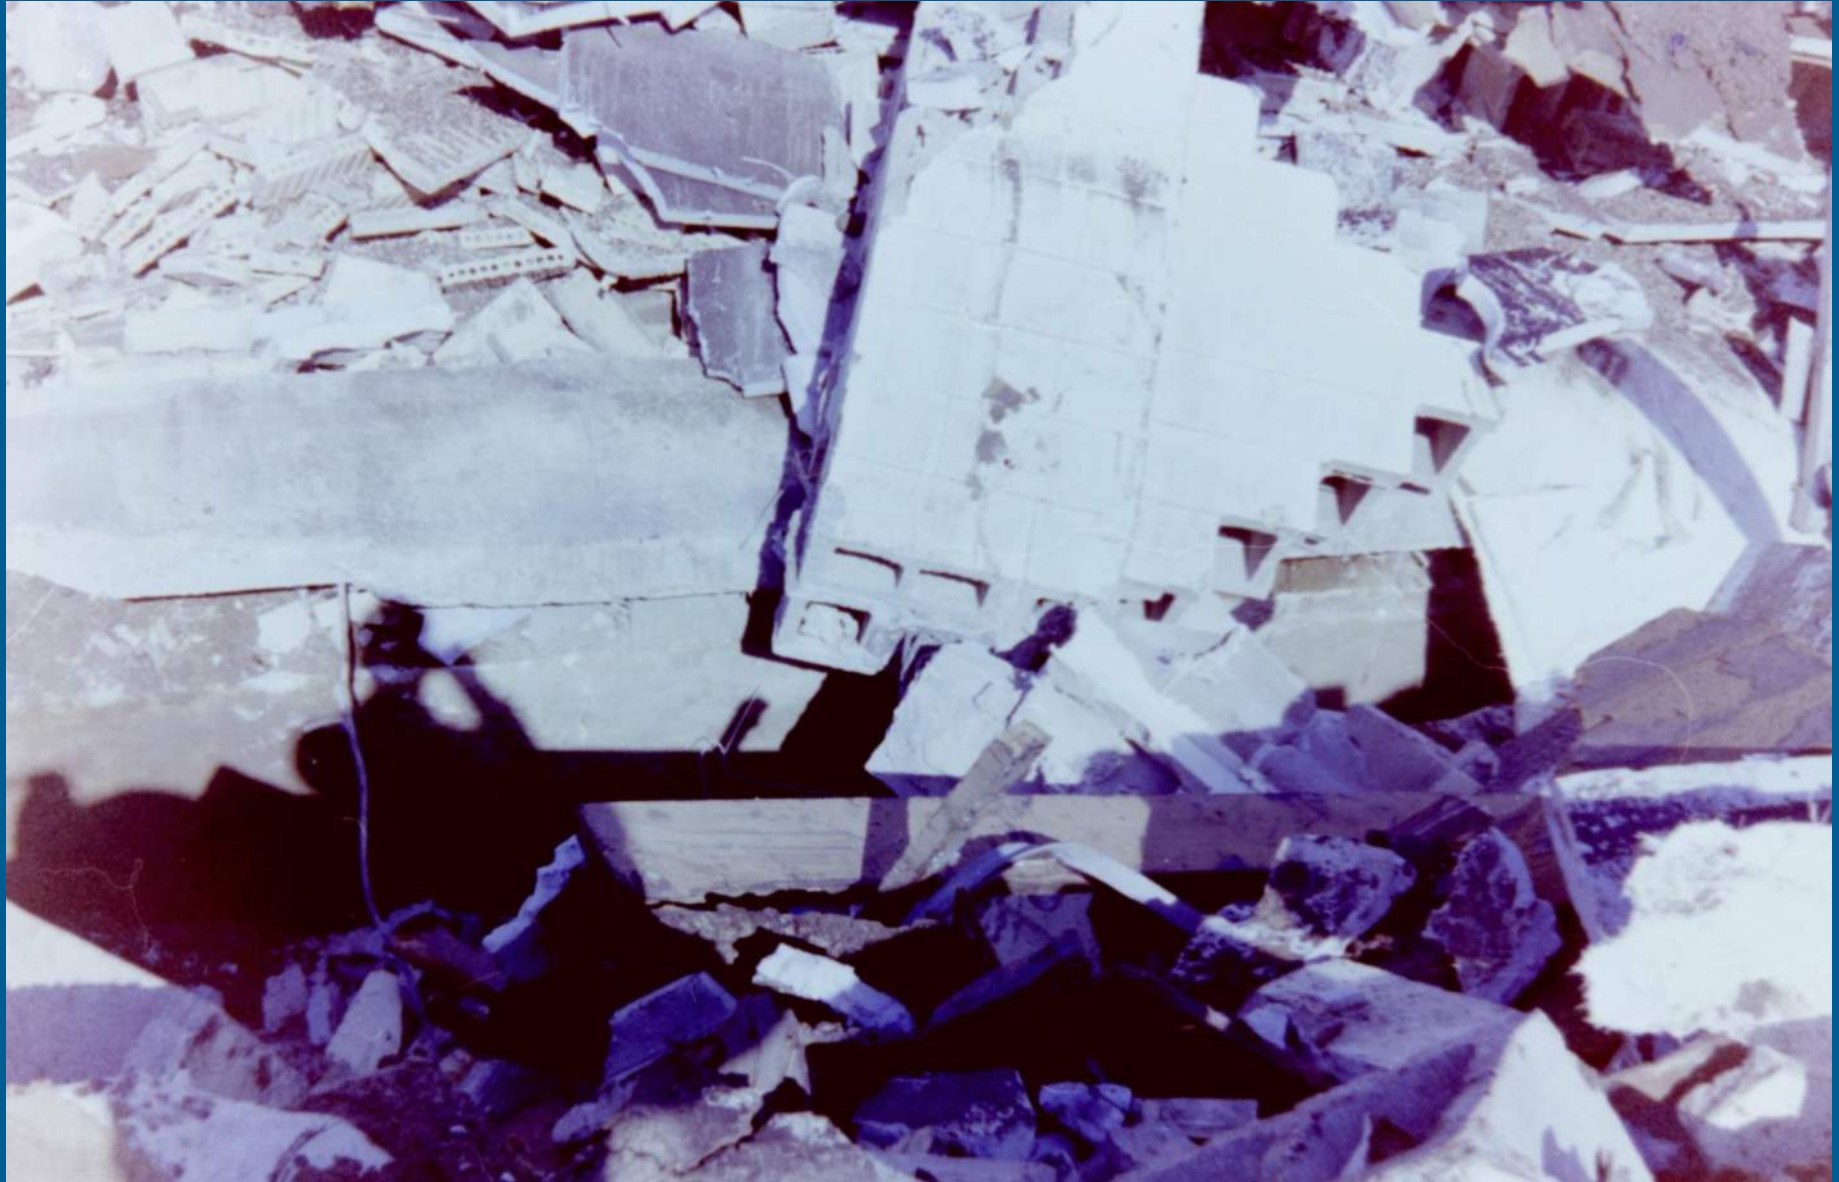
Unreinforced Masonry Wall

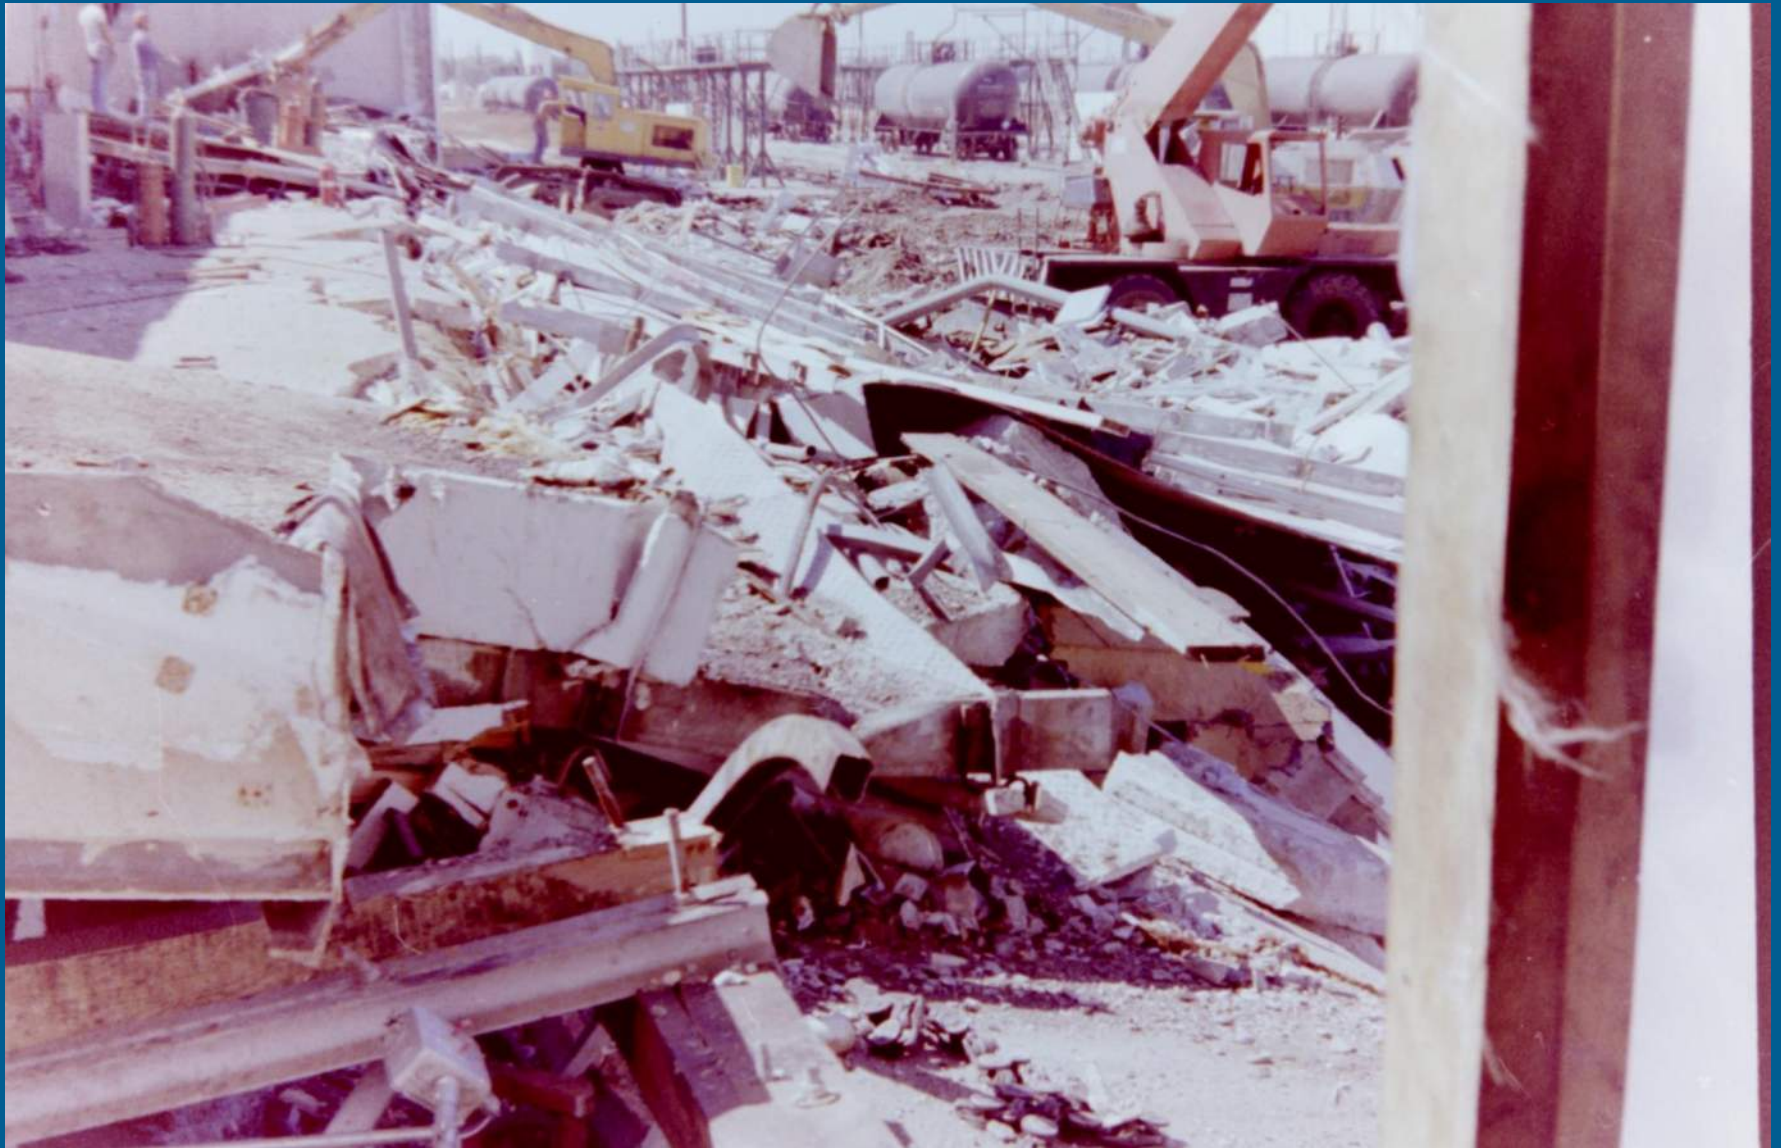
Wall and Floor Slab Collapsed Into Excavation

- The Contractor did not realize that exposing the foundation would reduce the bearing capacity and increase the bending stress in the wall
- Neither the plans nor the geotechnical report warned that excavation could result in failure.
- Who bears the responsibility?

- Excavate and replace the soil in short segments
- Tie the wall to the opposite wall
- Shore the roof structure
- The footing might have failed anyway
