Some Lessons Learned Through 54 Years of Mistakes: HYDROCOMPRESSION SETTLEMENT OF DEEP EARTH FILLS

CHUCK EASTON, P.E.
cne@freese.com

Some Lessons Learned Through 54 Years of Mistakes

Collapse of Tempering Cooler

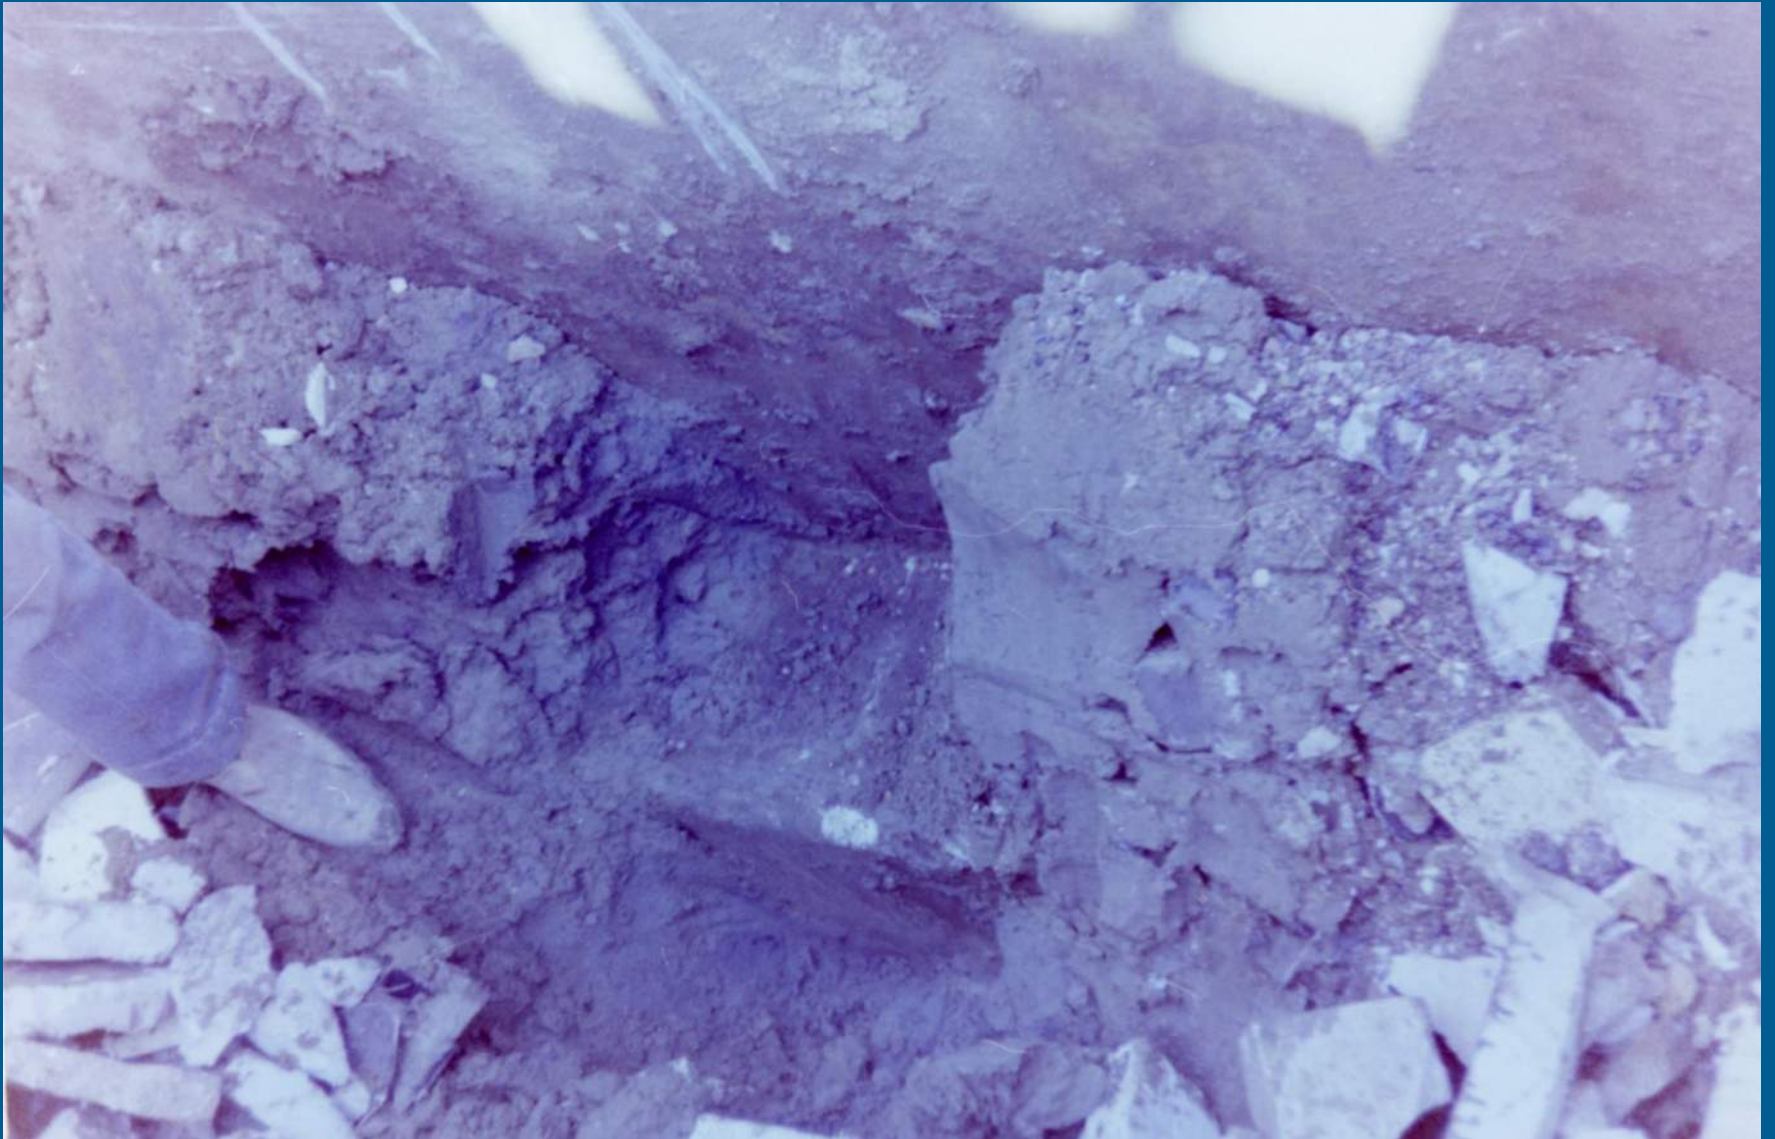
Wall Footing and Foundation Wall

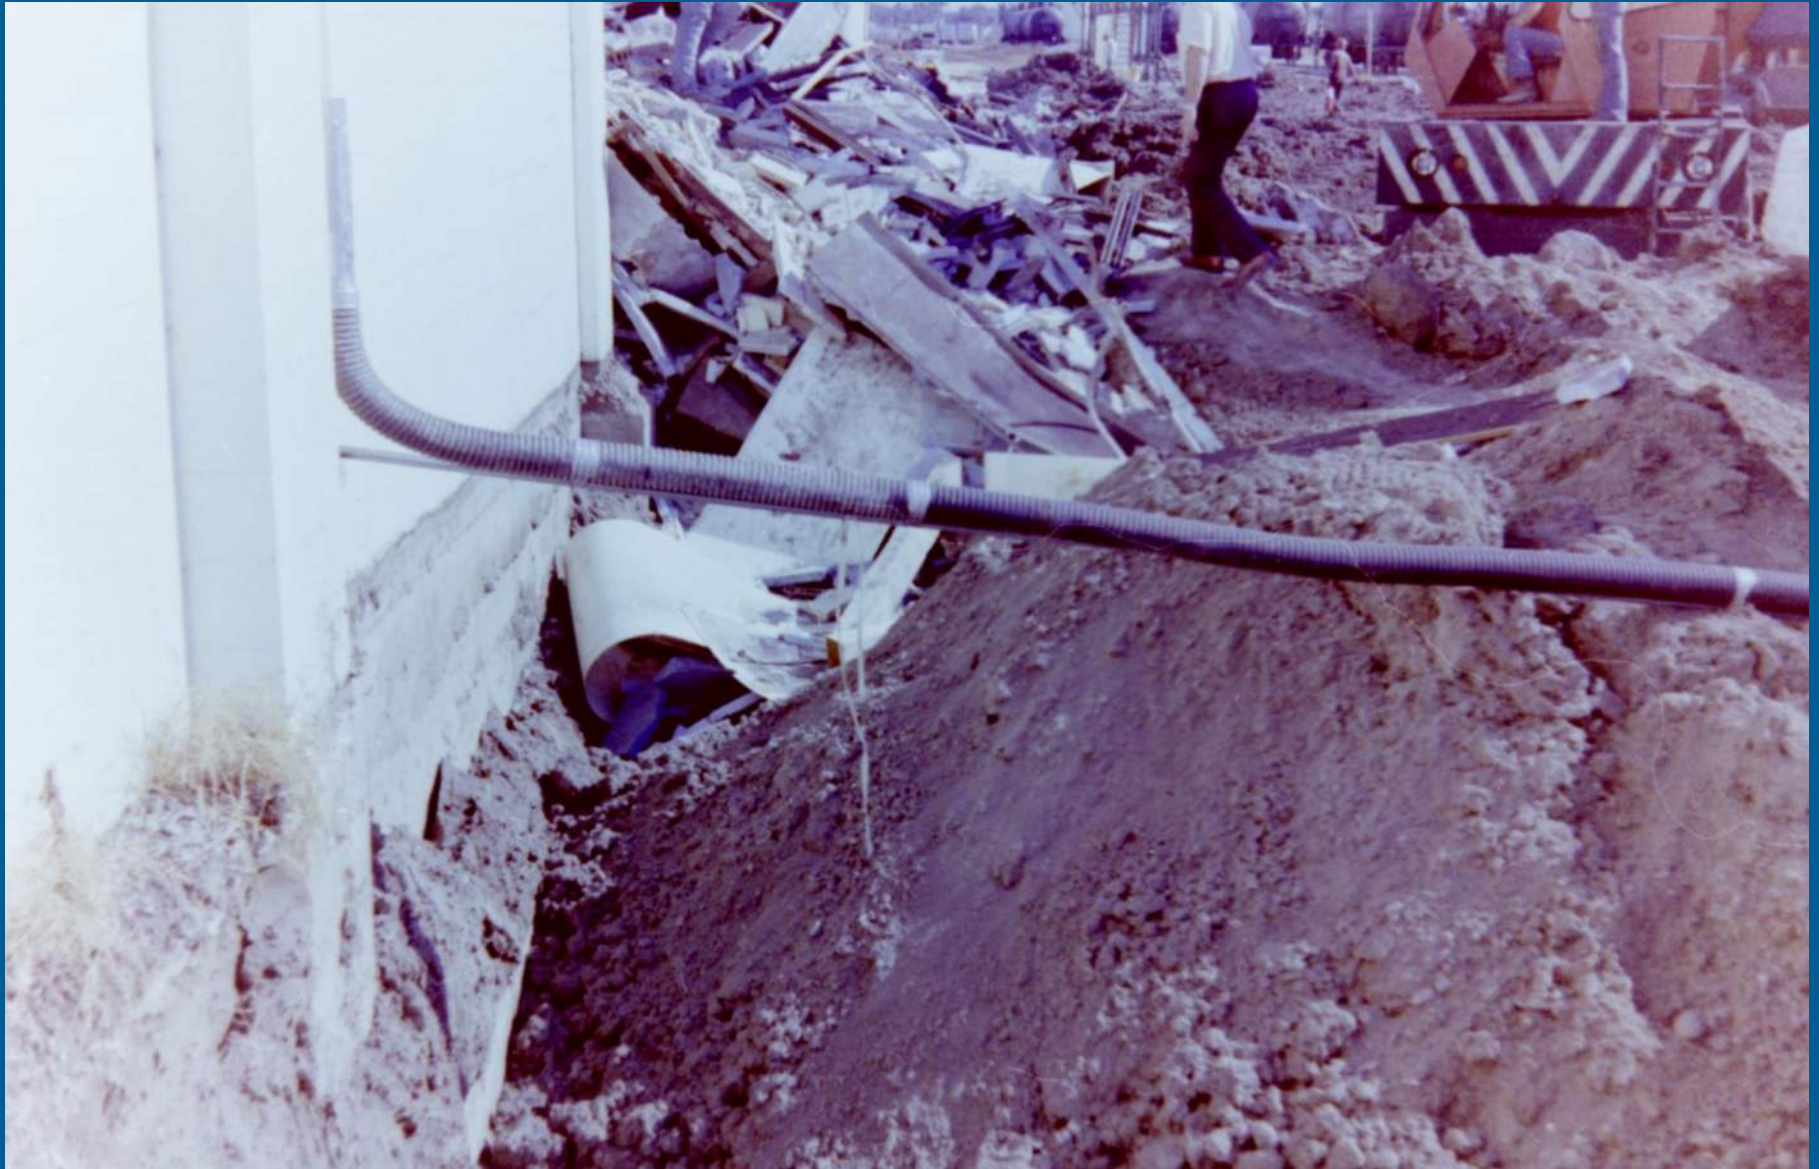
Collapse Stopped at Precast Column

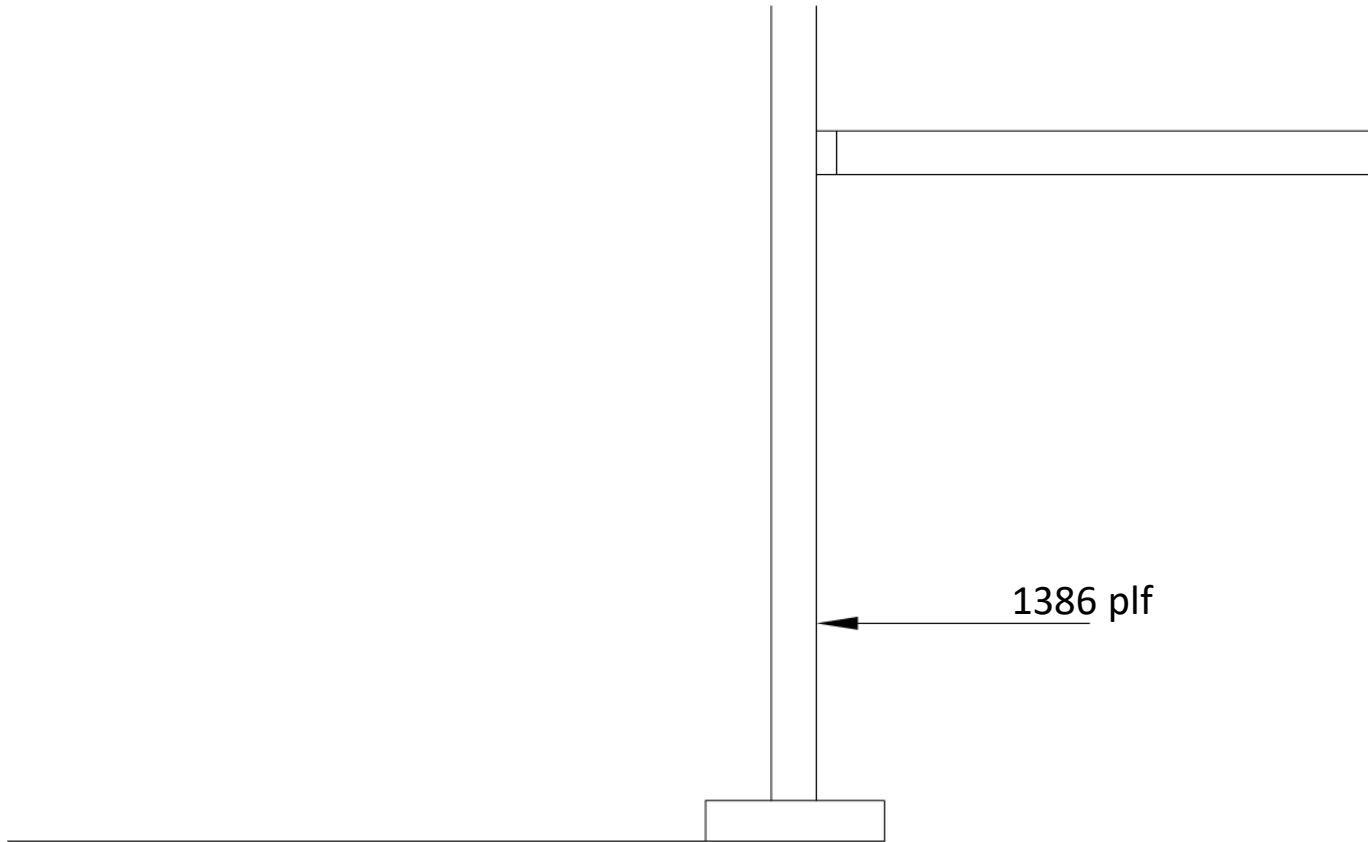
Sliding of the footing and flexural failure of the wall were also marginal.

If the wall had not failed, the footing might have slid out

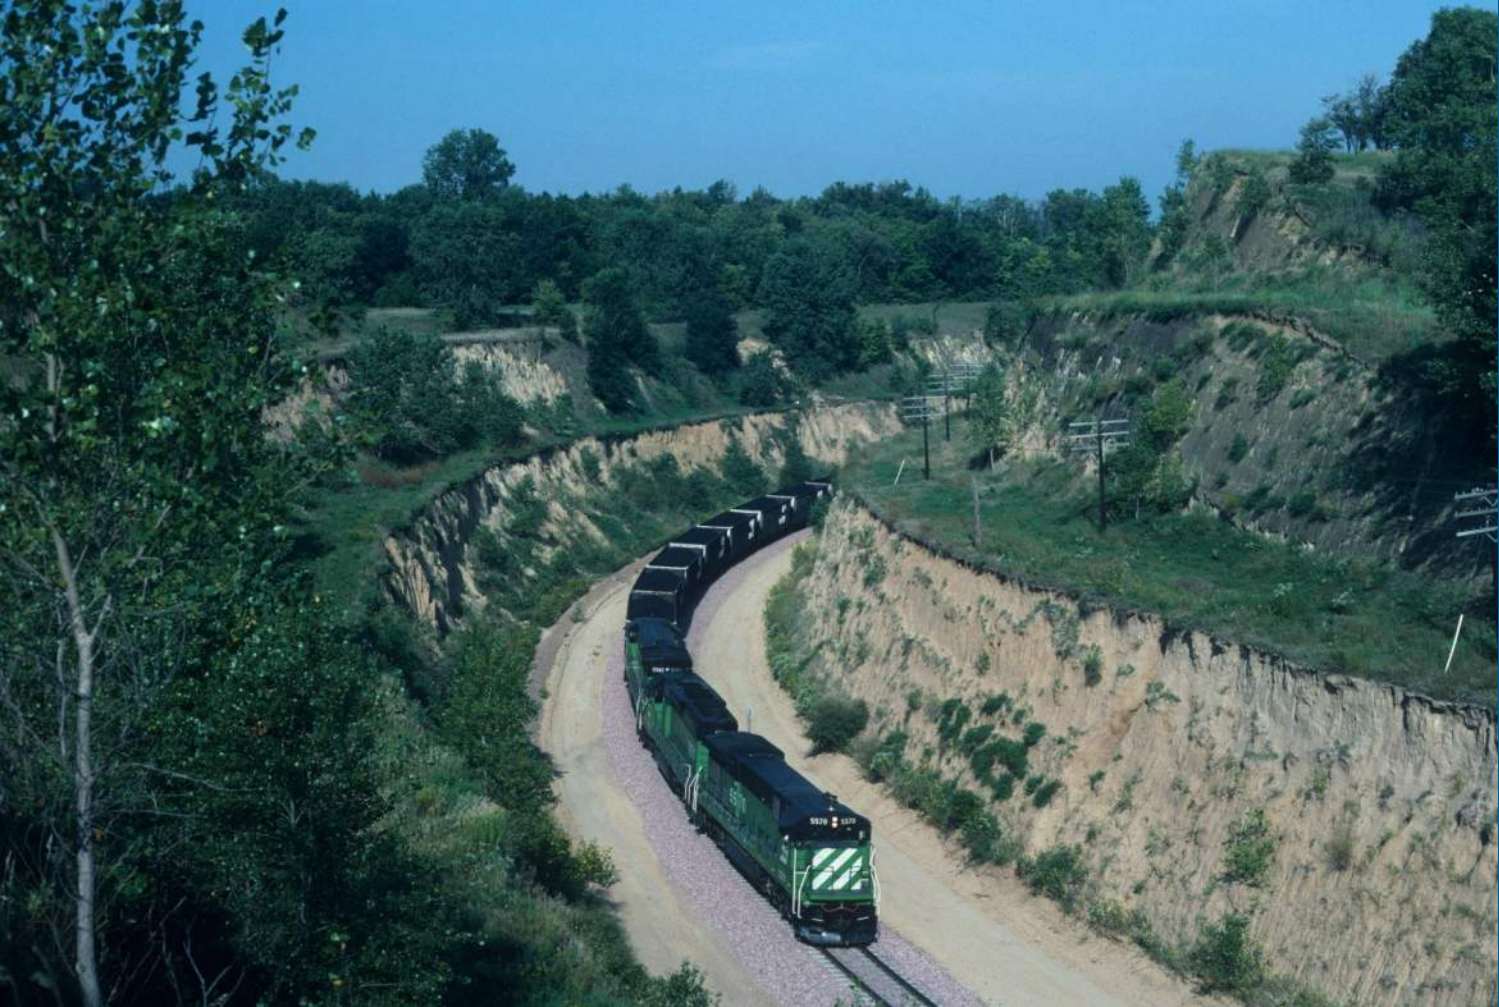
THE CUT A FEW YEARS AFTER CONSTRUCTION

Note the sloughing and accumulation along
the lower outside slope

Sloughing was worst in the lower part of the south slope.

Sampling and testing showed that the soil in the lower part was saturated because infiltrating water became perched on the glacial till.

In winter, freezing penetrated about 2 feet into the face and created thin ice lenses parallel to the slope.

In spring, the ice thawed, and the soil loosened by freezing fell down the slope.
