# Earth Retention is a Team Sport Progressive Protein

February 9, 2018

# Progressive Protein

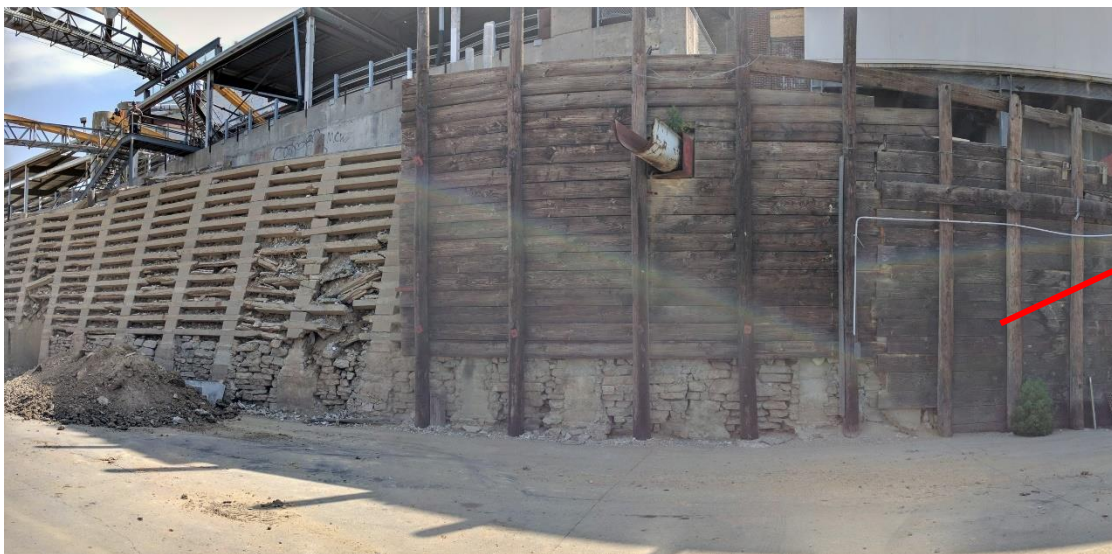
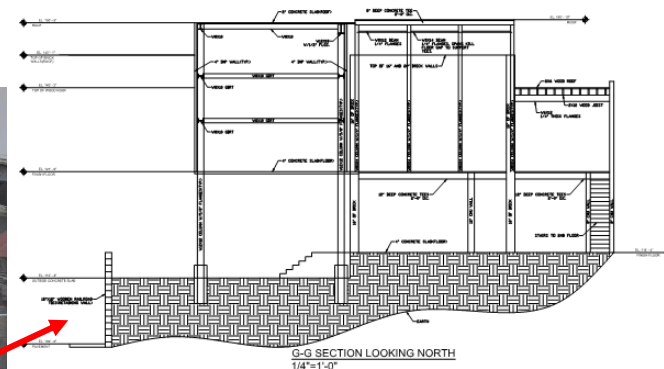
# Proposed addition includes removal of existing wood crib wall

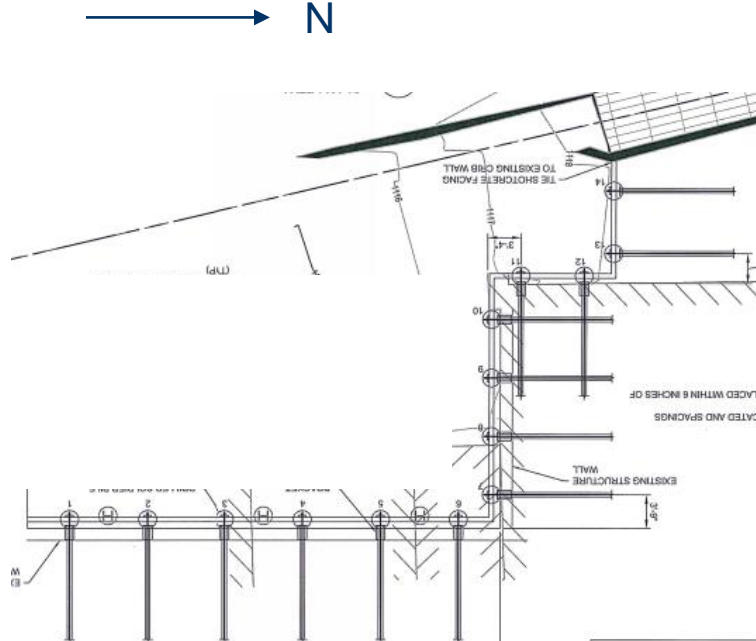
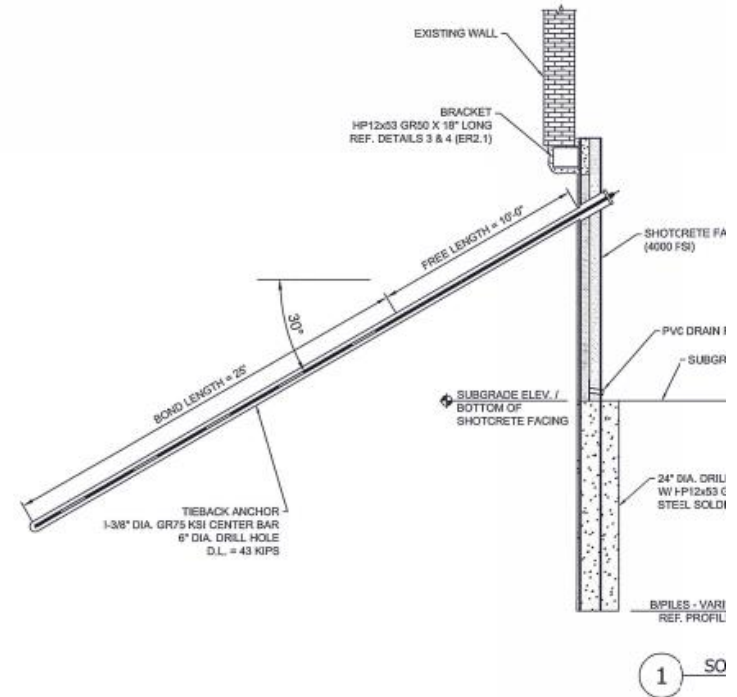
# Design for Anchored Soldier Pile Wall

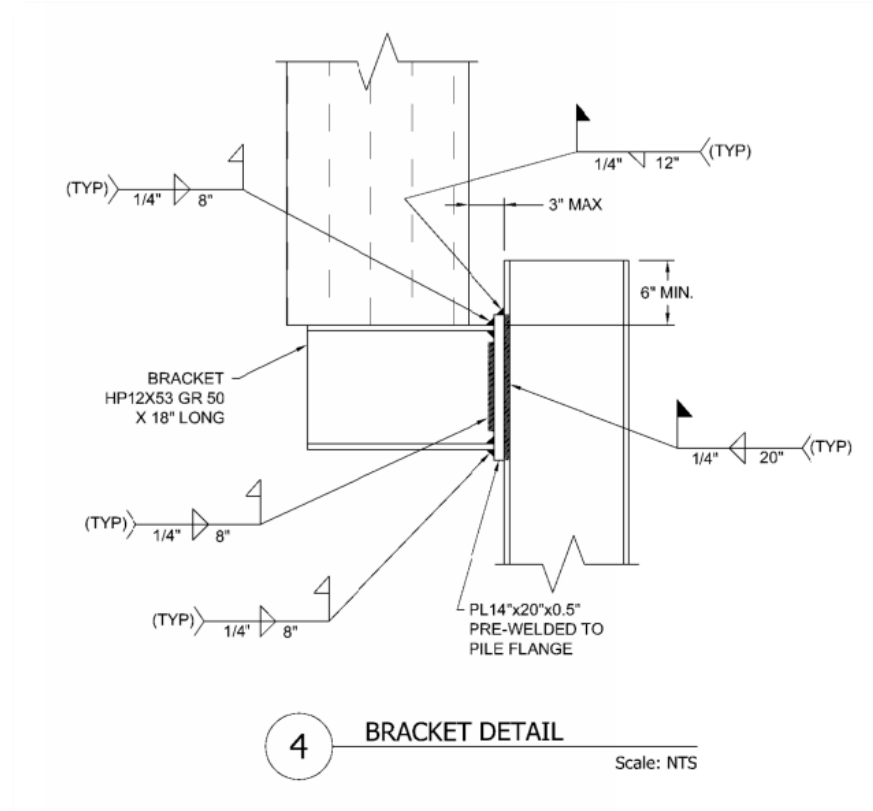
# Underpinning Bracket

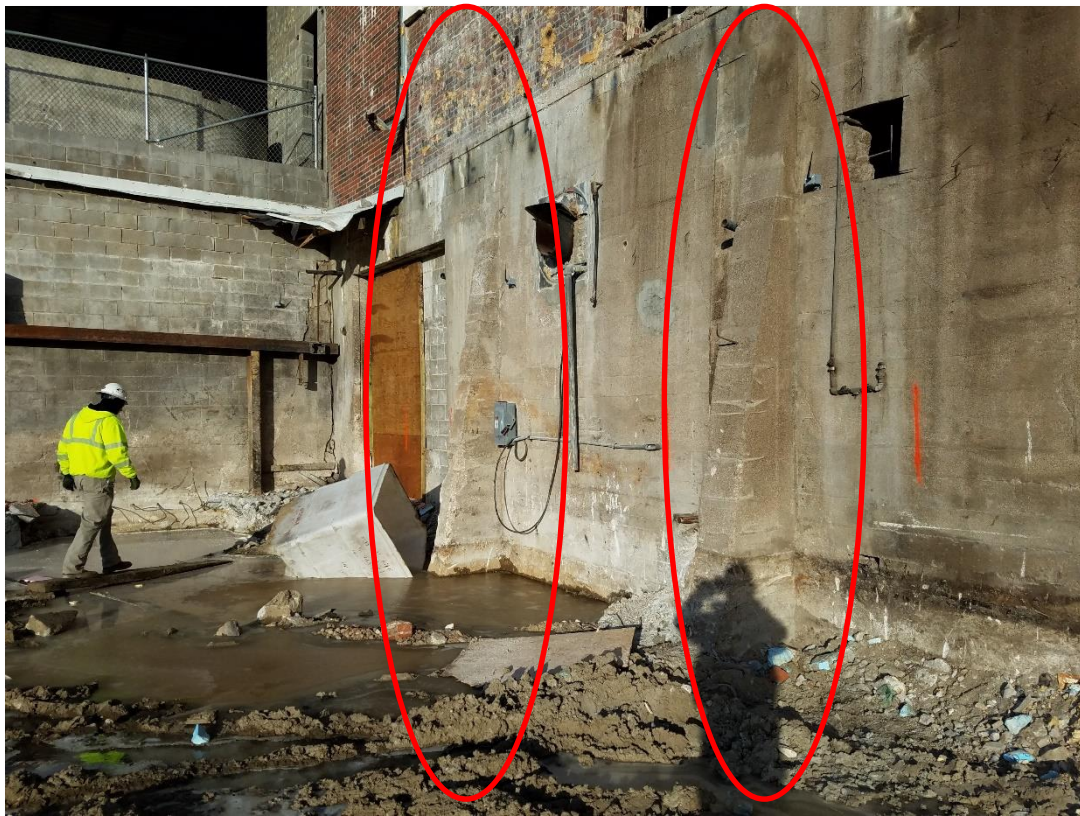
# Problem #1

What are these counterforts doing here?

- 1<sup>st</sup> round of demolition uncovered unexpected counterforts

## Changes that Counterforts required:

1. Add tie-backs to inside structure
2. Soldier Beams can no longer support wall – Add micropiles

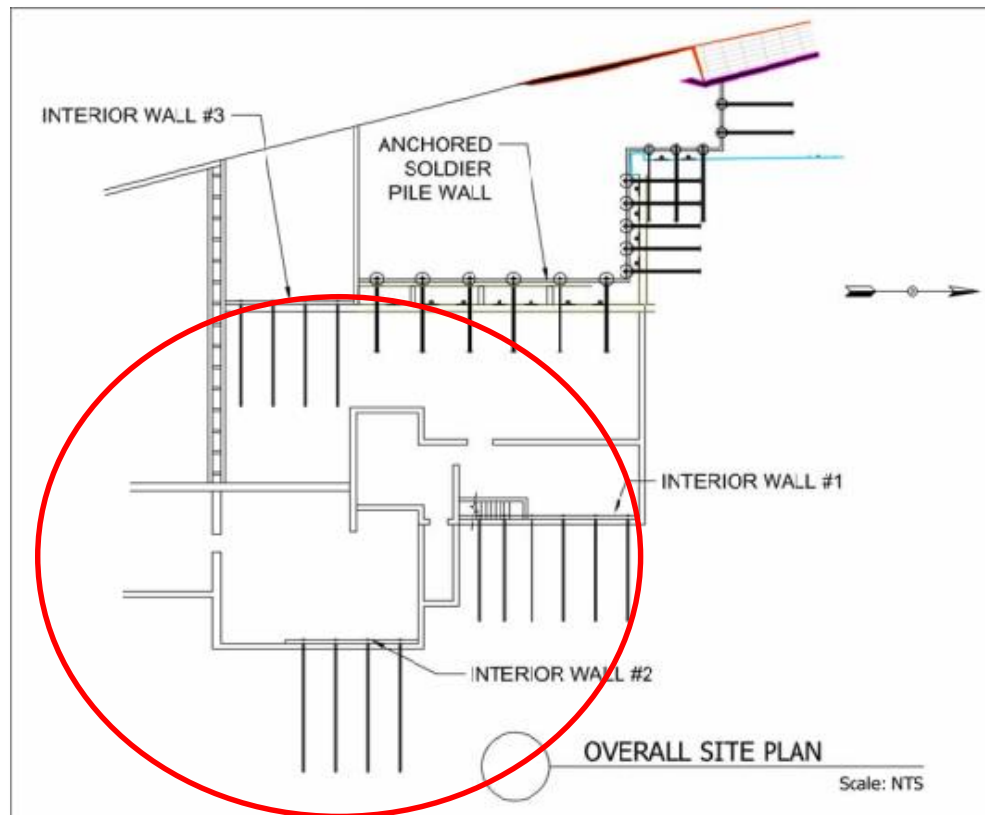
# Interior Tie-backs

- To address lateral load imbalance HBI installed Tie-Backs inside the structure

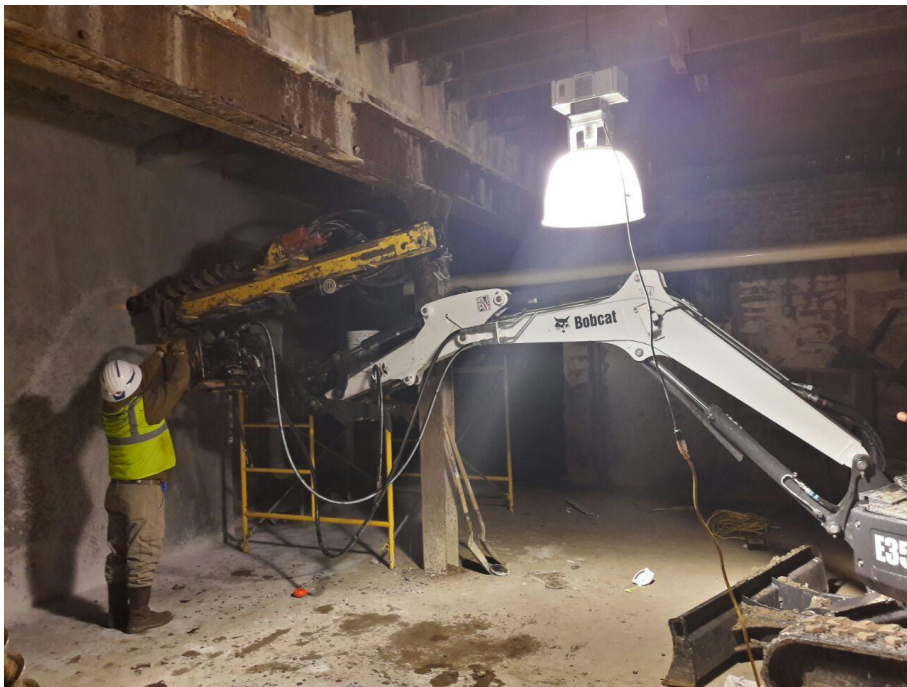
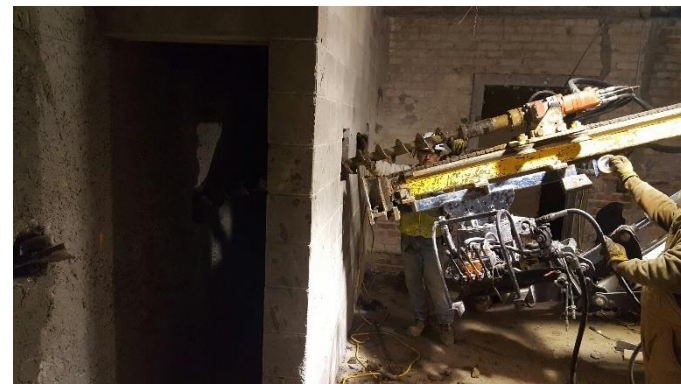
# Tight Access: No Problem

- Soil Nails installed to handle lateral imbalance
- Installed in as little as 9ft headroom with mini-excavator mounted drill

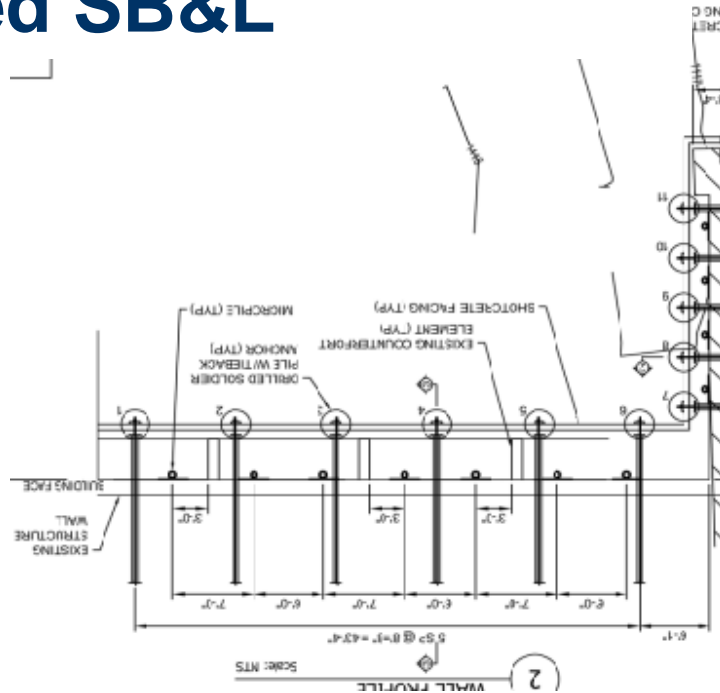
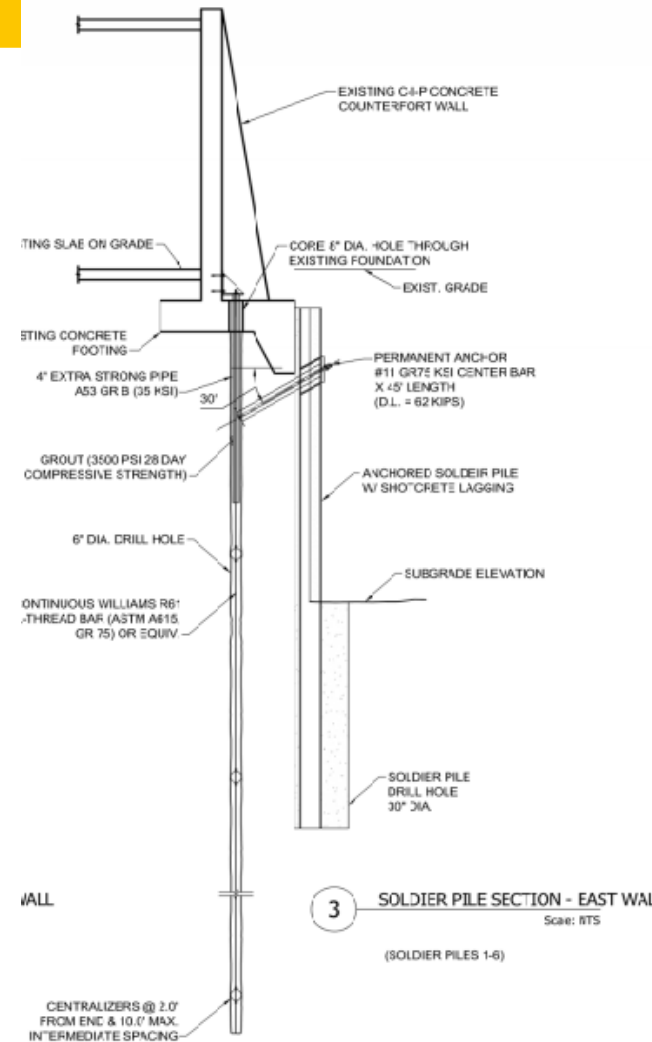
# Modifying East Wall Anchored SB&L

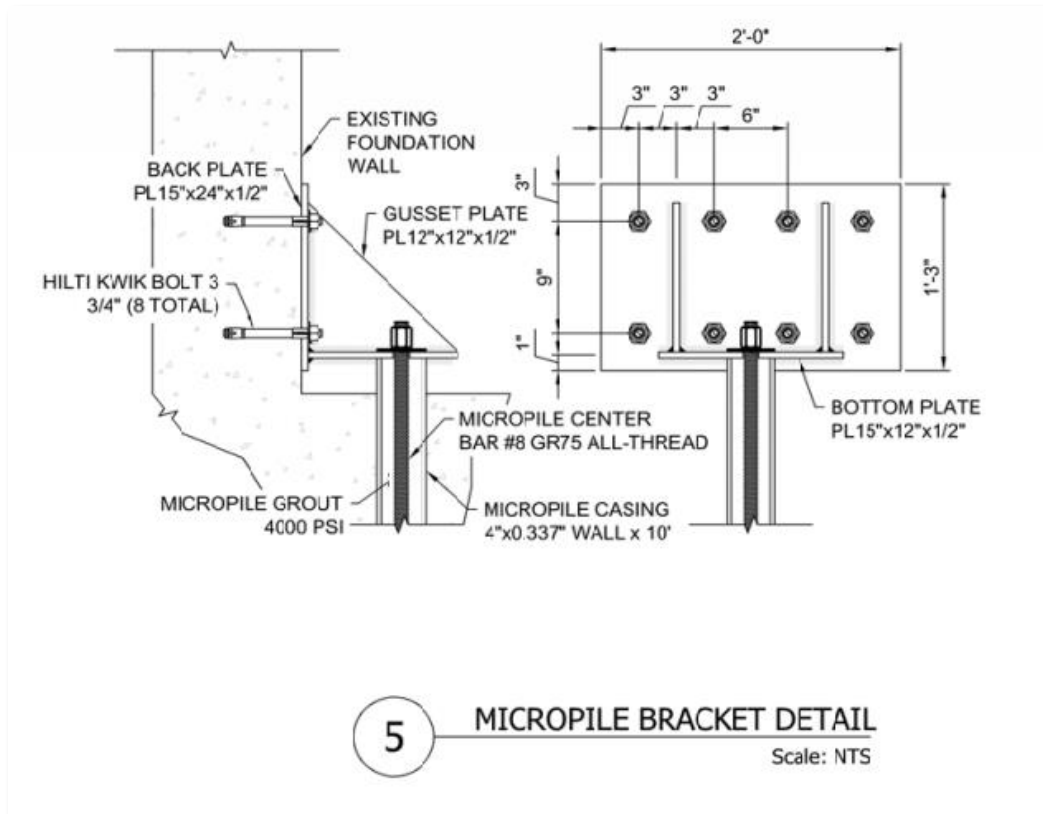
# Micropiles

- Soldier Beams could no longer brace the footing
- Installed micropiles to underpin existing footing

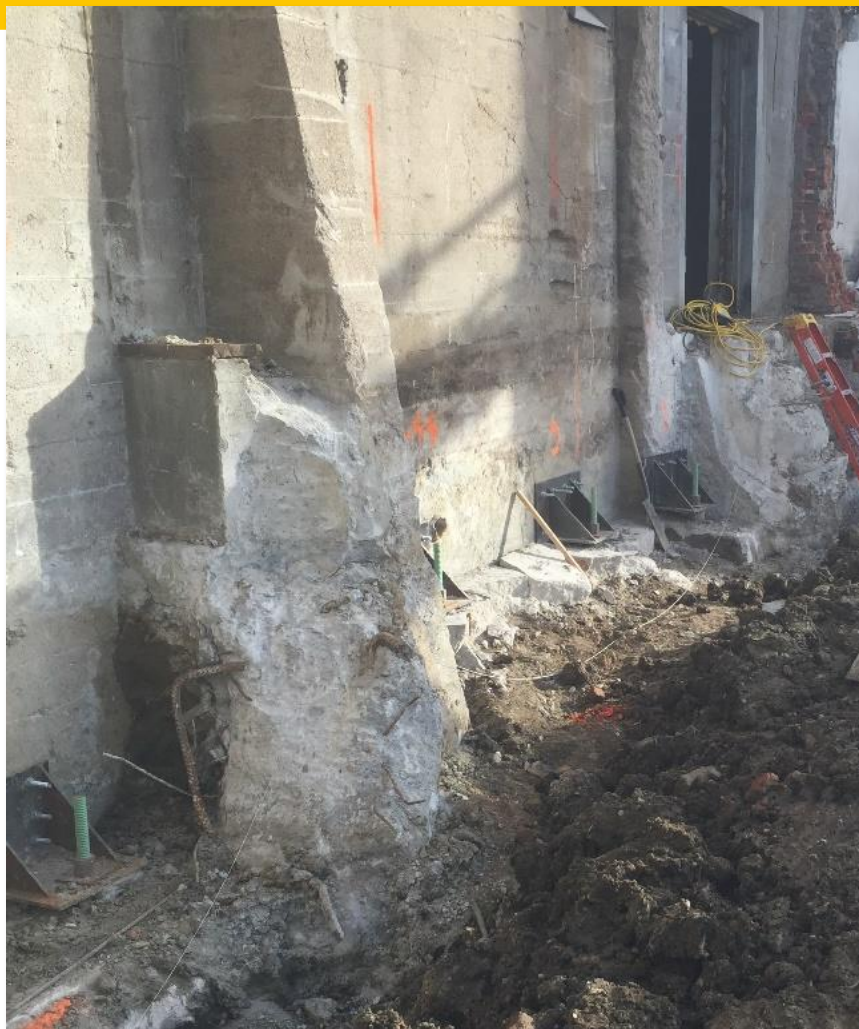
# Micropiles

- Soldier Beams could no longer brace the footing
- Installed micropiles to underpin existing footing

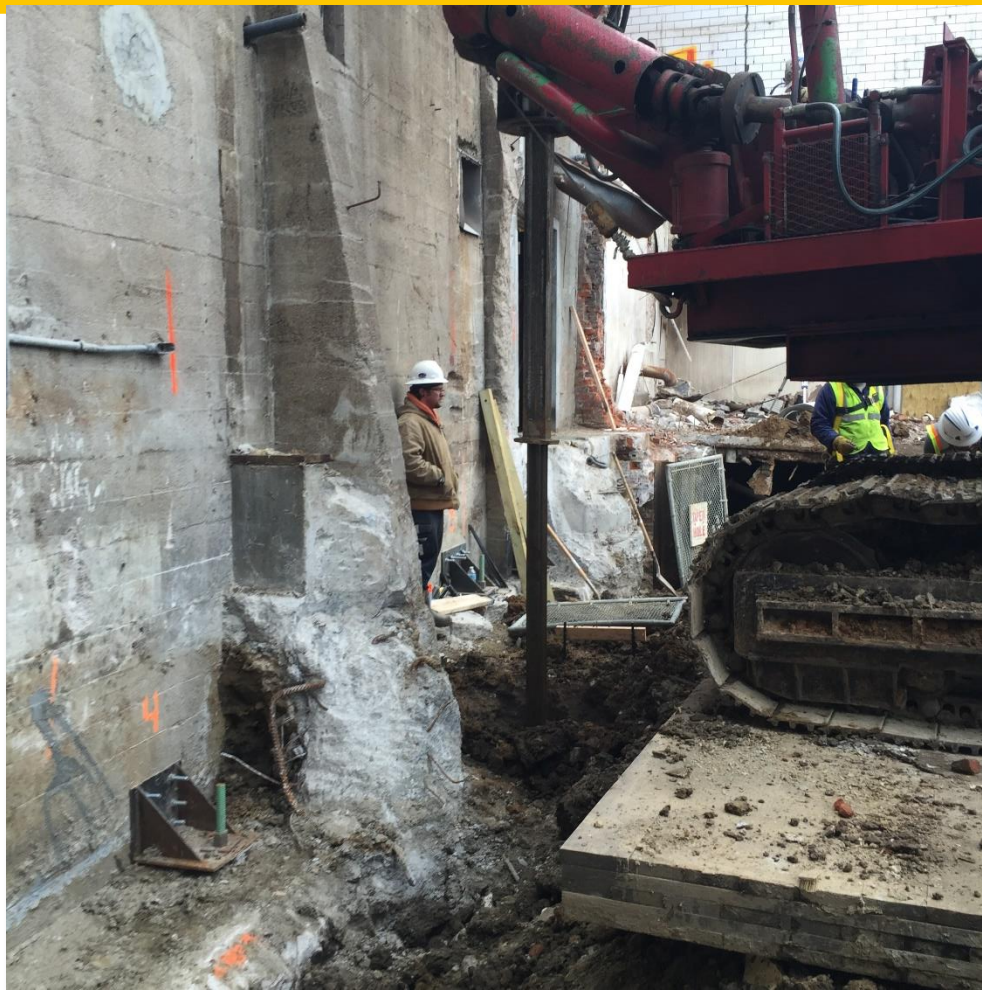
# Drilling the Soldier Piles

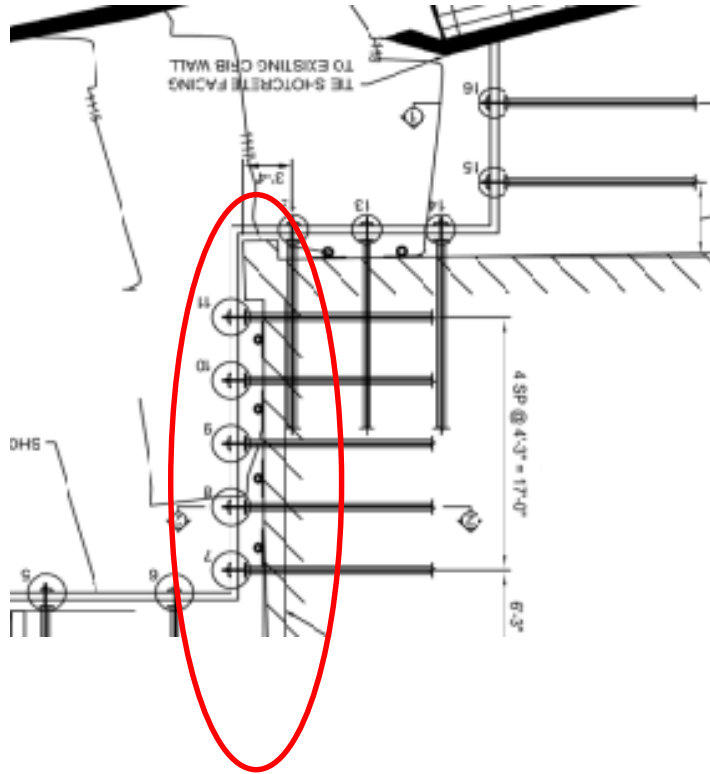
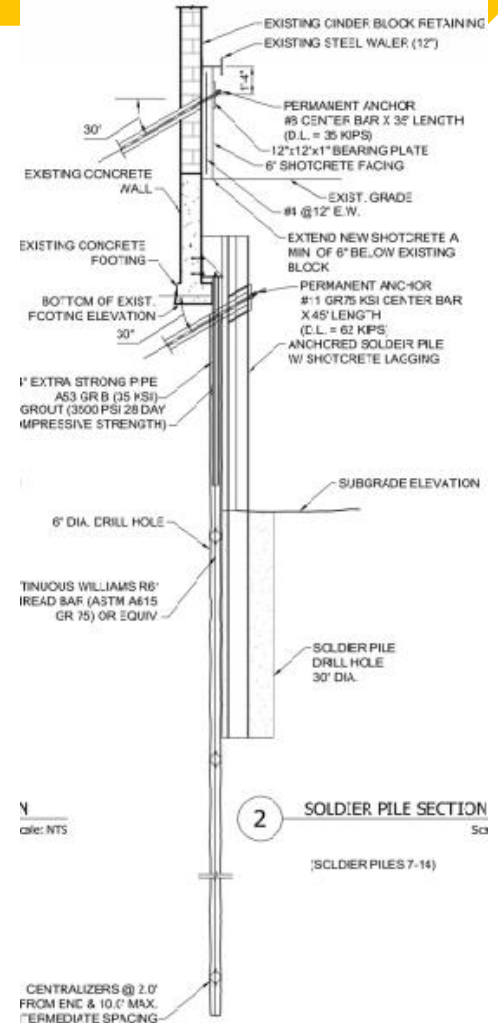
# North Wall Started to move during initial excavation

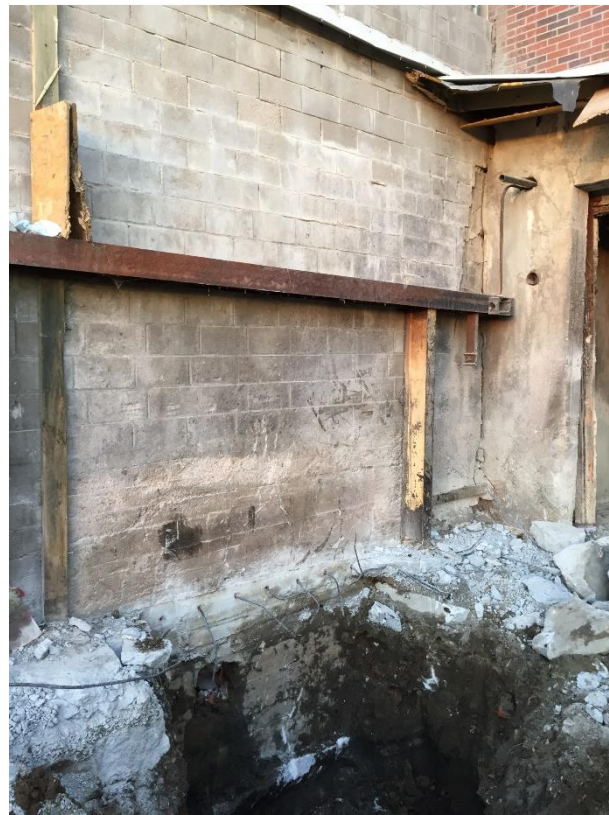
# Failing wall with soil on backside

- Five (5') feet of soil with slab stressing existing wall
- Wall previously fixed
- Started to move during initial excavation
- Installed tilt monitoring

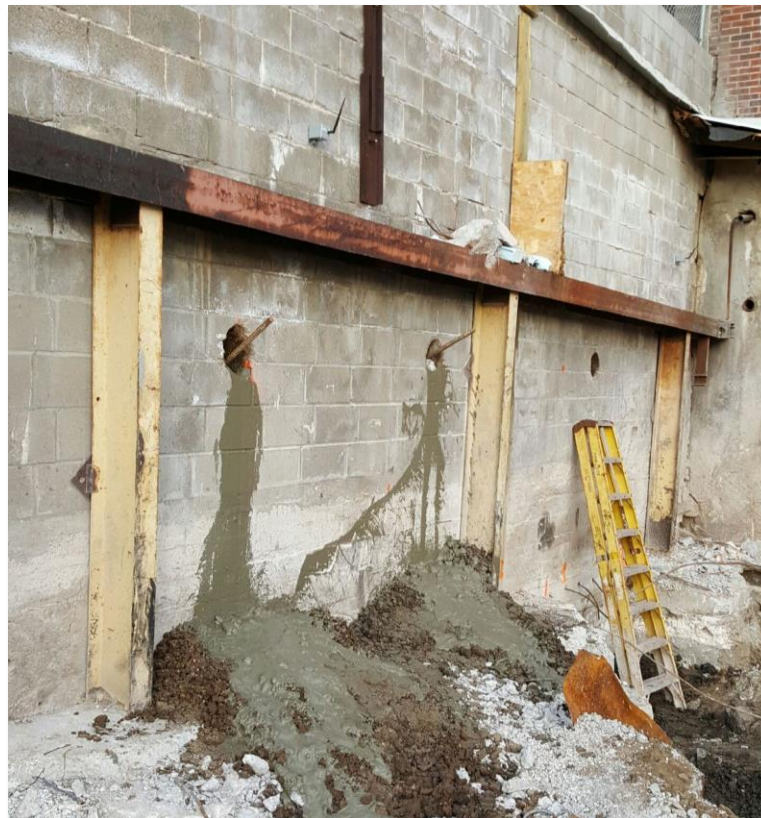
# Anchors to support wall

- Installed through CMU wall into fill material
- Shotcrete lagging between installed anchors

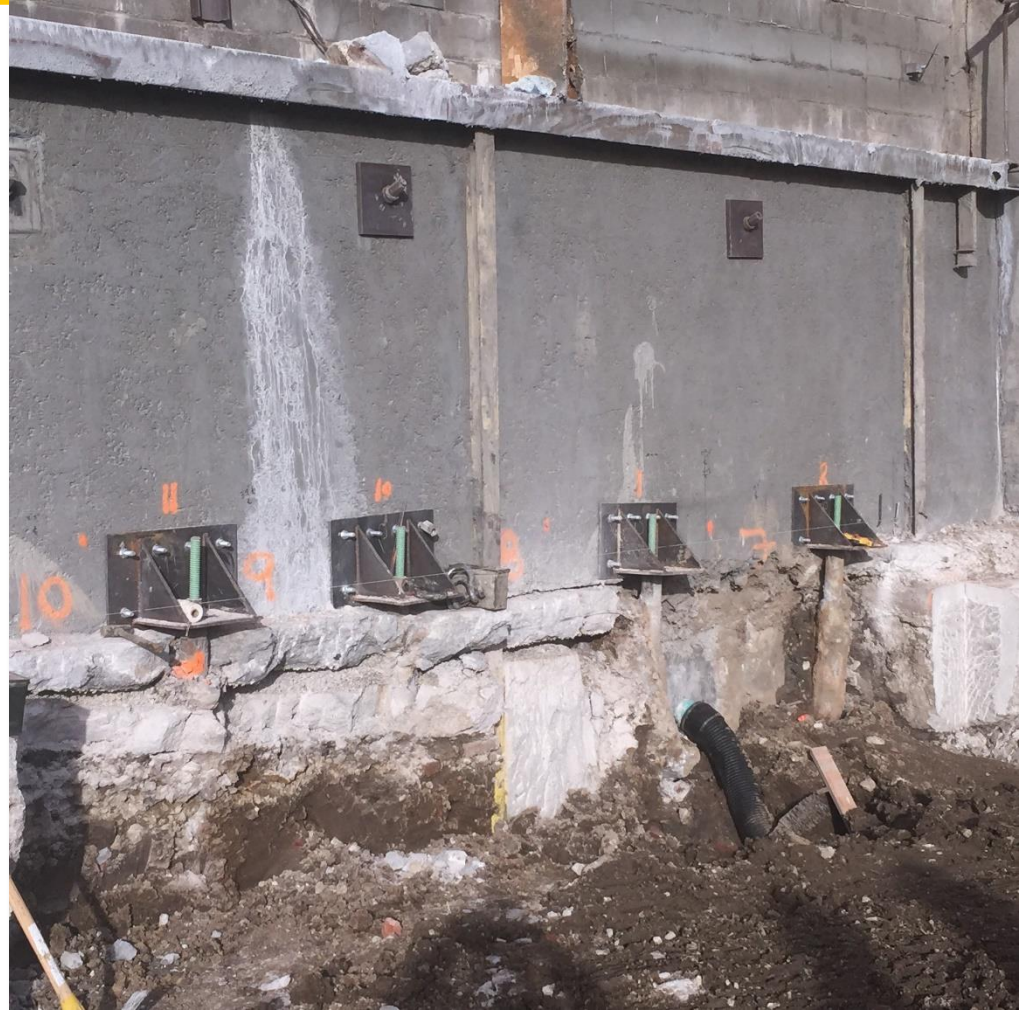
# Installed Anchors and Micropiles

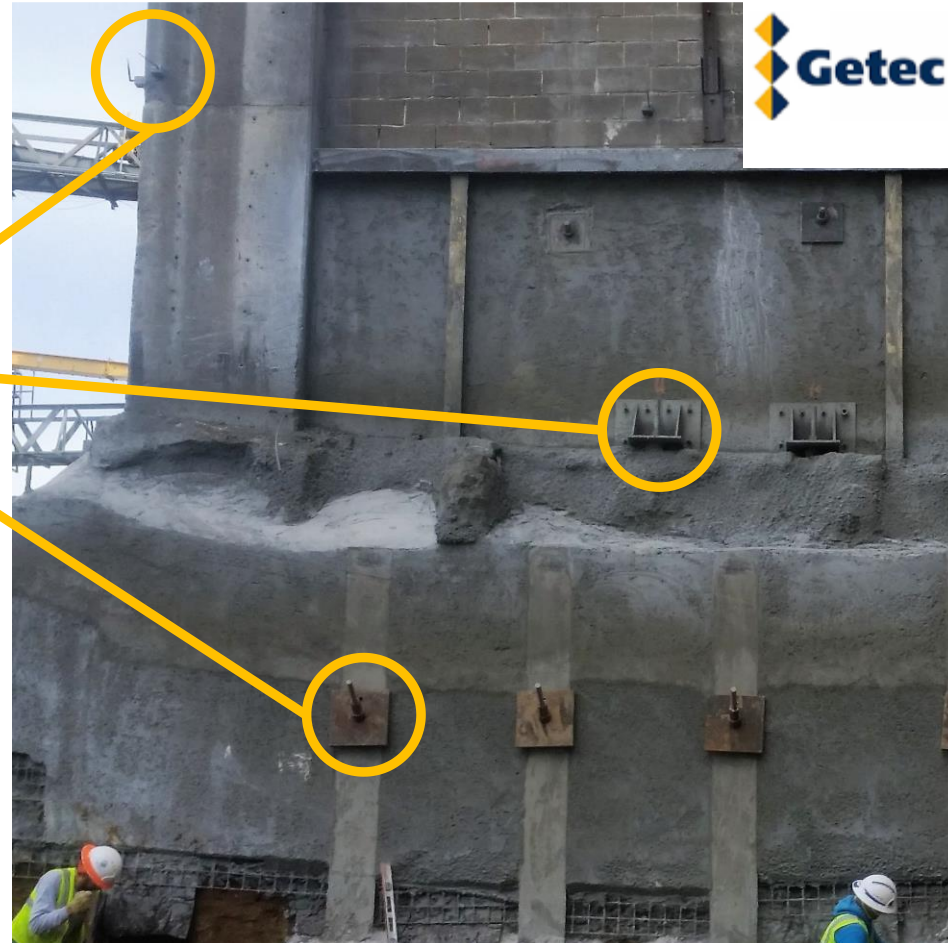
# Real Time Monitoring

- Getec (now Geo-Instruments) installed tilt monitors for real-time monitoring

Tilt Monitors

Micropiles

Anchors

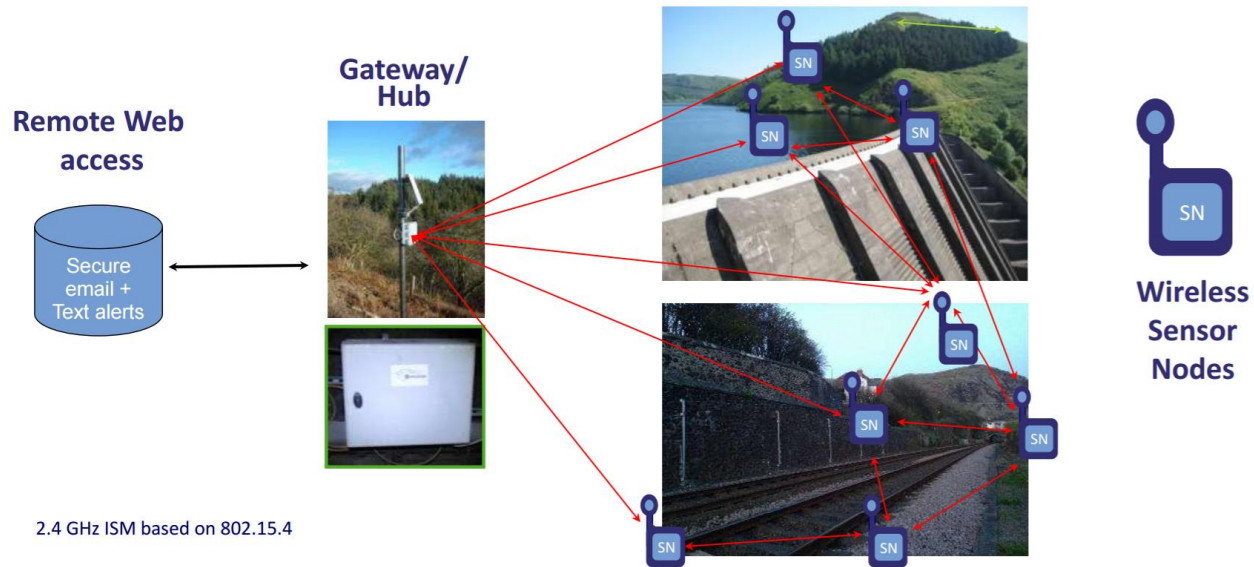
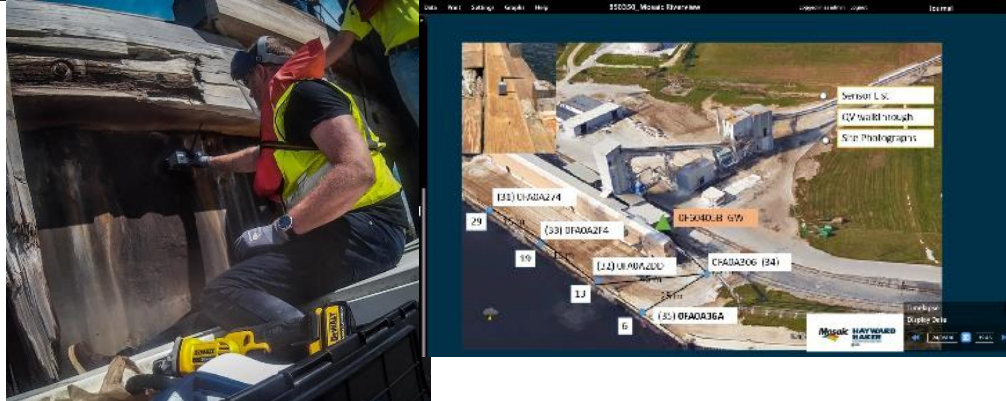
# Mesh Networks

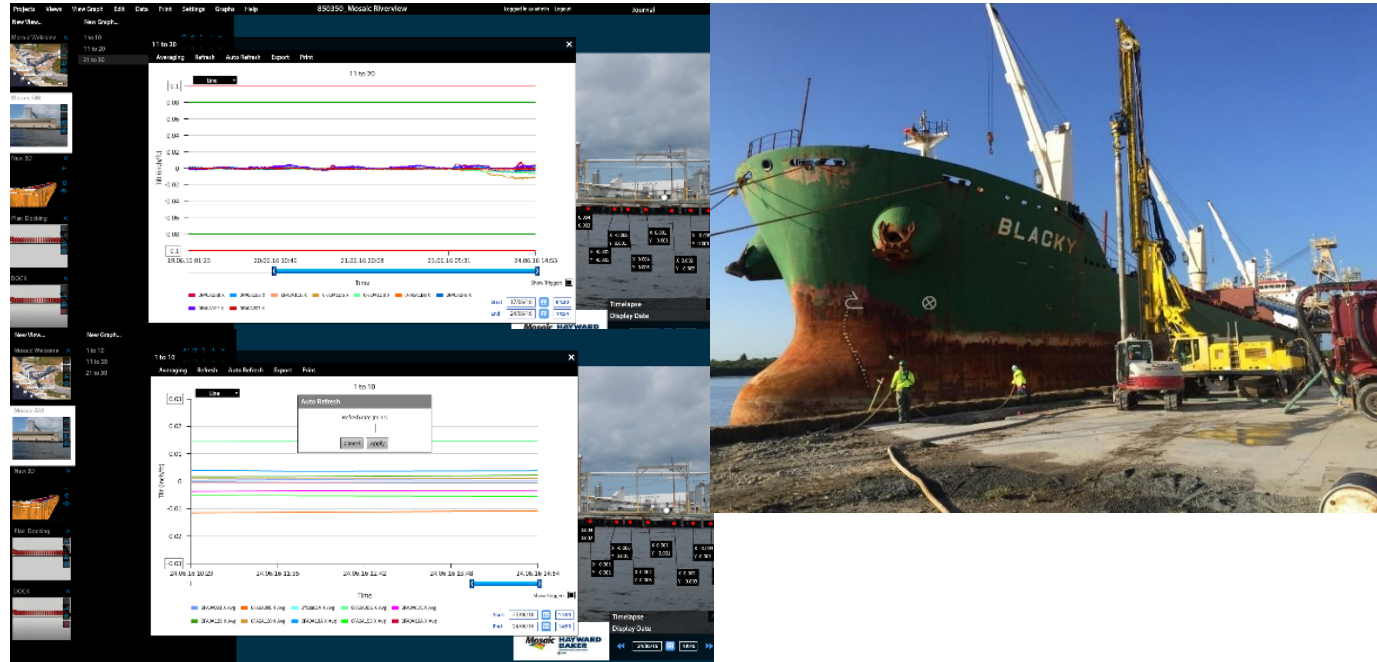
# Auto refresh 1 min & 10 sec alarm

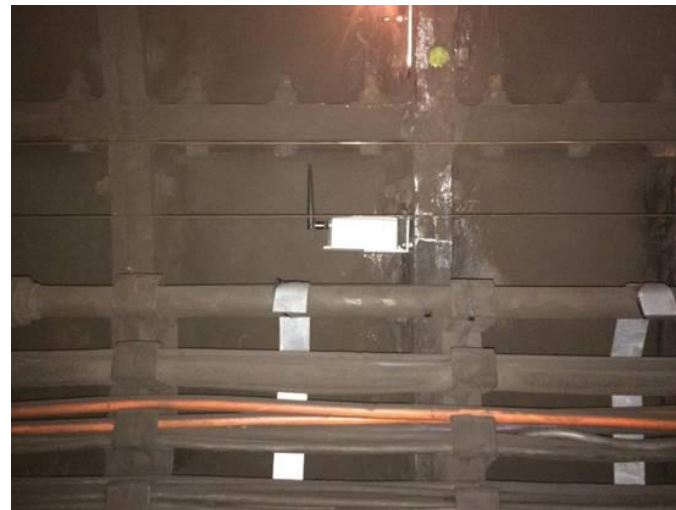
# Wireless Biaxial Tilt Nodes

- Integrated dual axis tilt sensor
- Extremely low noise performance
- Resolution of  $0.001^{\circ}$  (0.018mm/m) and repeatability of  $\pm 0.003^{\circ}$  (0.053mm/m)
- 12 -15 years battery life, including when acting as a relay node within the mesh communications network
- Integrated temperature sensor
- Waterproof to IP66 / IP67 / IP68
- Up to 300m range using a mesh network

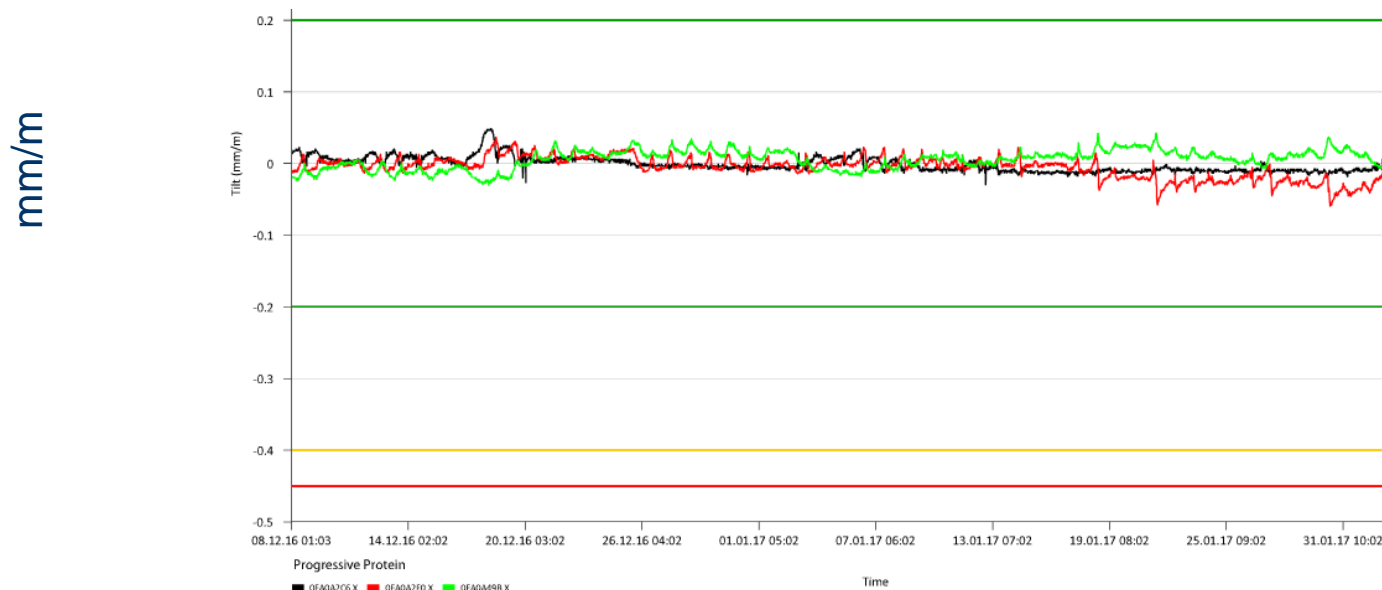
# Progressive Protein Monitoring – East Wall

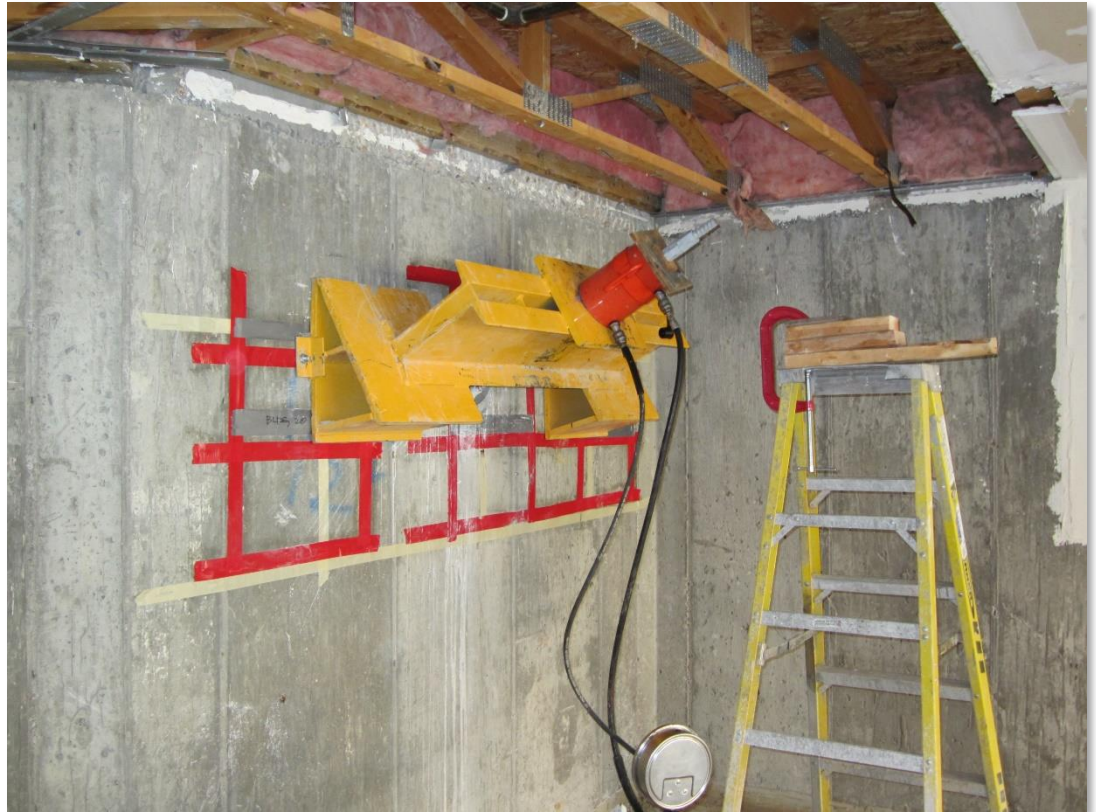
# Stressing

- Limited access stressing

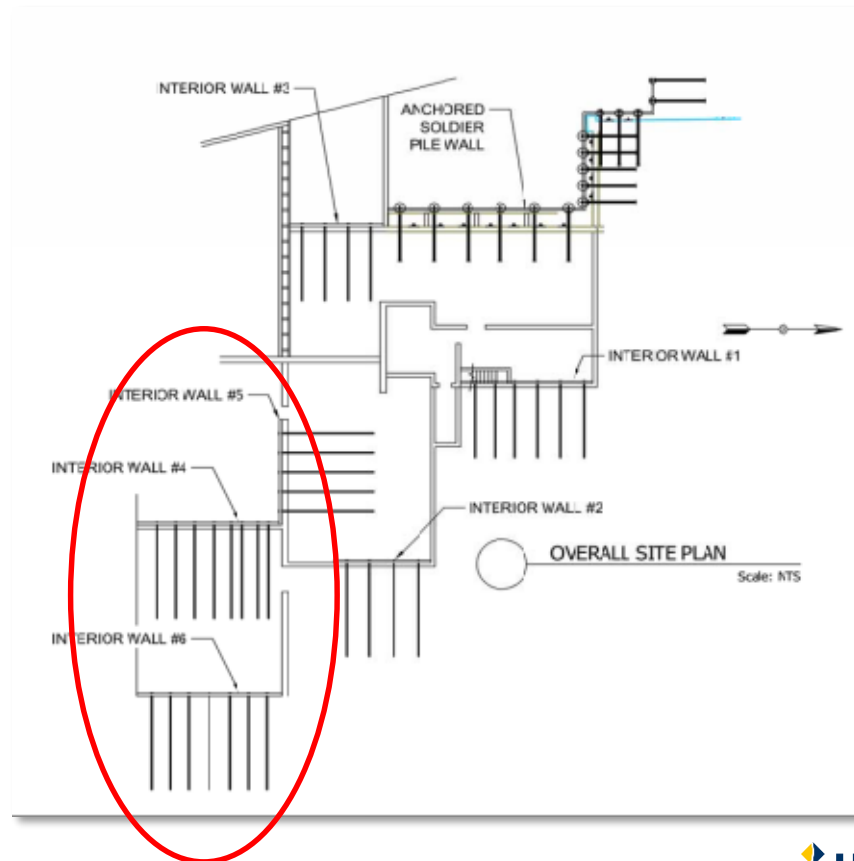
# Additional Work

- Can you brace the walls so we can remove a floor?
- After completing excavation we moved to more internal work

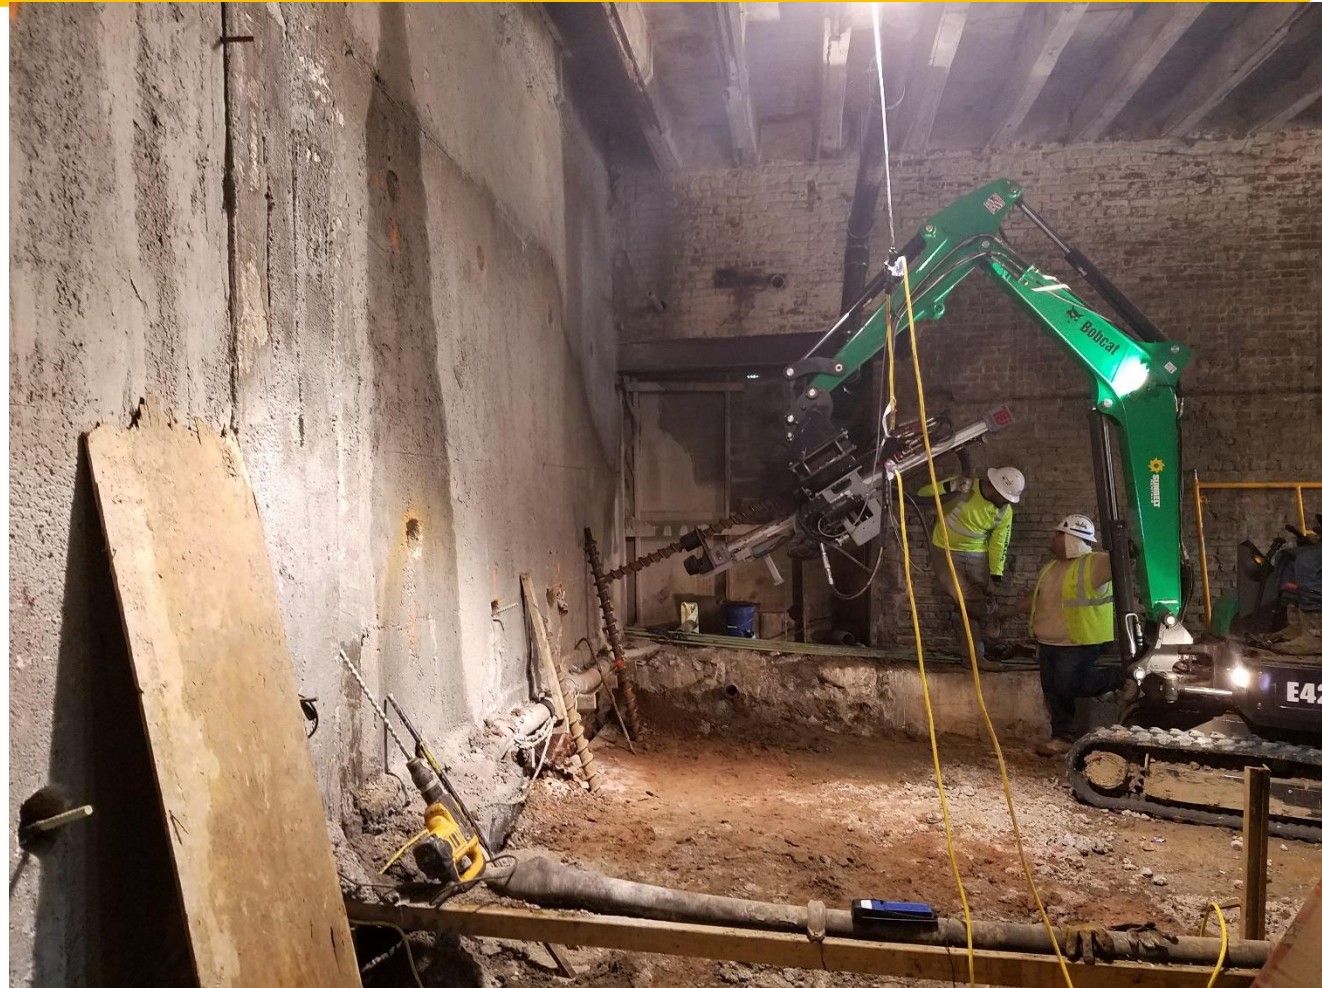
# Installing at Wall #4
