Lessons Learned Through 54 Years of Mistakes

Chuck Easton, P.E.
Freese and Nichols, Inc.
Fort Worth, Texas

Lessons Learned Through 54 Years of Mistakes: SOME EXPERIENCES WITH AUGERED PILES

Some Lessons Learned Through 54 Years of Mistakes:

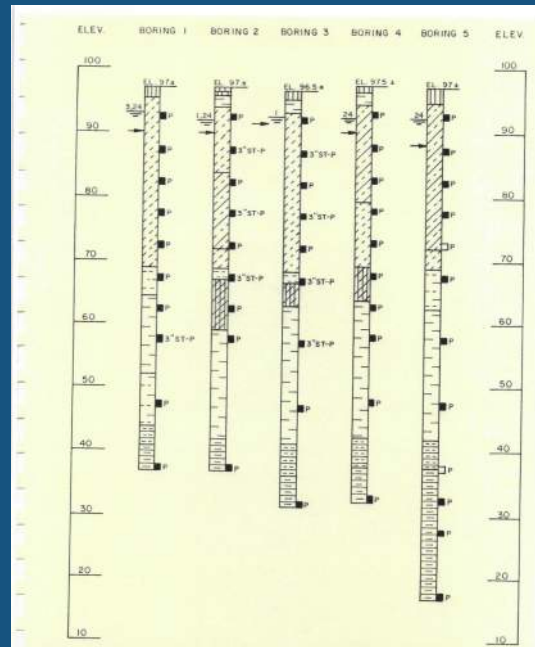
Boring Logs

The site was on a broad plain of loess underlain by glacial till. Borings showed a water table within a few feet of the ground surface, probably perched on the till. The Peorian Loess and the Loveland loess were both present, saturated, and compressible.

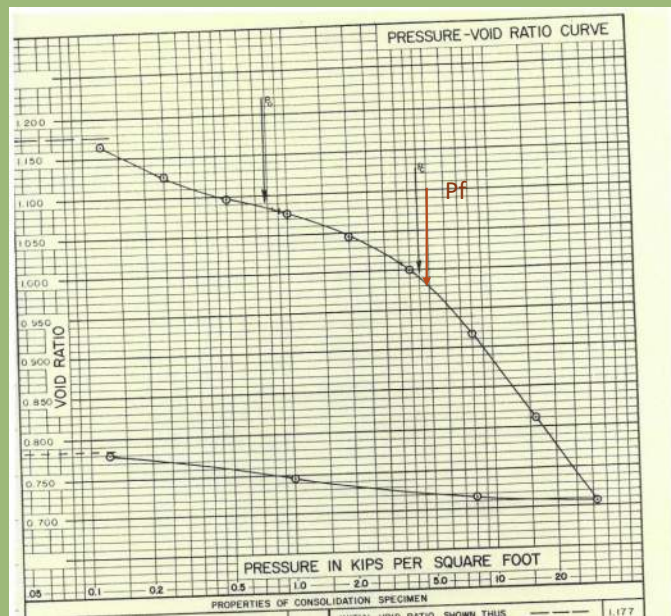
Consolidation Test B-2 @ 9.8 ft.

Consolidation tests showed the loess to be moderately overconsolidated, with preconsolidation pressures of about 4 to 6 kips per square foot.

When the distributed pressures from the foundation load were added to the existing overburden pressure, the vertical effective stress would slightly exceed the preconsolidation pressure. Although most of the stress change would be recompression, the settlement of the elevator would be large.

The settlement of the elevator was estimated to be 8 to 10 inches. Tilting was a concern. The recommendation was made to overexcavate the site and place about ten feet of compacted fill using the excavated silty clay (after much drying) to support the mat foundation and reduce settlement.

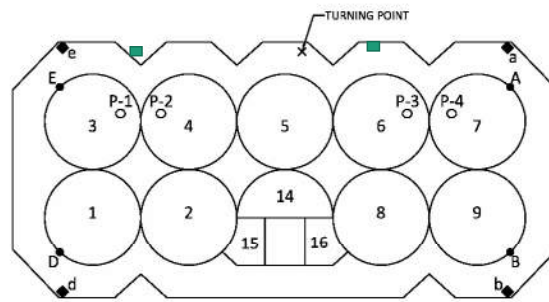
REVISED MAT PLAN

The designer suggested that the mat foundation could be enlarged by extending it 8 feet beyond the cell walls, reducing the net average bearing pressure to 6.65 ksf. This was agreed.

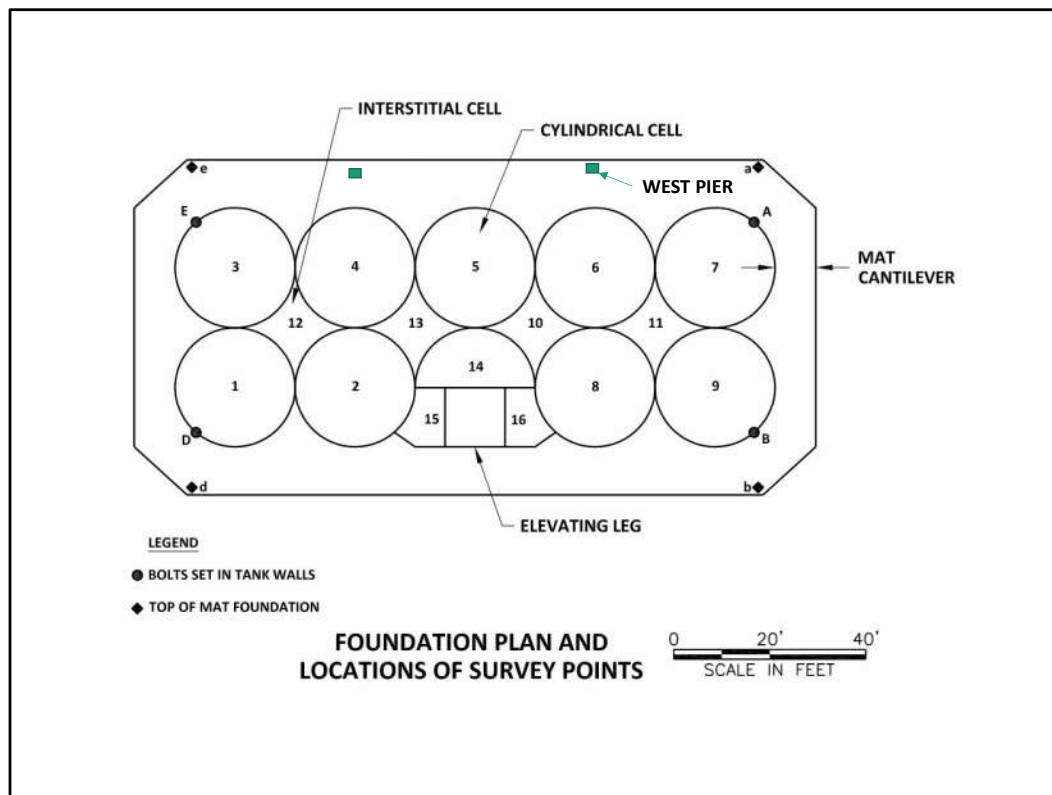
A pier supporting a railcar loading chute was used as a turning point as the surveys were looped around the structure. It was noticed that the turning point was not settling as much as the two anchor bolts on the southeast and southwest corners of the elevator, suggesting that the cantilever of the mat foundation might be deflecting upwards. Steel rods were driven to the top of the mat and surveyed as time went on.

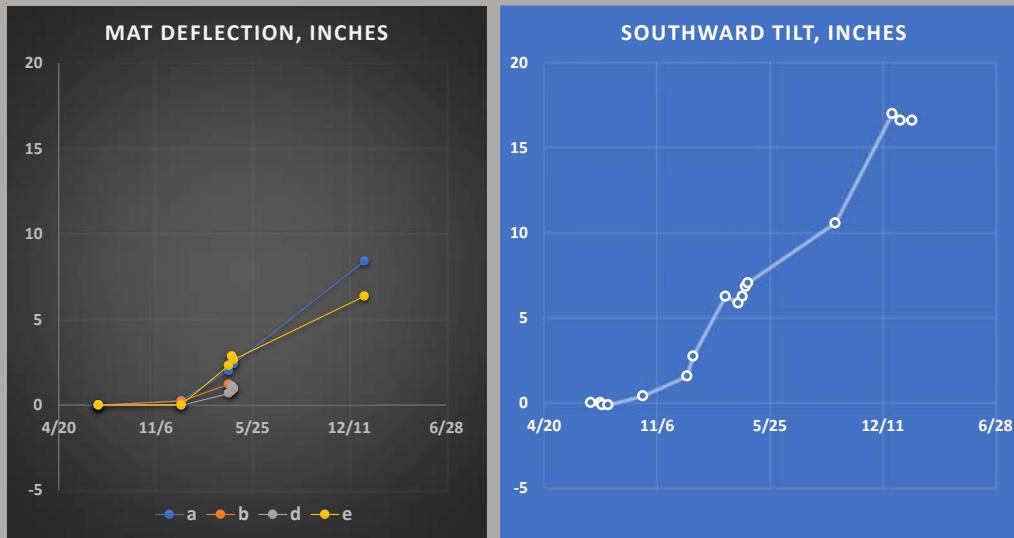
Settlement of Mat vs Cells

The two south corners of the mat had deflected upwards about 5.2 and 6.8 inches. This deflection must have involved a structural failure of the foundation.

The owner and designer/builder were informed that the mat was undoubtedly broken. The builder said: “We built it. We will fix it.”

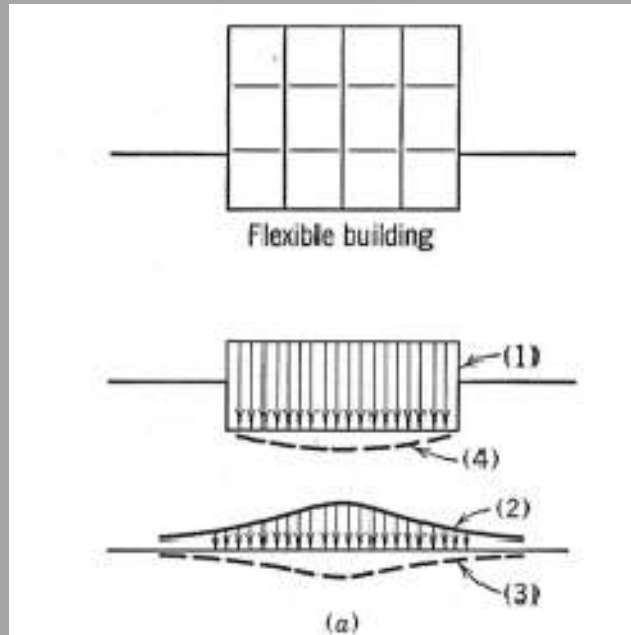
Stress Distribution Under Uniform Load

Elastic analysis shows us that an area loaded with a uniform pressure tends to cause higher pressure at the center and lower pressure at the edges on a plane at substantial depth. The foundation will tend to become bowl-shaped.

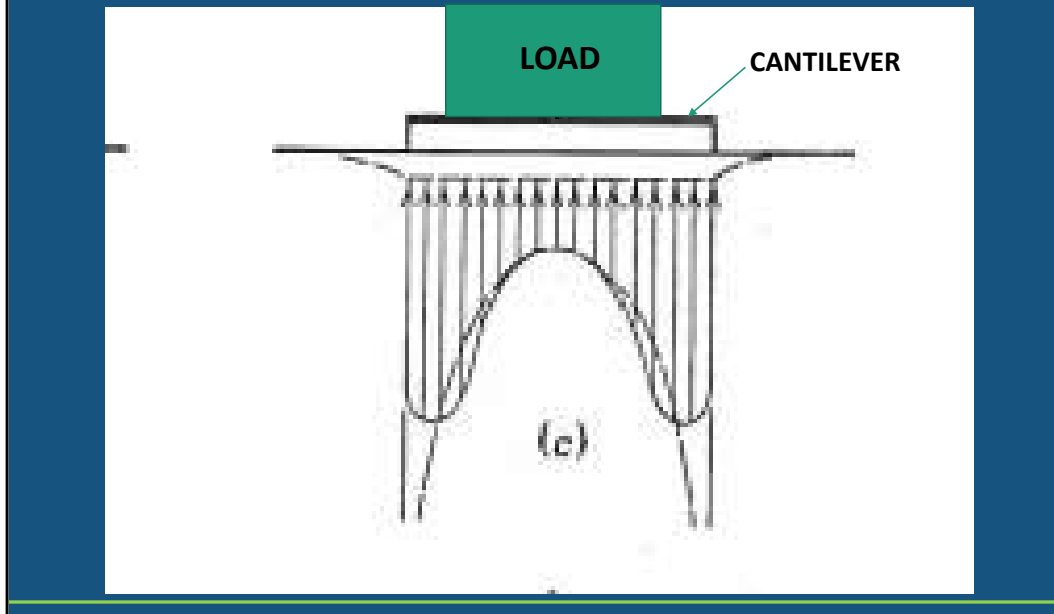
Contact Pressure Under Rigid Mat

According to elastic theory, the pressure approaches infinity at the edge. This will not occur on a real soil because the soil will shear and move out from under the edge.

Still, the pressure under the outer few feet of a mat can readily exceed two or three times the average pressure, and the pressure near the center can be near one-half the average. Unfortunately, the very different stress distribution under a rigid foundation is only briefly discussed in most textbooks and design guides.

- The mat foundation was designed assuming a uniform soil bearing pressure across the mat, including the cantilevered parts outside the walls. The high pressures that developed there created bending and shear stresses that greatly exceeded the strength of the reinforced concrete.

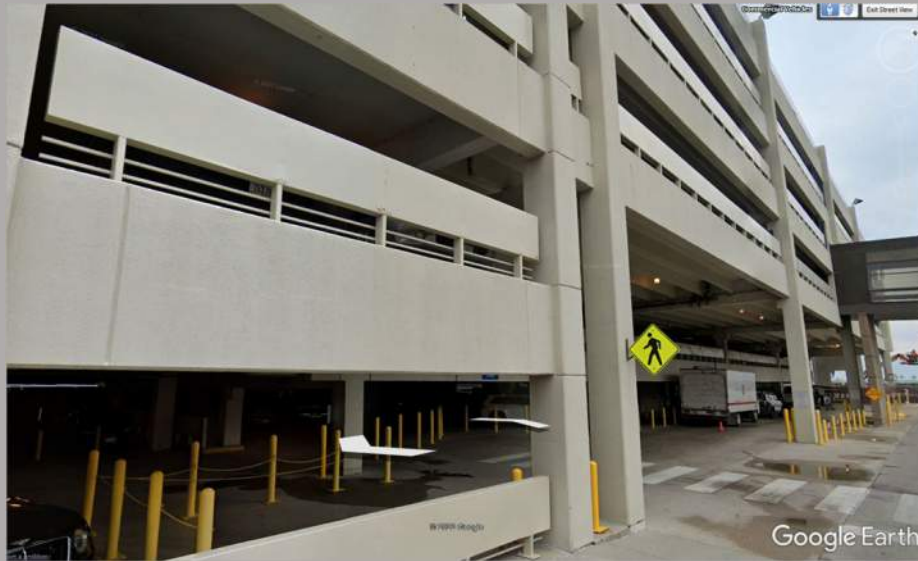
NEW STRUCTURE MEETS OLD ONE

Because the two garages were combined, new column foundations were needed adjacent to the existing structure.

The column spacings were different, so most of the new columns were offset from the existing ones. At the southeast corner of Garage #1, the two foundations would be adjacent.

THE FOLLOWING MORNING, THE SOUTHEAST COLUMN OF THE EXISTING GARAGE WAS FOUND TO HAVE SETTLED ABOUT 7 INCHES OVERNIGHT.

The settlement was clearly due to the installation of the new augered piles close to the existing Franki PIFs.

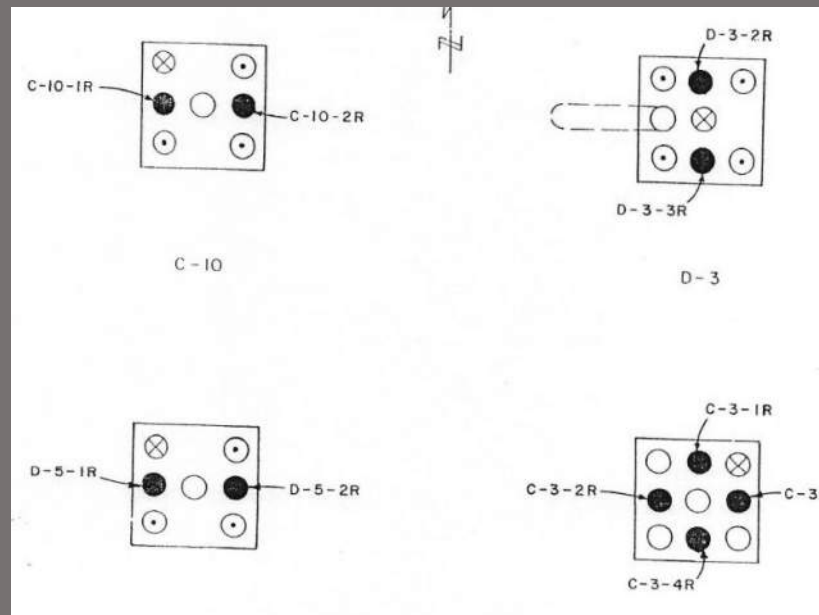
ASSUMED EFFECT OF PULLING AUGER

Previously placed piles adjacent to a re-augered pile were assumed to have negligible capacity. Piles added after the re-augered pile were assumed to have full design capacity. Steel piles were added to make up the lost capacity and provide balanced support. It was assumed that the heavy steel piles bearing on rock could provide more than 120 tons support if needed.

STEEL PIPE PILES WERE LOCATED IN PLACE OF OR BETWEEN THE AUGERED PILES AND DRIVEN TO BEDROCK AT DEPTHS RANGING FROM ABOUT 116 TO 147 FEET.

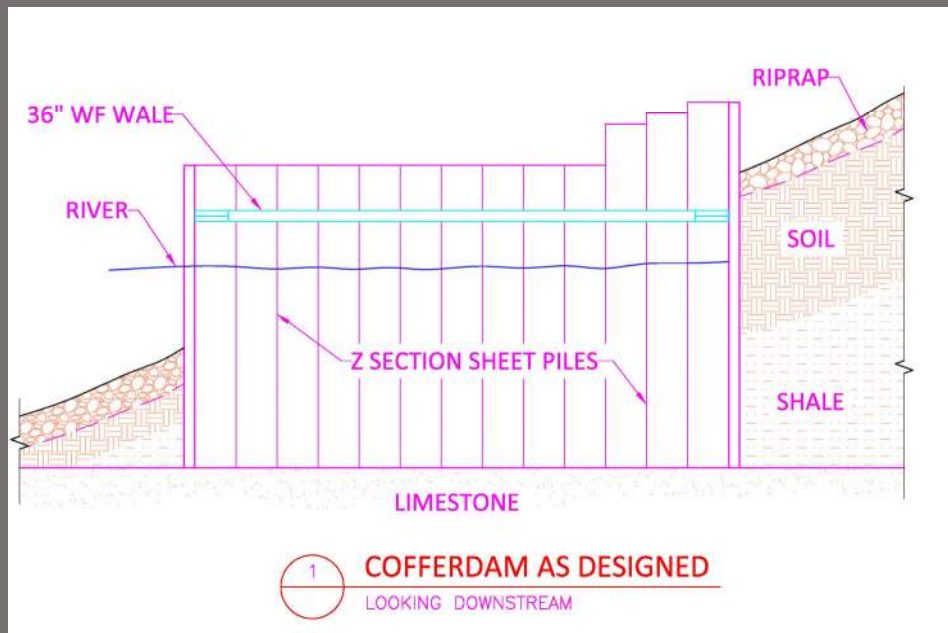
COFFERDAM AS DESIGNED

The cofferdam would be about 40 by 60 feet in plan. It was to be built using Z-section steel sheet piles driven through the shale to the limestone. It would be braced using 36-inch wide-flange beams serving as wales and struts.
