Foundation Performance of Millennium Tower in San Francisco, CA

Jonathan P. Stewart, PhD, PE

UCLA Samueli Engineering

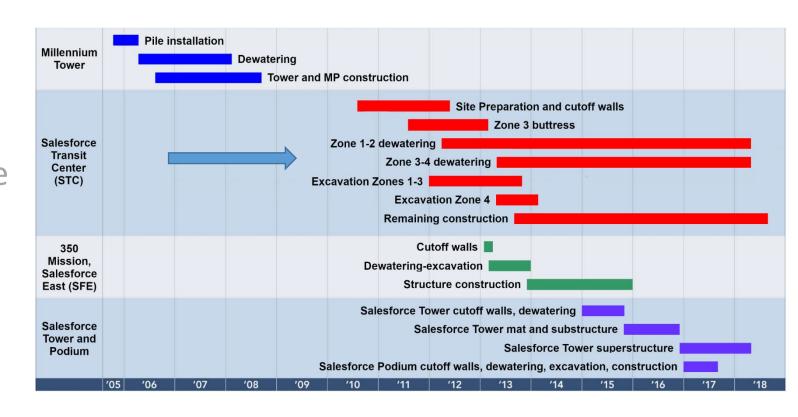
Transit center constructed in four "zones"

Zones 1-2 dewatering began in 2012

Zones 3-4 dewatering began in 2013

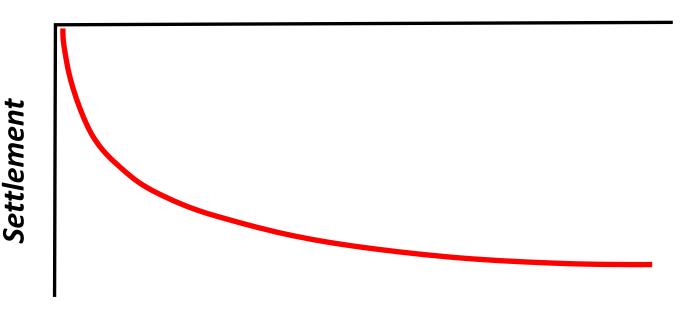
Settlement rate fast initially, then slows with time

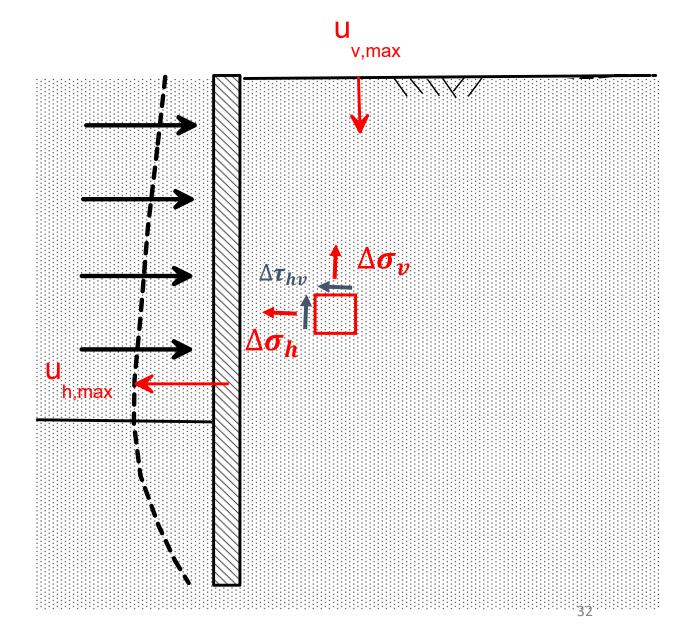
Shear Deformation of Braced Excavations

Supported excavations change stresses in retained soils

Wall movement inwards

Ground settlement behind wall

Produces tilt of structures towards excavation

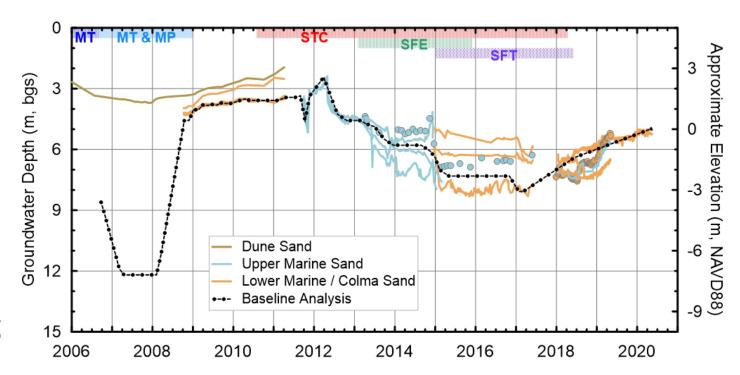
- Selected locations are outside of excavations & near MT
- Pre-construction gwt at ~3 m
- 2007-08: podium construction; rapid recovery
- 2012: STC Zone 1-2 dewatering
- 2013: Zone 3-4 and SFE dewatering
- 2015-17: SFT dewatering
- > 2018: recovery

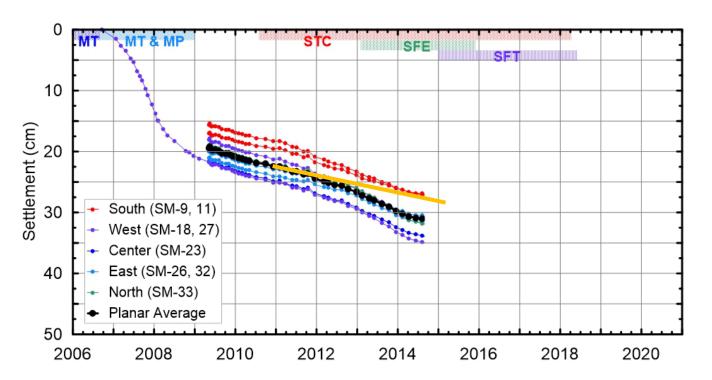
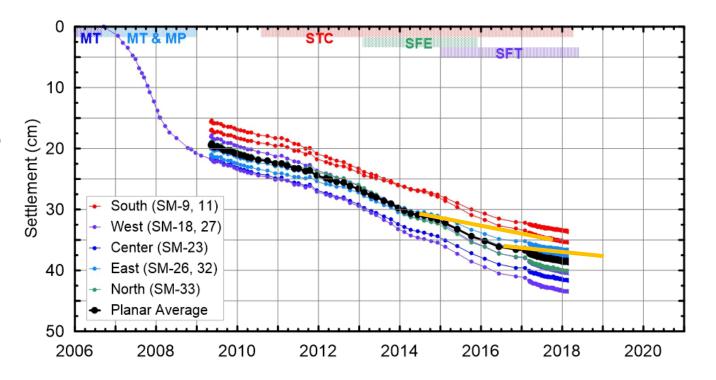
- 2006-09: single monument on 1st floor
- May '09 present: 31 markers
- 2006-11: Tower only
- 2012-13: onset of STC zoned dewatering. 2013 SFE

- 2006-09: single monument on 1st floor
- May '09 present: 31 markers
- 2006-11: Tower only
- 2012-13: onset of STC zoned dewatering. 2013 SFE
- 2015-18: SFT / plaza dewatering & construction

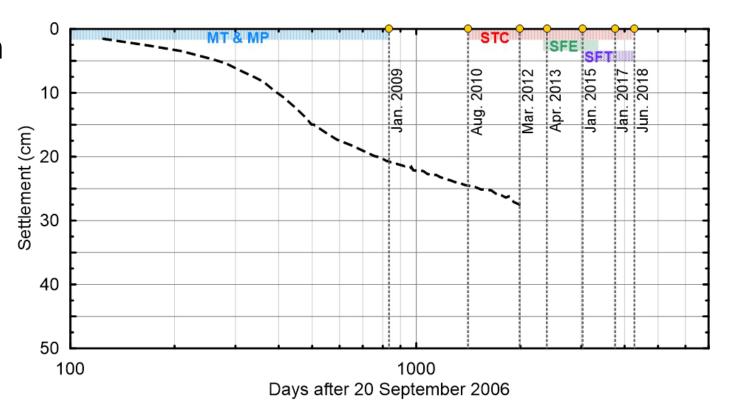
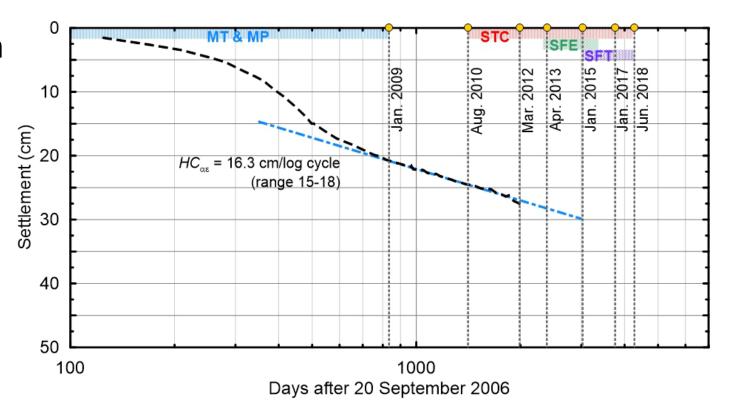
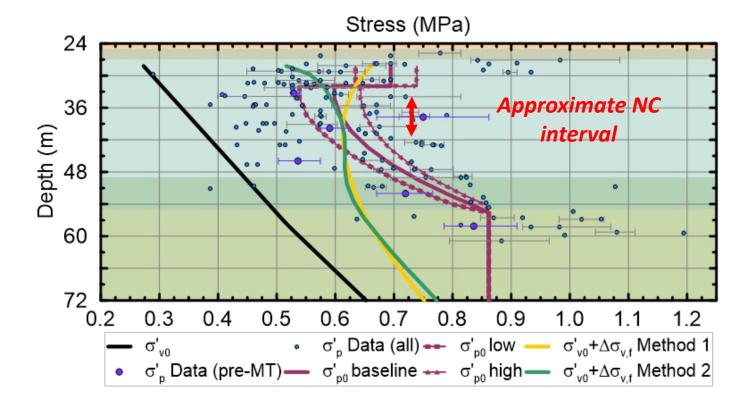
Prior to adjacent construction

• Stress comparison to σ_p'

- Stress comparison to σ_p'
- Secondary compression was strong contributor
- Some consolidation may have still been occurring > 2009

H=7-12 m \rightarrow implied $C_{\alpha\varepsilon} = 0.013 - 0.022$

Laboratory data: 0.006-0.016 (avg 0.01)

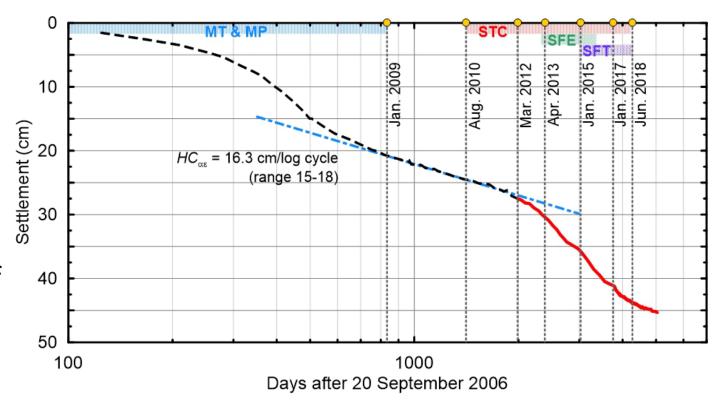
- Stress comparison to σ_p'
- Secondary compression was strong contributor
- Some consolidation may have still been occurring
- Acceleration following onset of adjacent construction

Since 2012

- Concept of time "reset"
- Reset in 2012
- Pattern complicated by multiple loading cycles
- Recent slope suggests consolidation is complete

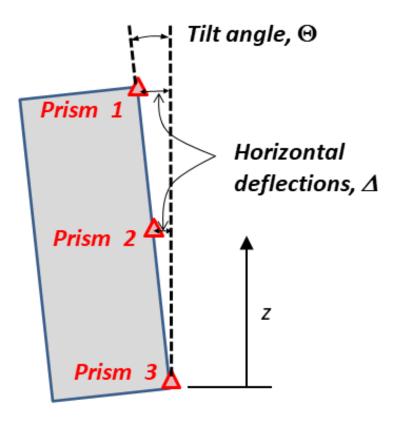
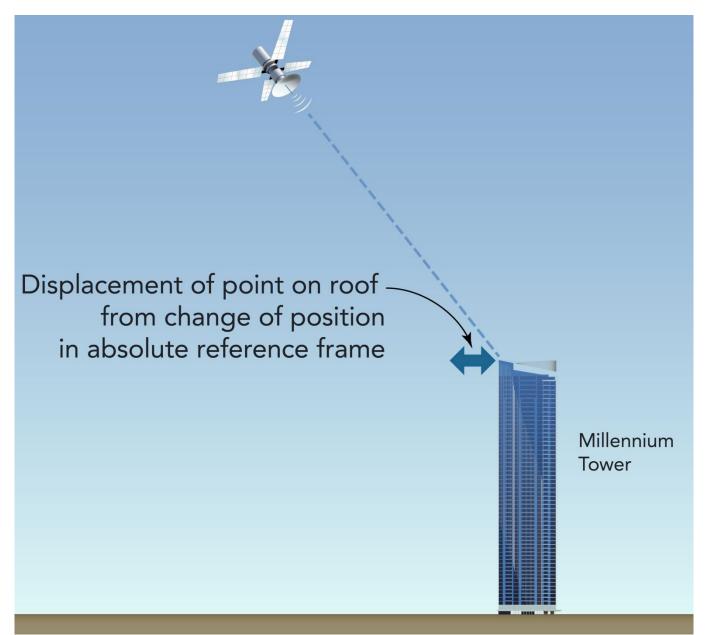
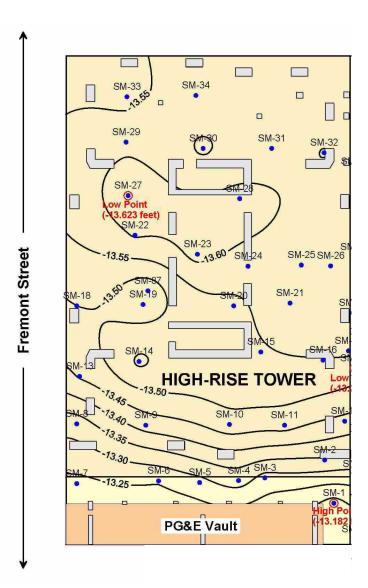
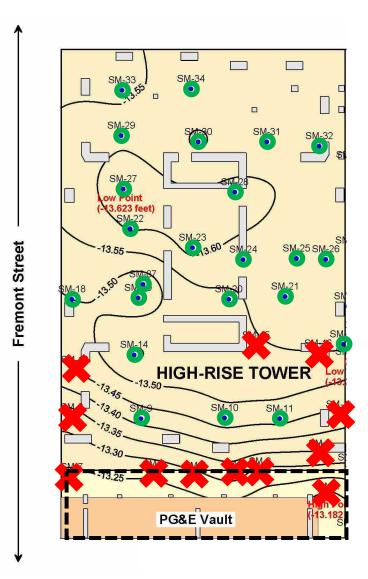
- Prisms (Jan '17 present)
- InSAR data (May '09 Mar '17)

- Prisms (Jan '17 present)
- InSAR data (May '09 Mar '17)
- Settlement markers (May '09 present)

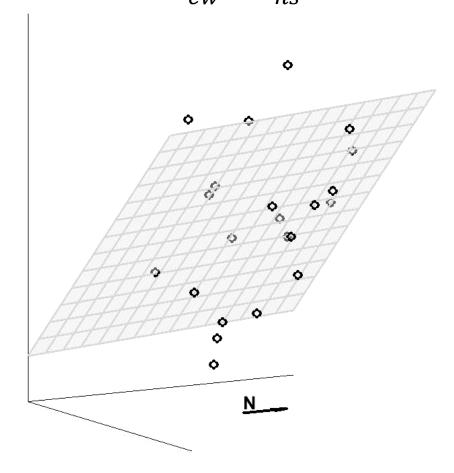
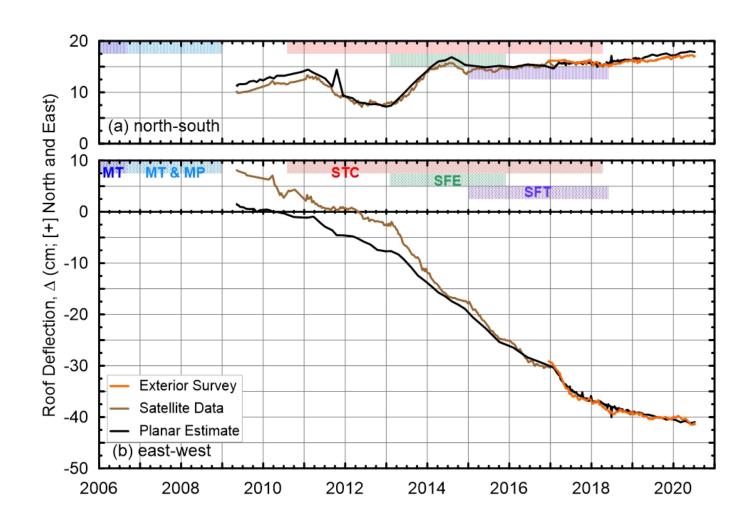
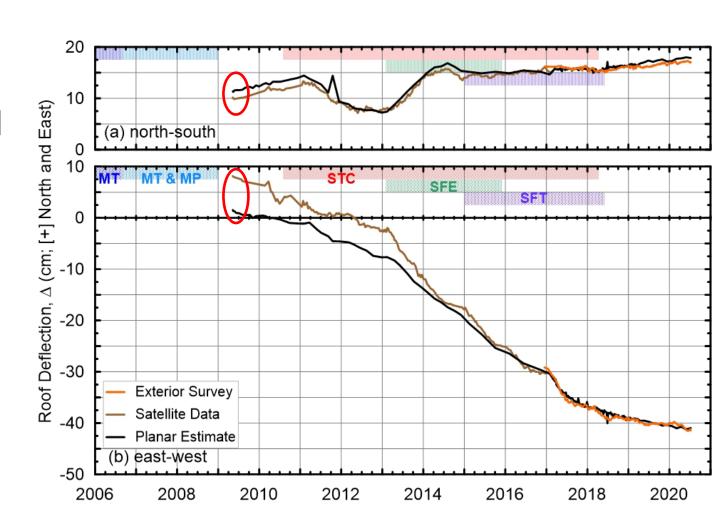
Initial (May '09) tilts estimated

Why initial tilt to east?

2009-11: movement to north and west

Why the west trend in tilt?

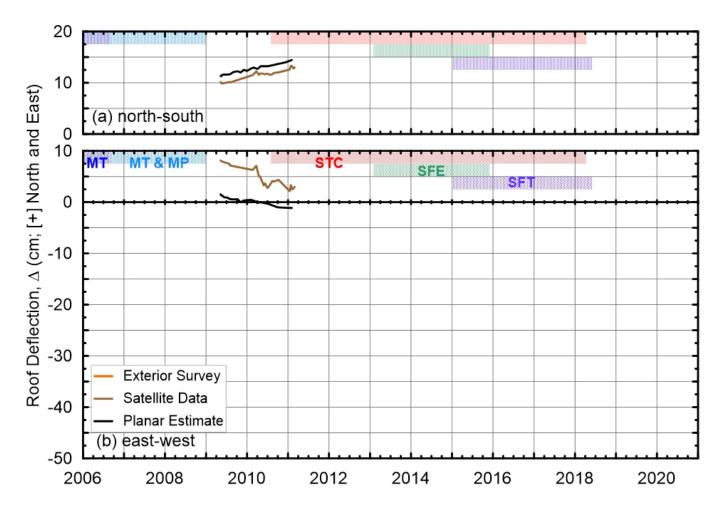
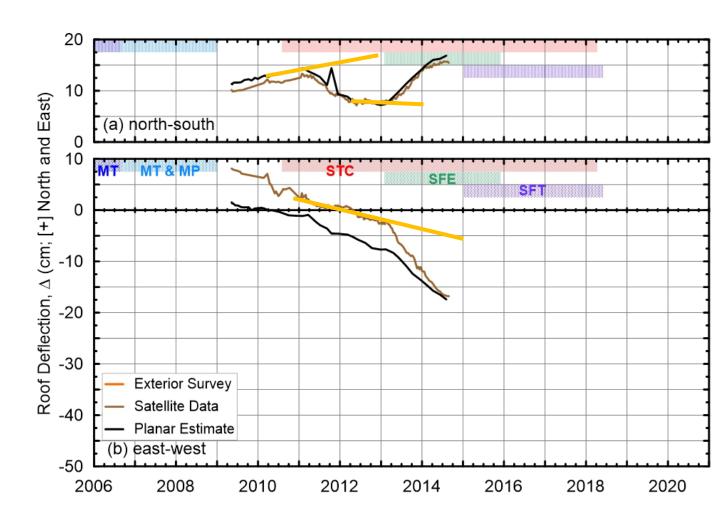
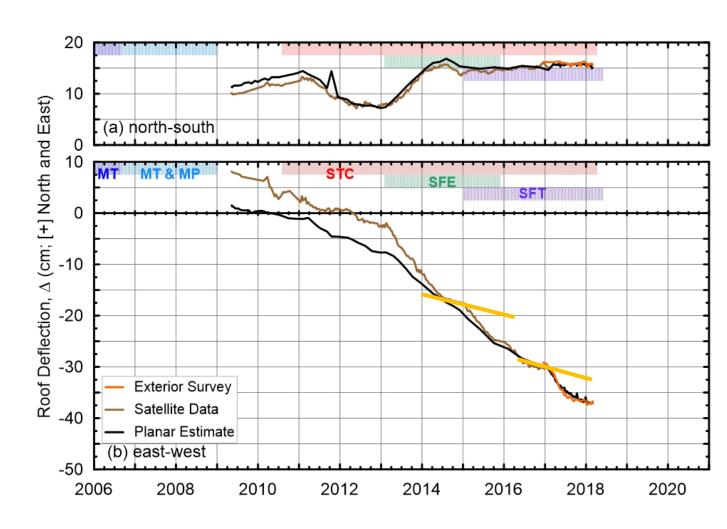
Initial (May '09) tilts estimated 2009-11: movement to north and west

2012-13: STC dewatering & excavation. 2013 SFE

2015-18: SFT / plaza dewatering & construction

After 2018: deceleration of W tilt

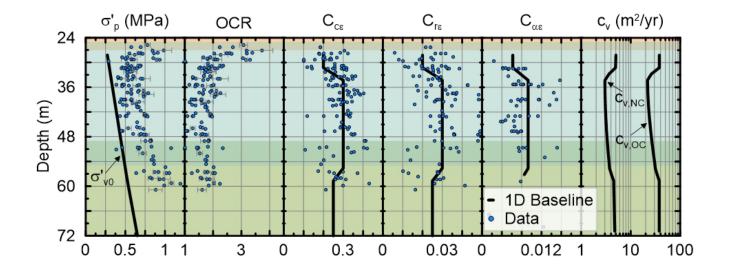
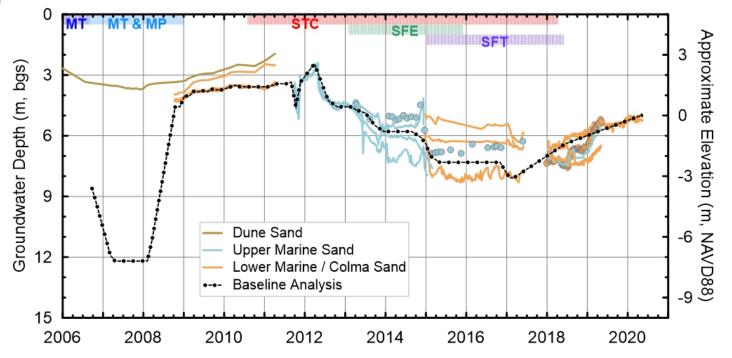
Adjacent construction considered through gw variations in time

- U_{1D} =81% (late 2011)
- U_{1D}=96% (late 4/2019)
- OCR = 1.02 in 5/2020 due to gw rebound (2.1 m)

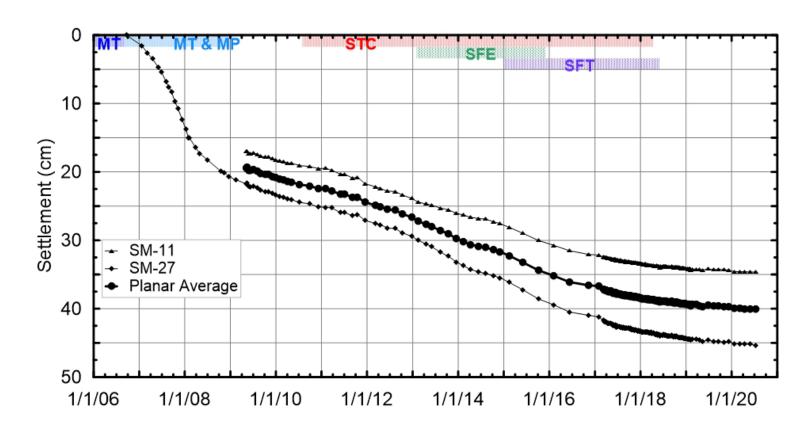
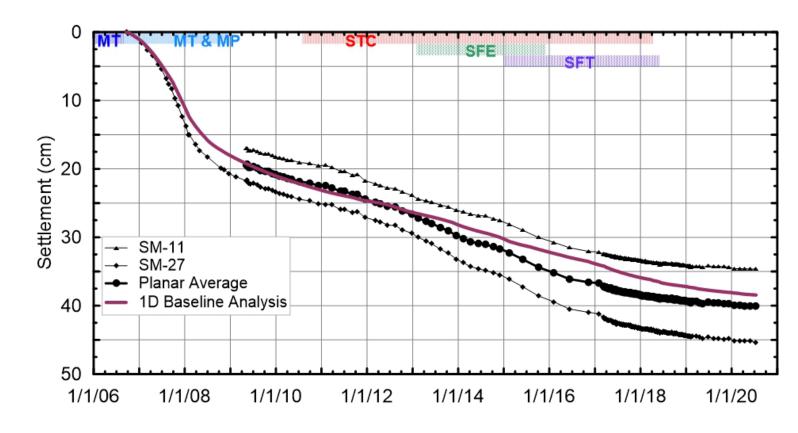
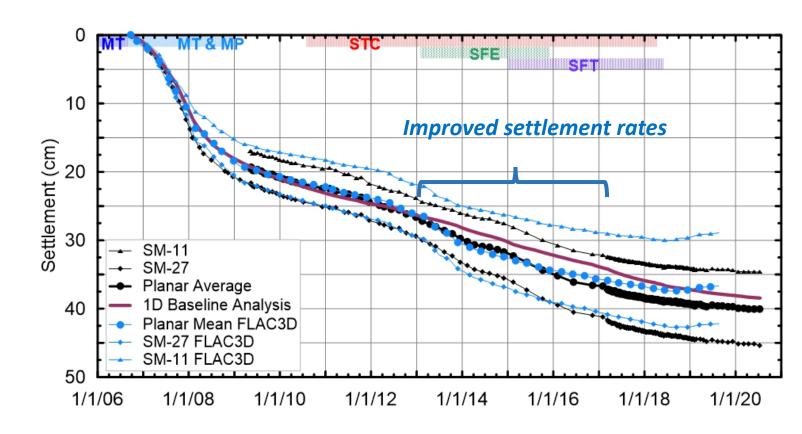
- U_{3D} =90% (late 2011)
- U_{3D}=100% (late 4/2019)

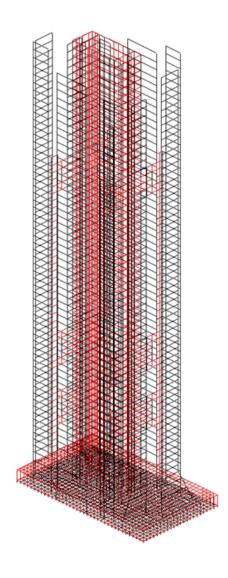
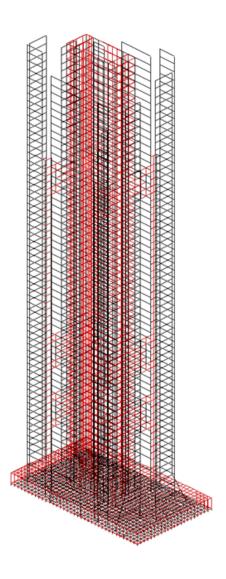
Tower "seismic response considering settlement is essentially the same as that neglecting it"

Retrofit not required

Retrofit underway to address stigma-related losses

Perimeter piles (N and W sides)
