Some Lessons Learned Through 54 Years of Mistakes: HYDROCOMPRESSION SETTLEMENT OF DEEP EARTH FILLS

CHUCK EASTON, P.E.
cne@freese.com

Some Lessons Learned Through 54 Years of Mistakes

Collapse of Tempering Cooler

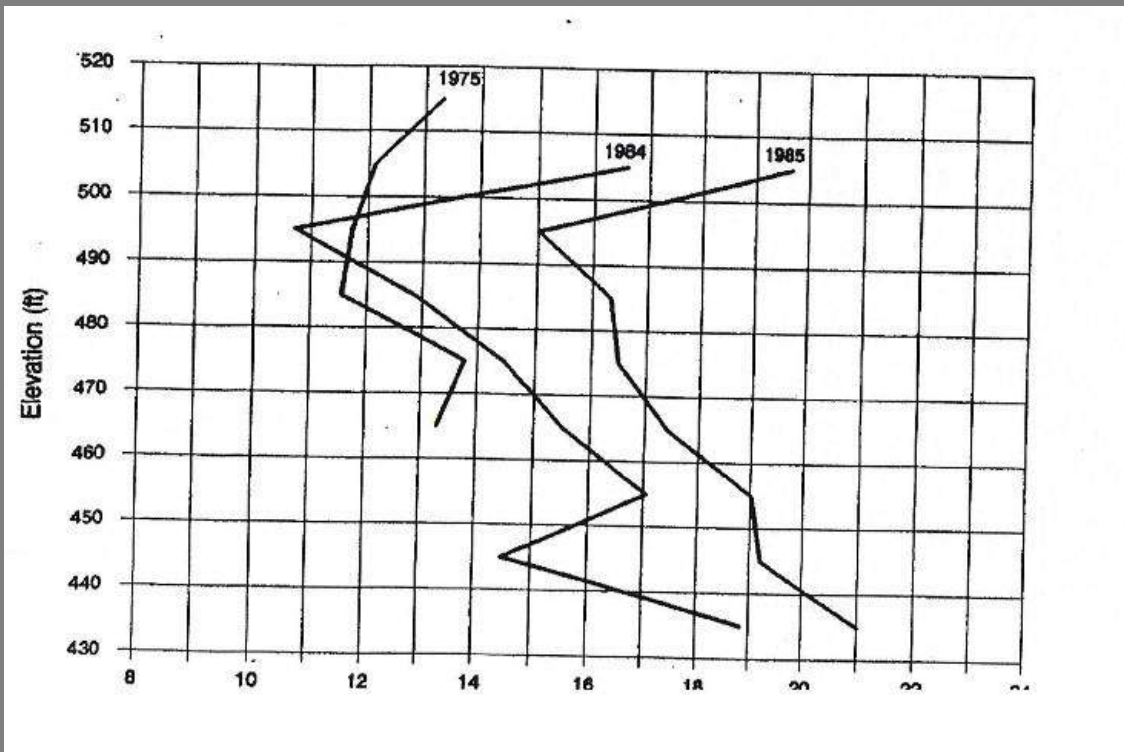
- HEAVY IRRIGATION OF LAWNS HAD BECOME COMMON
- EQUIVALENT ANNUAL RAINFALL INCREASED FROM 8 INCHES TO 70 INCHES PER YEAR!
- BORINGS SHOWED THAT WATER CONTENTS AT DEPTH HAD INCREASED TO 16 TO 21%

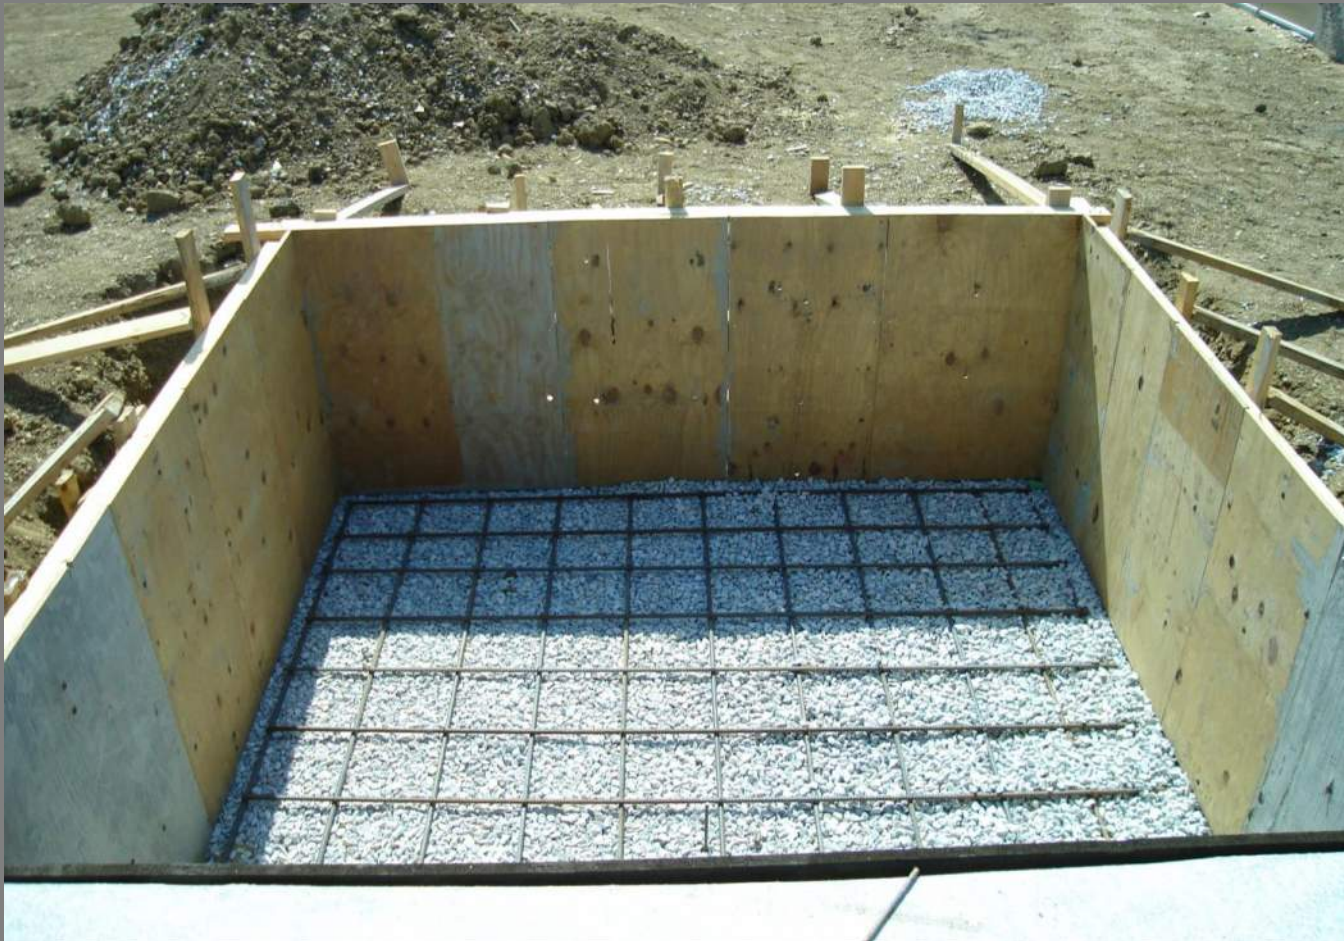
- A BLOCK FOOTING TO SUPPORT A JIB CRANE WAS CONSTRUCTED ON THE BACKFILL, ADJACENT TO THE LIFT STATION, ON AUGUST 14, 2006

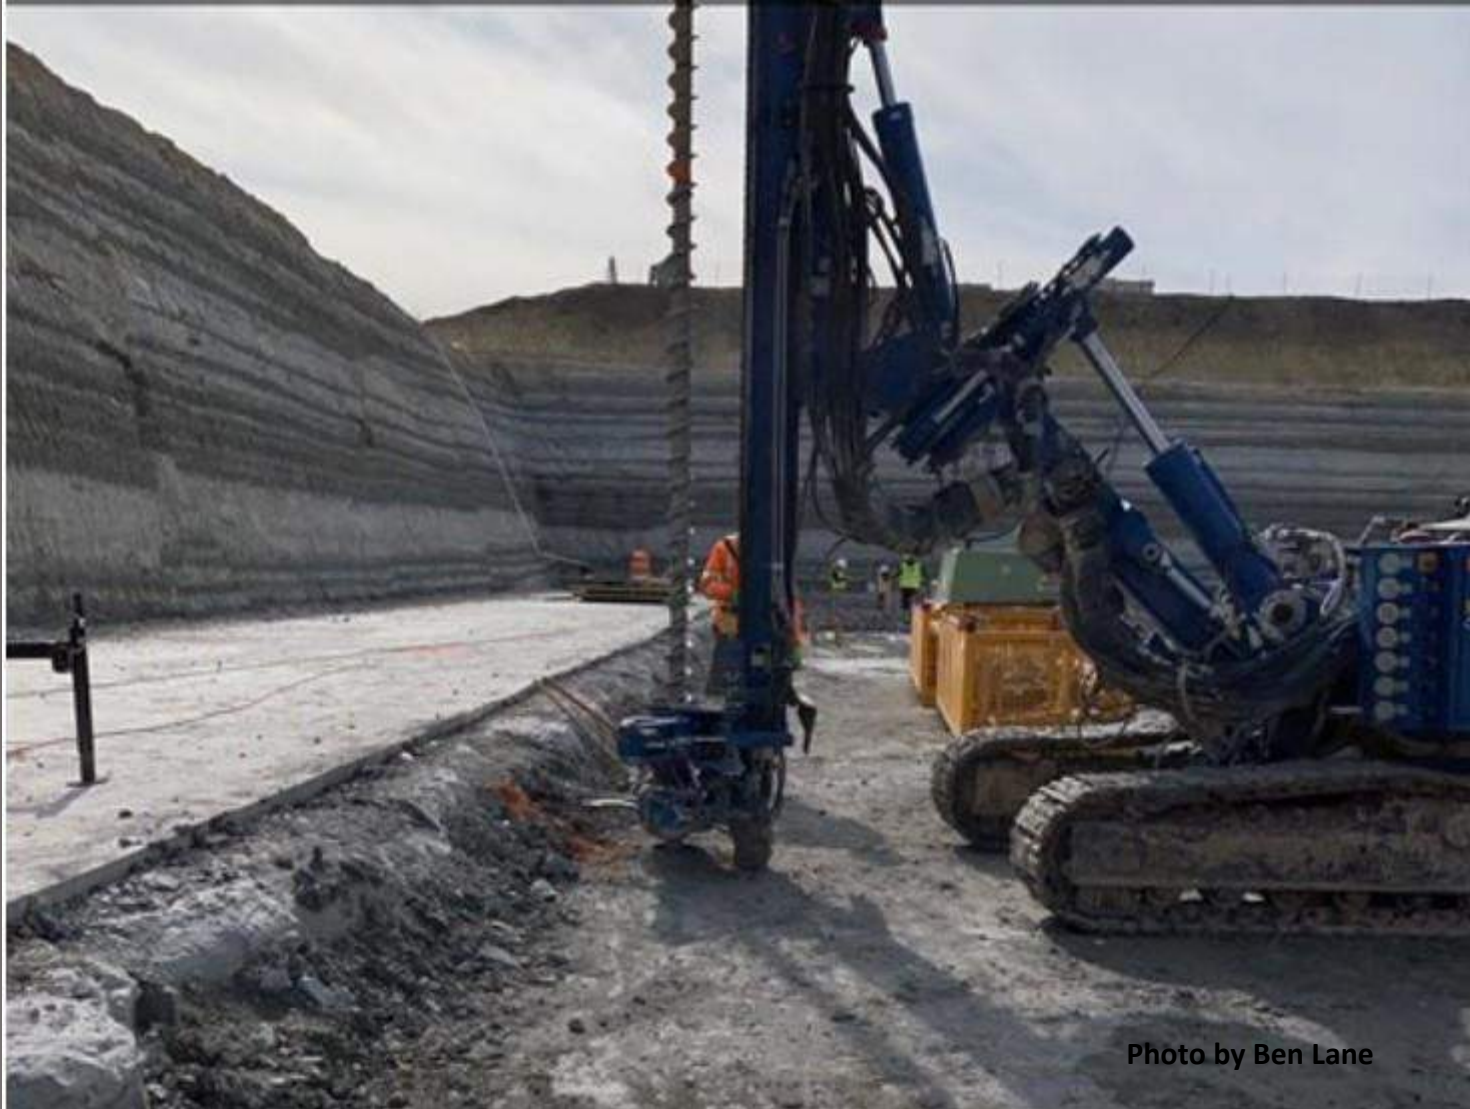
Boreholes Were Augered

A 6-inch ordinary auger was used.

Each 10-foot hole required more than 2 hours to drill.

The cuttings were very fine.

We believe that the cuttings fell back around the auger and bogged down the auger. The holes were lined with dust.

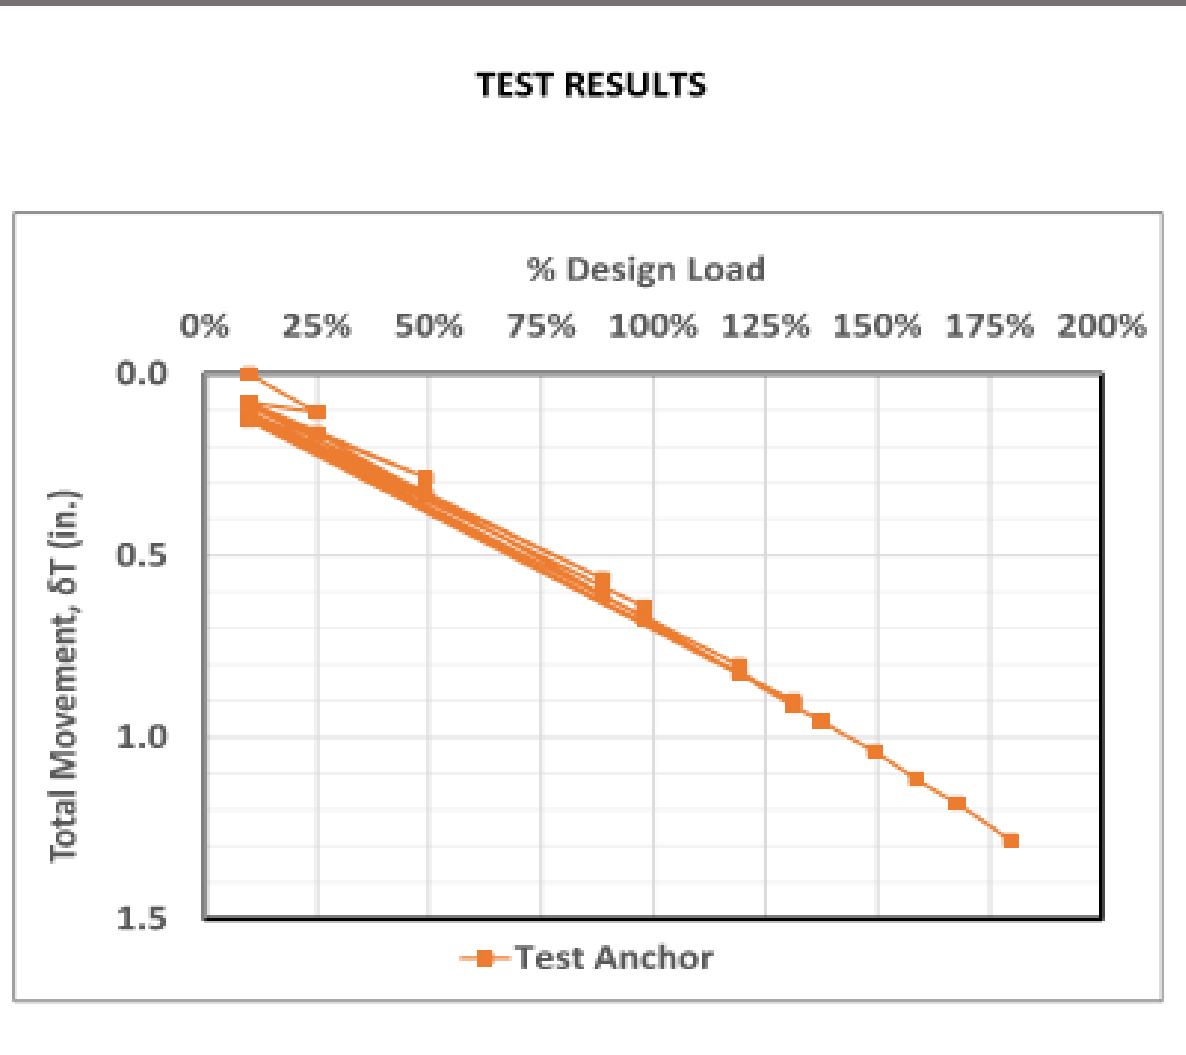
Second Performance Anchor Testing Results

TA#4. Design Load = 151 kips. Max bond stress = 130 psi

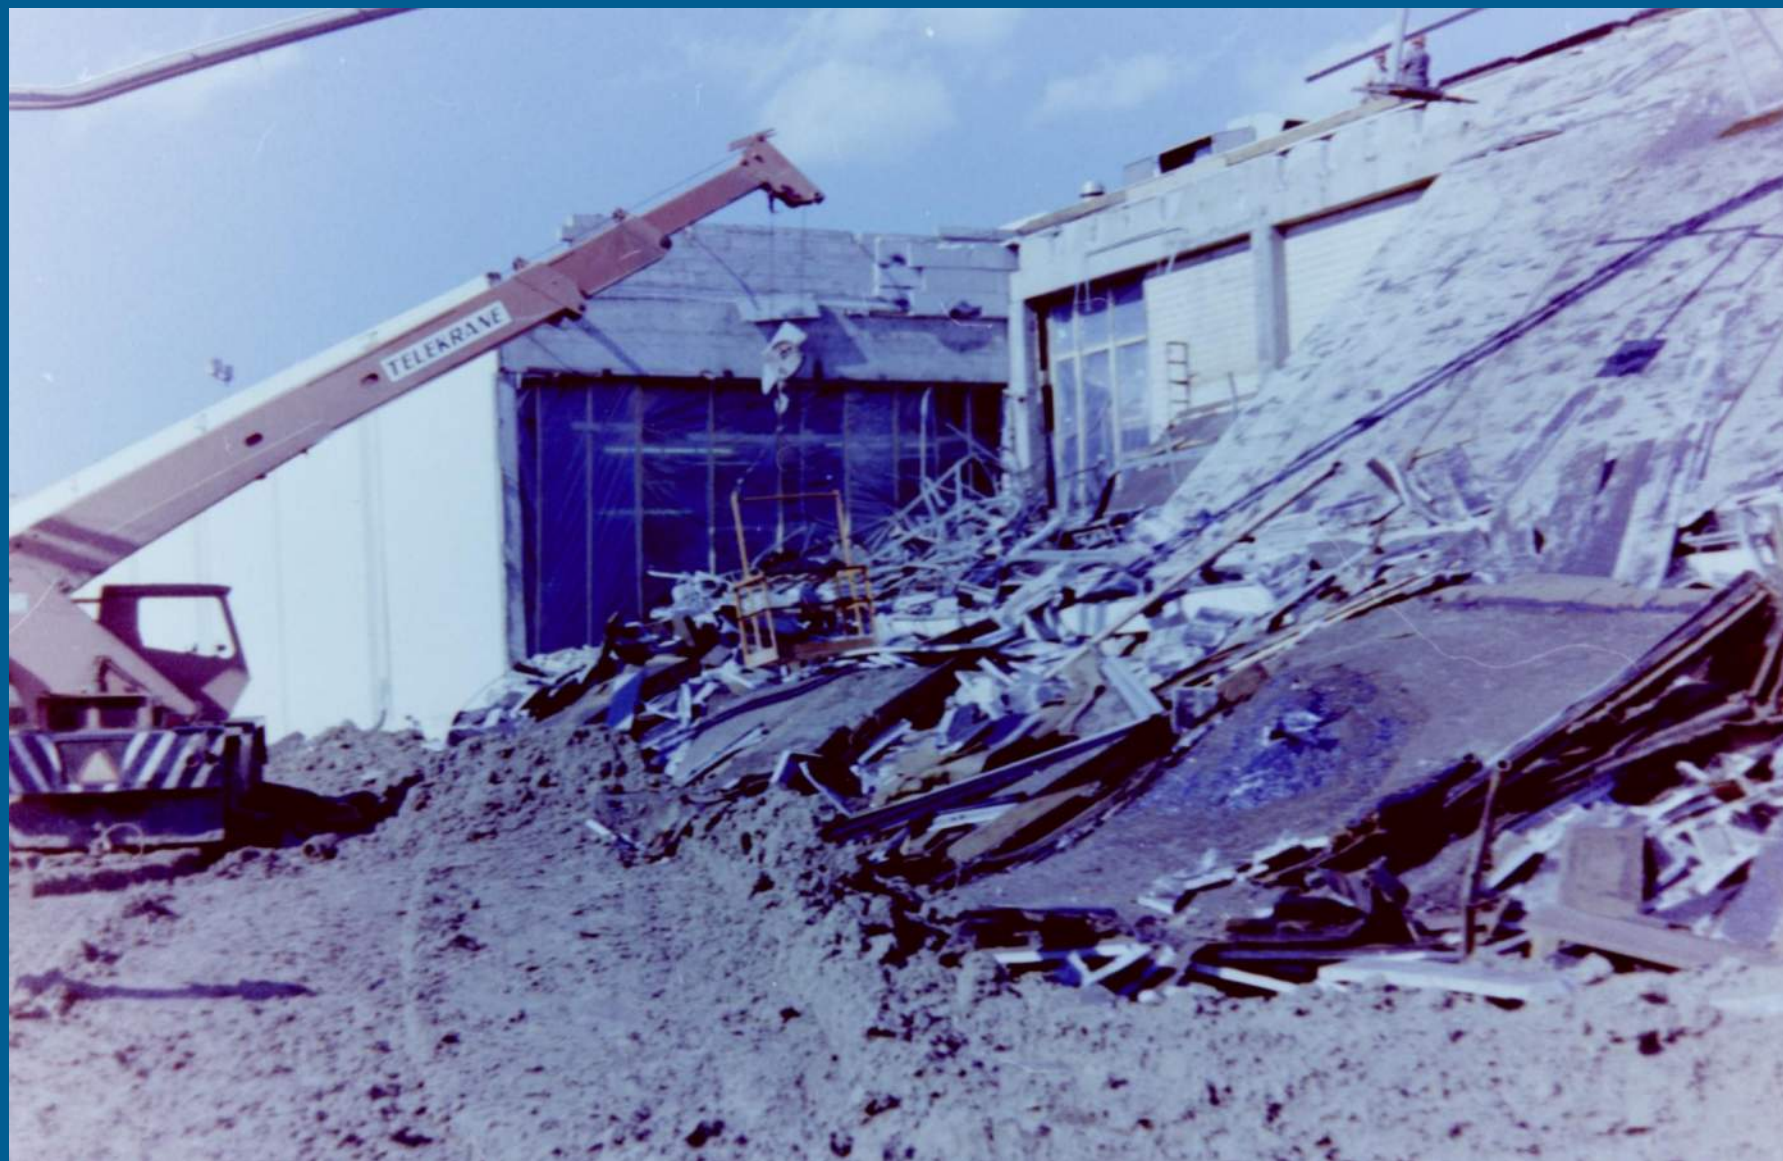
Room North of Cooler That Did Not Collapse

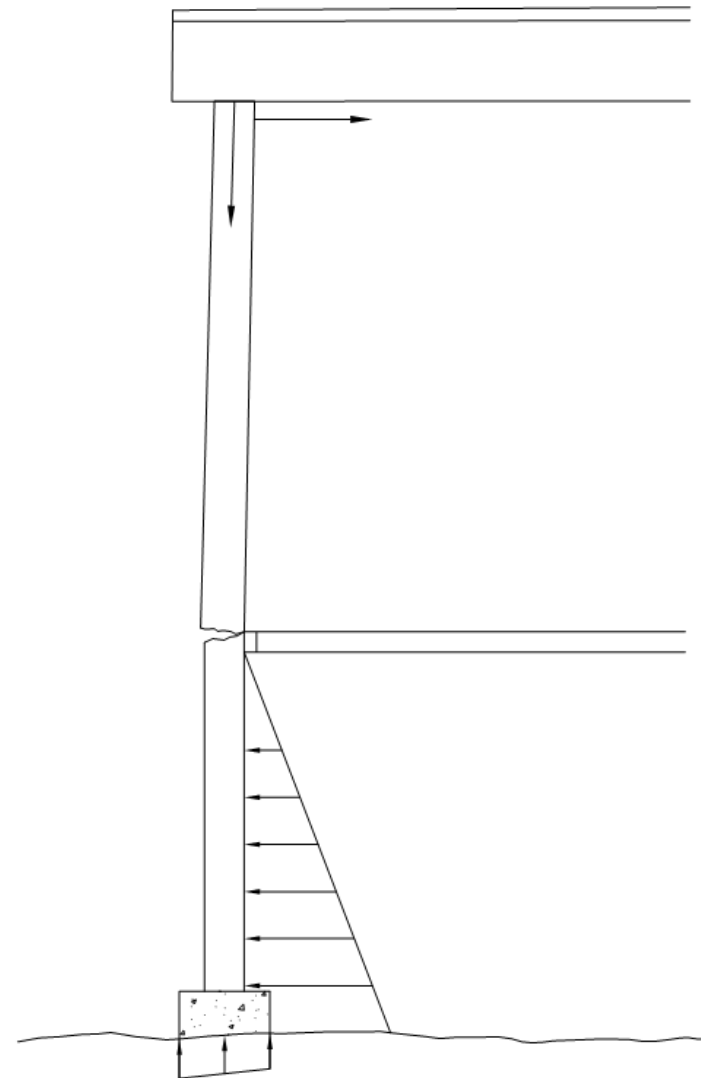
AFTER EXCAVATION

Sliding of the footing and flexural failure of the wall were also marginal.

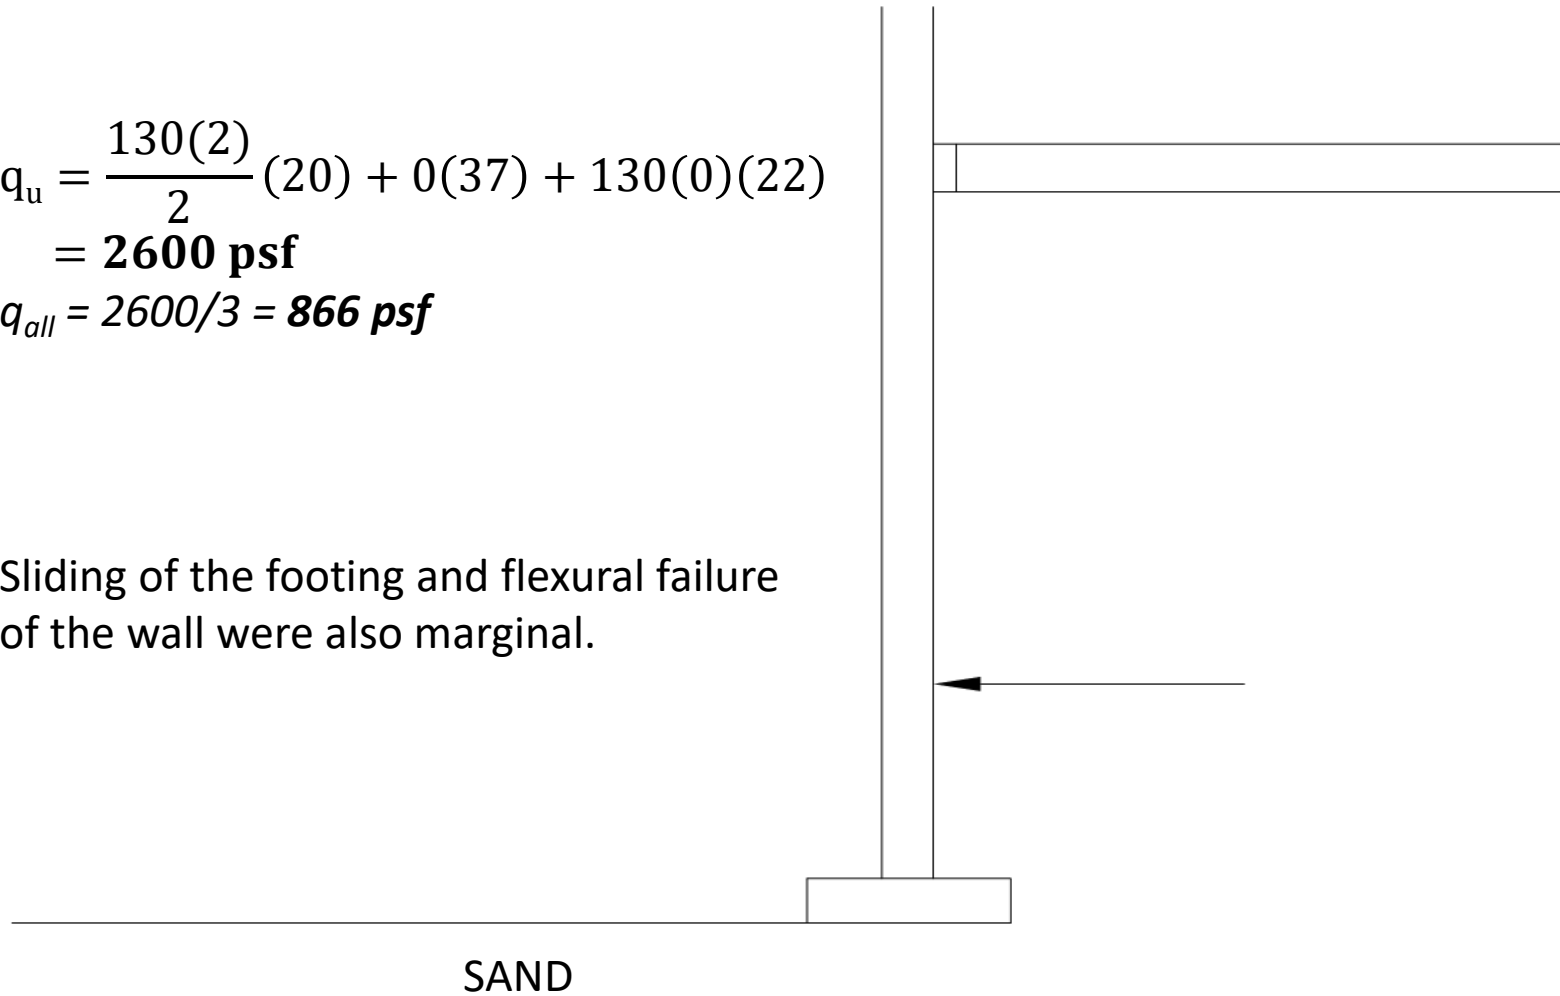
If the wall had not failed, the footing might have slid out

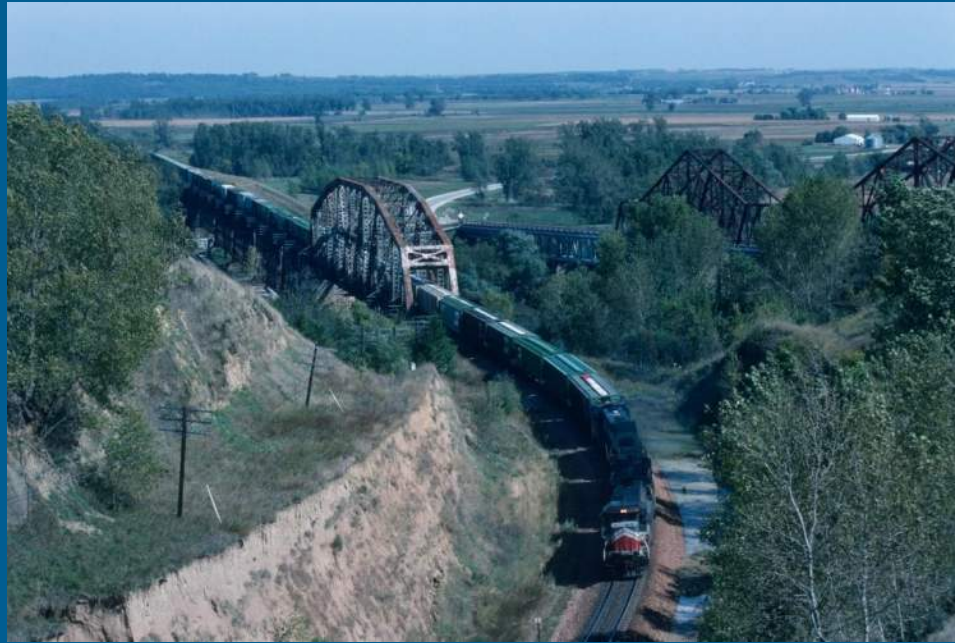
Note the sloughing and accumulation along
the lower outside slope

Sloughing was worst in the lower part of the south slope.

Sampling and testing showed that the soil in the lower part was saturated because infiltrating water became perched on the glacial till.

In winter, freezing penetrated about 2 feet into the face and created thin ice lenses parallel to the slope.

In spring, the ice thawed, and the soil loosened by freezing fell down the slope.

Saturated loess is susceptible to damaging frost action.
